Town of North East

Road-Stream Crossing Management Plan

Delivered by
The Housatonic Valley Association
October 14, 2020
Updated
November 8, 2021

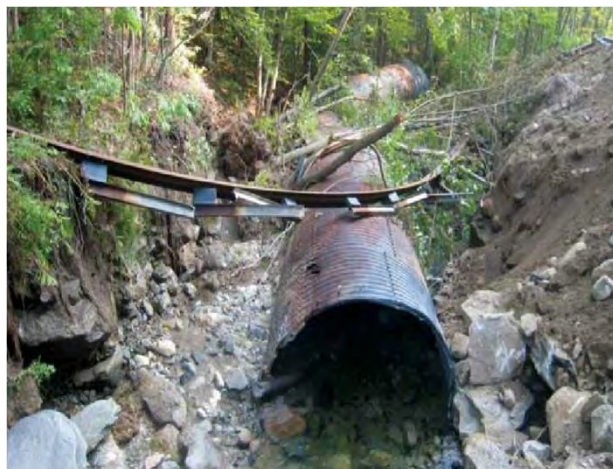
Road failure at a 3-m culvert placed within a 6-m bankfull width stream, GMNF

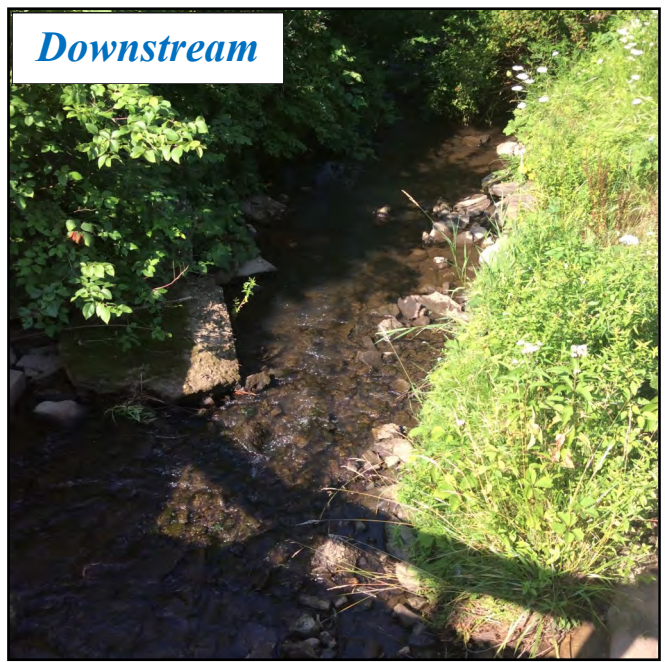
Downstream

Crossing Comments: Horizontal cracks spanning inlet and outlet headwalls

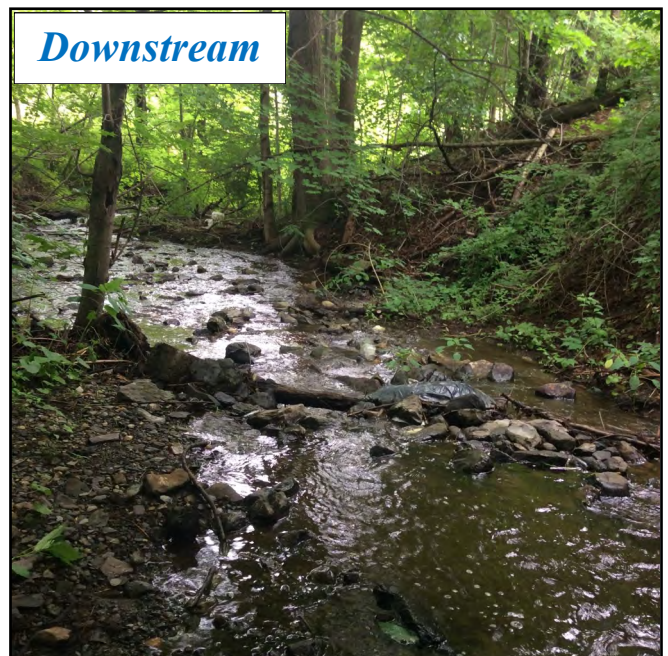
Downstream

Crossing Comments: Wingwall starting to crumble at inlet side and headwall cracking at outlet side.

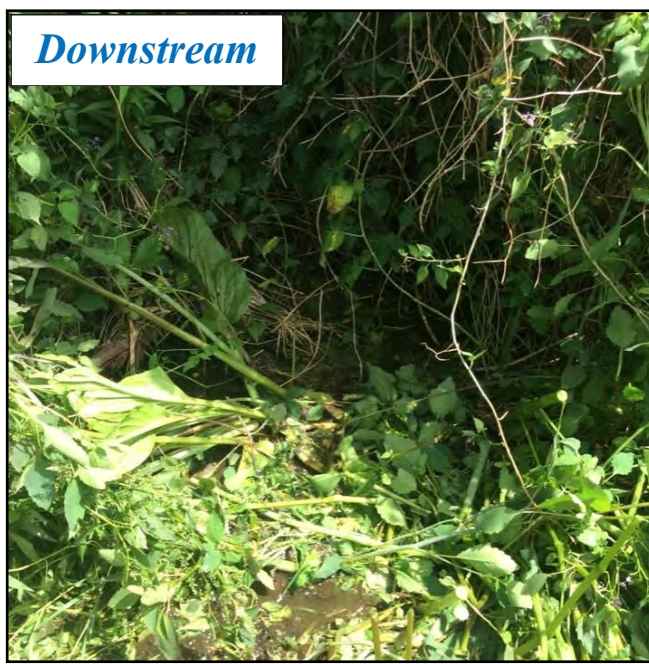
Downstream

Crossing Comments: The upstream is all wetlands and difficult to estimate. There is pond of standing water. Structure is collapsing and in very poor condition. Outlet side has eroded sediment hanging in front of it.

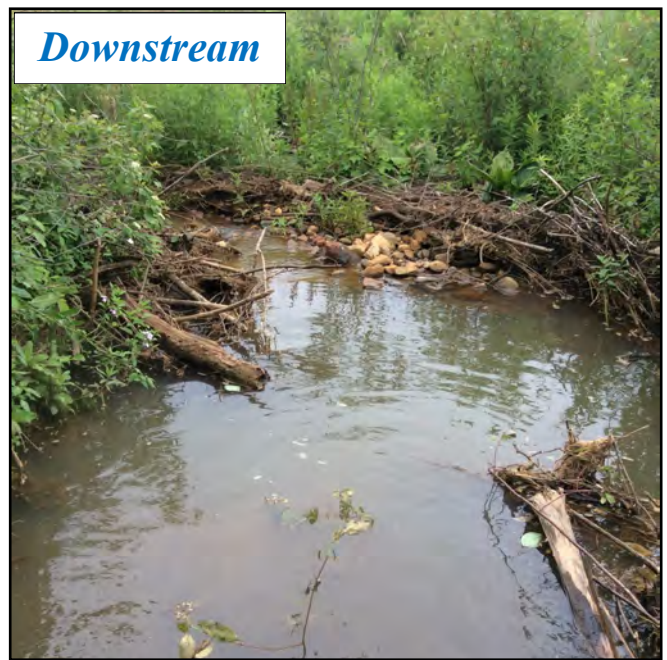
**Downstream**

**Crossing Comments:** There is a channel flowing around culvert. Very poor shape. Metal corroding and land over culvert eroding. Bankfull is estimated due to upstream being a pond.

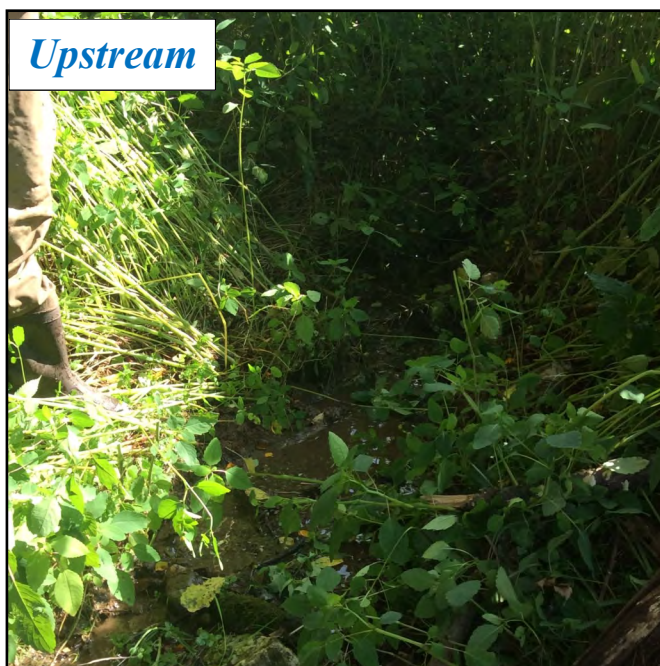
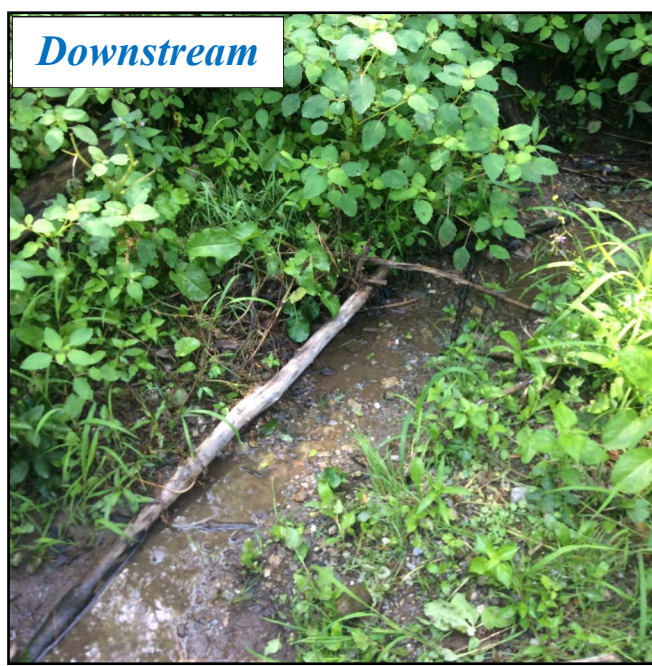
Crossing Comments: Forks off upstream into two channels, one leads to pond 15 feet up the other is presumably for runoff and is dry. Only one bankfull measurement due to brevity of upstream channel before it opens up to the pond. Condition poor due to corrosion at bottom.

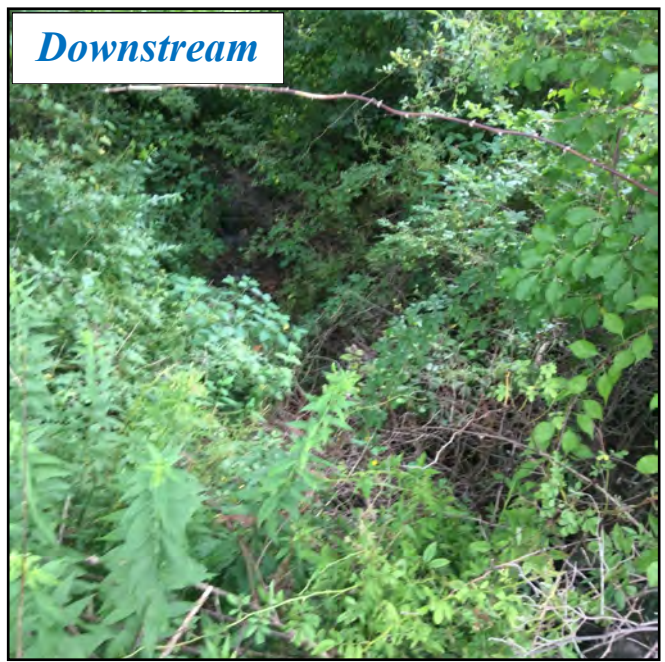
Downstream

Crossing Comments: Bankfull low estimated due to overgrown vegetation and dry condition. Fencing on top of outlet, see other photo

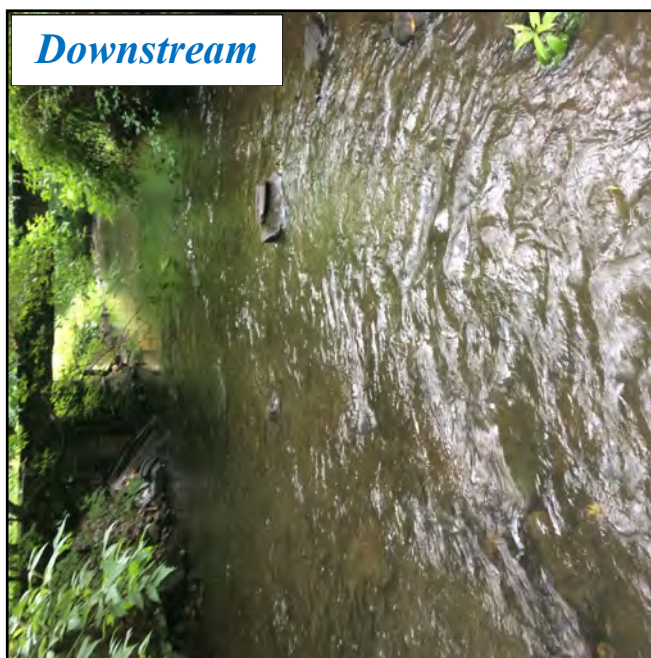
**Downstream**

Crossing Comments: The bridge is in poor condition because pieces of wood and the underside of the bridge on the outlet side is falling down and separating.

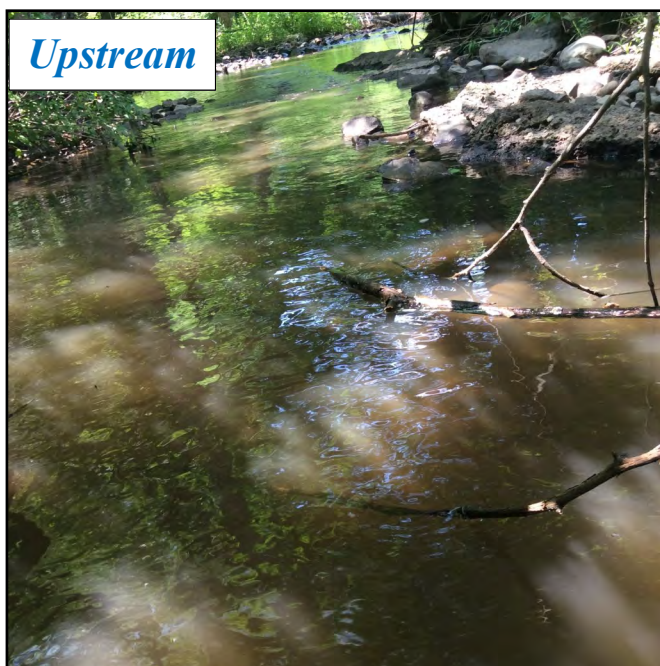
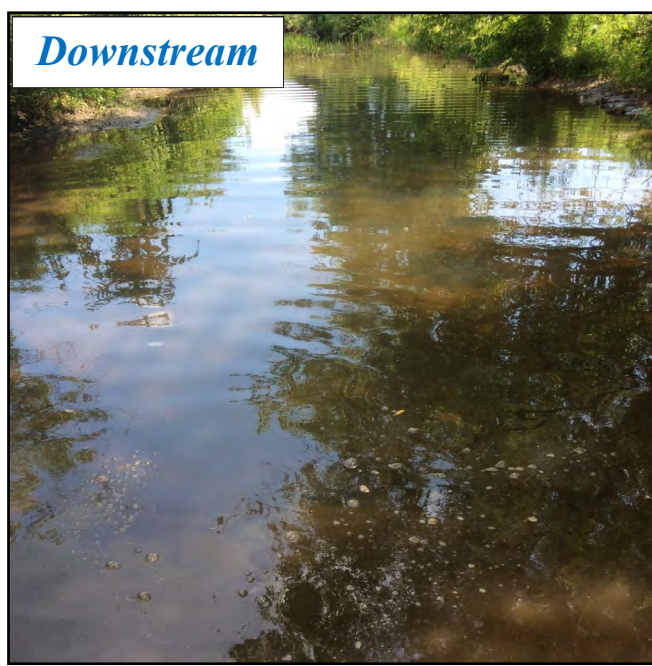
Crossing Comments: There is a large pool at inlet side due to debris damming up both inlet structures. Structure in poor condition. Tops are flattening out.
