Culvert Prioritization Results

Top 7 Crossings for Flood Risk

Town Prioritization Workshop Results

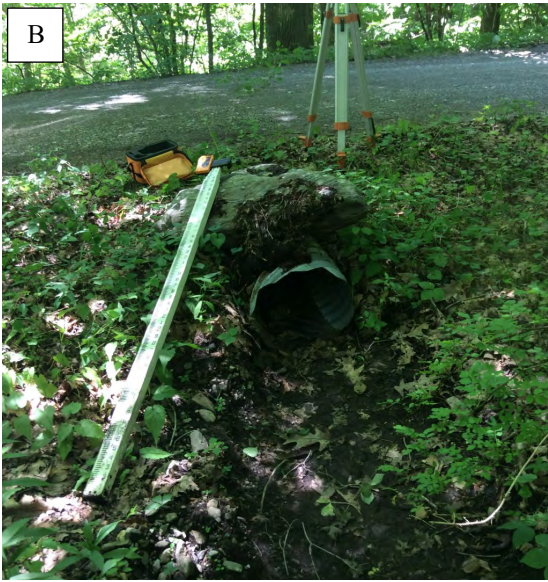
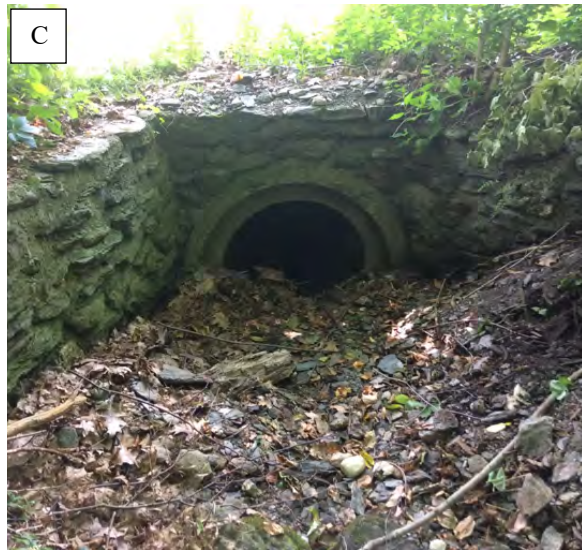
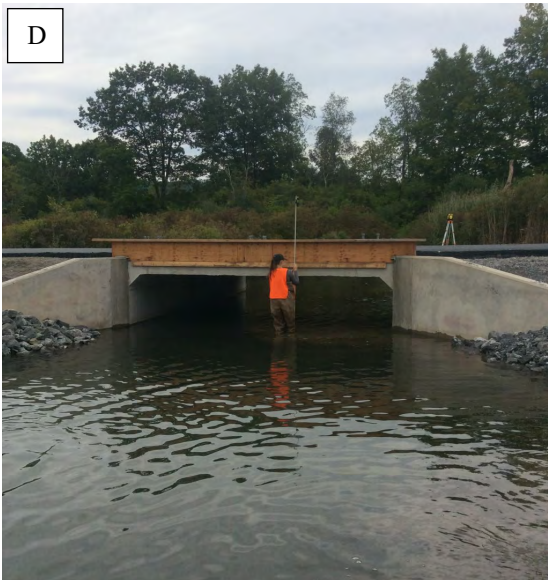
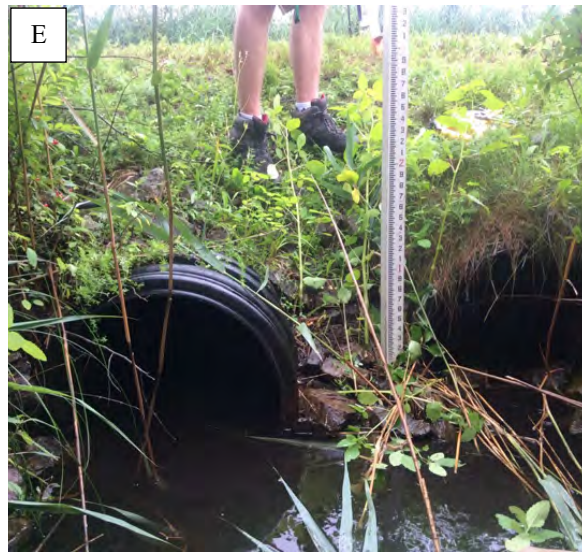
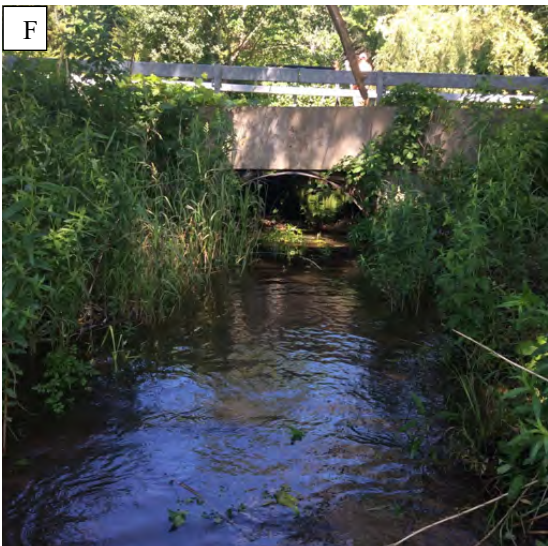
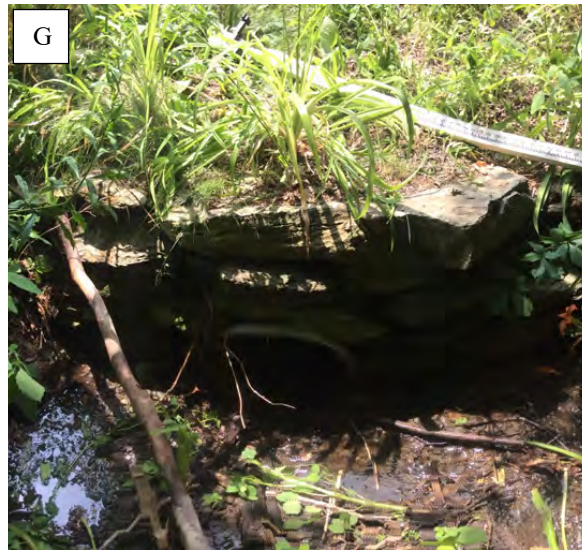
Photo	Flood Interval	Structure #	Road	Map Key	Crossing Code
A	2	27	Mill Road	4E	xy4193453873513191
B	2	106	Kaye Road Detour	2E	xy4200003373496673
C	2	16	Rudd Drive	3E	xy4197944973504130
D	5	24	Mill Road	4E	xy4191837473518146
E	10	52	Boston Corners Road	2E	xy4199734673507936
F	2	25	Mill Road	4E	xy4192036973518111
G	50	53	Boston Corners Road	2E	xy4200652573508196

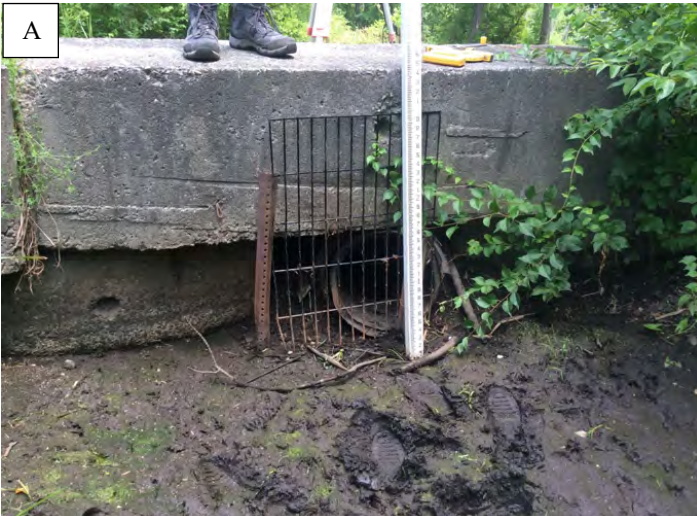
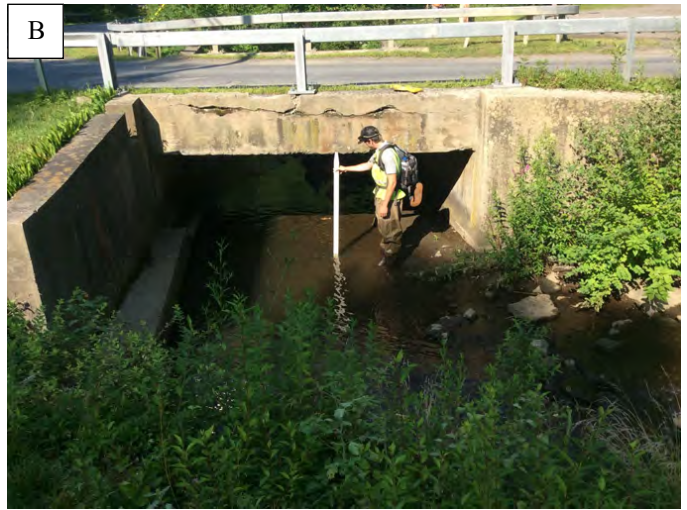
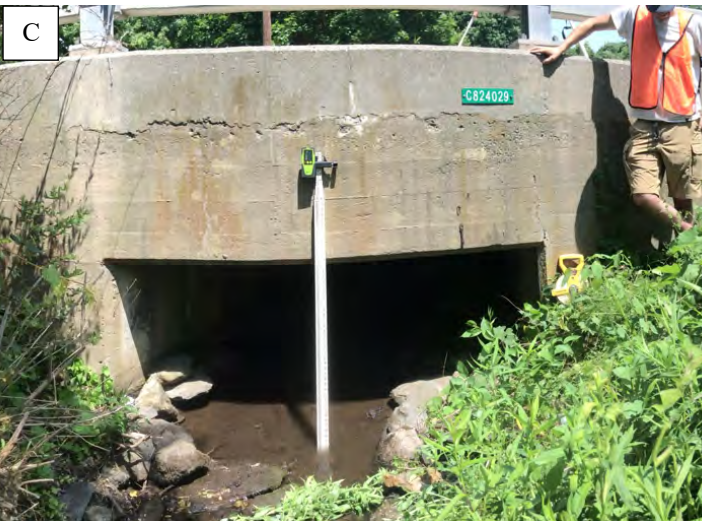
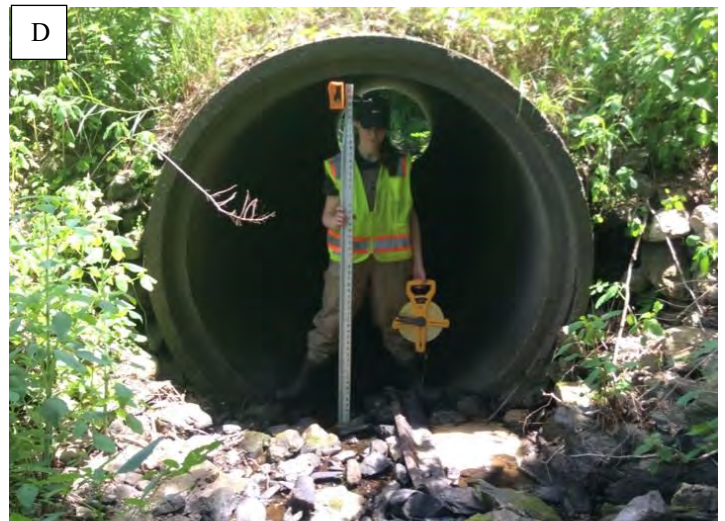
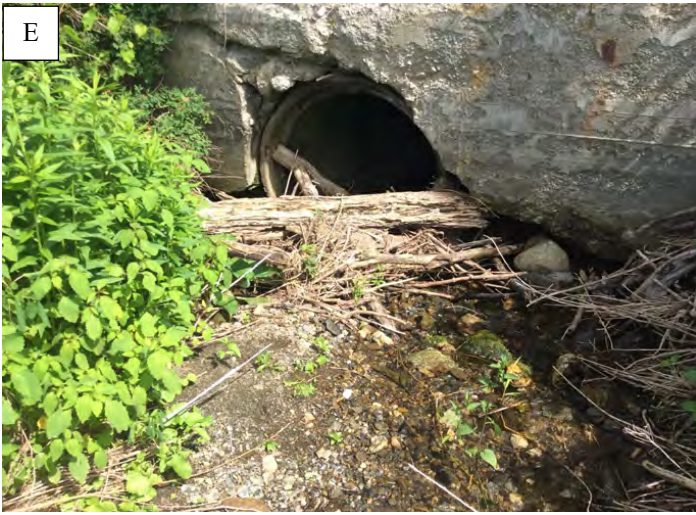
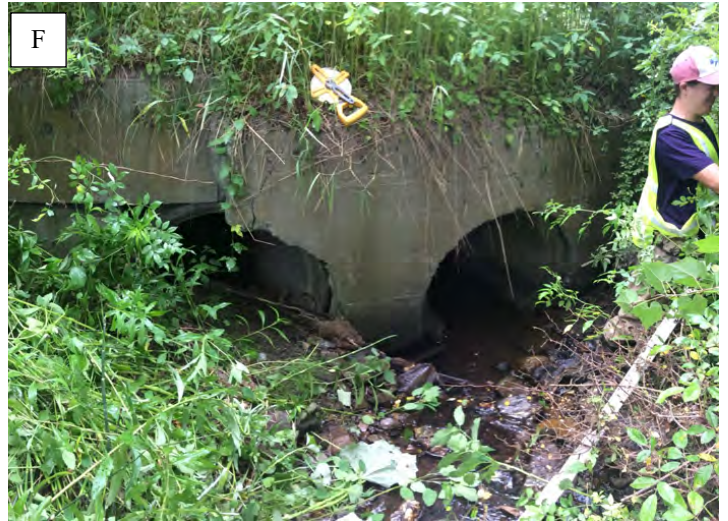
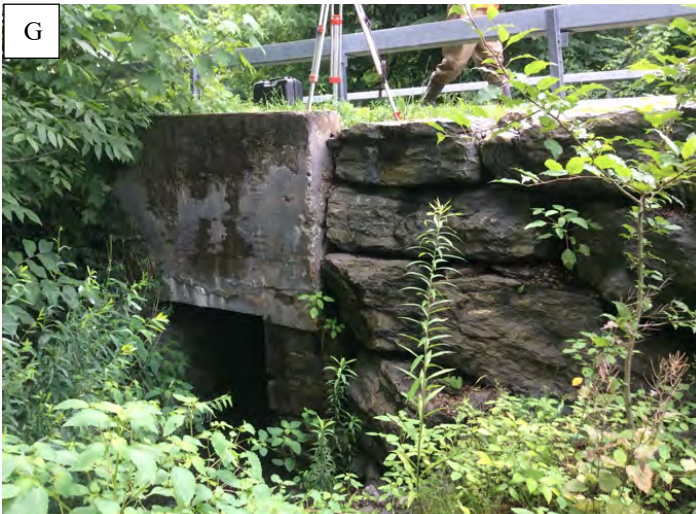
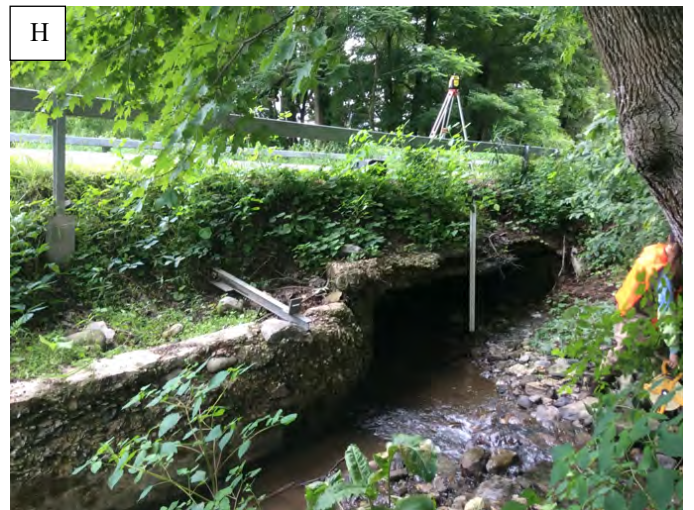
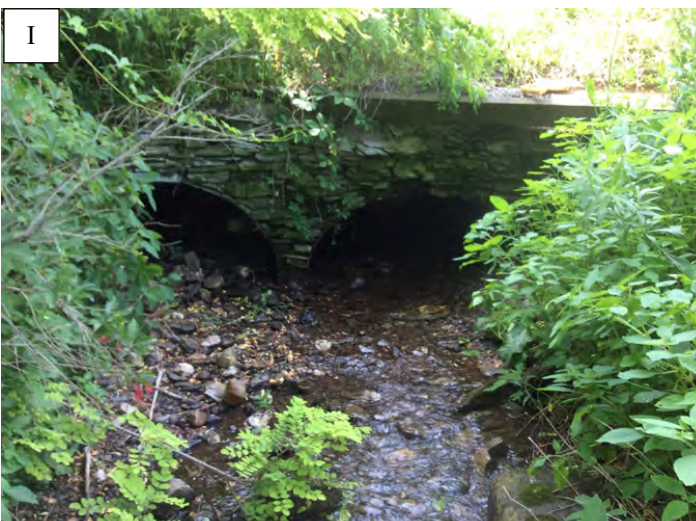
Photo	Structure #	Map Key	Road	Crossing Code	Notes
A	12	3E	Wakeman Road	xy4195340273517144	Cole Lawrence has observed increased frequency of flooding, about six times per summer. NAACC barrier evaluation = moderate
B	9	3E	South Center Street	xy4194997673508970	The stream takes a 90 degree turn to enter the structure; no water over the road in the past 3 years (since Cole has been around), but the situation seems to be getting worse [with the water hitting the structure as it turns]; Cole Lawrence said he hasn't had to go in and clear out debris
C	88	3E	Route 22	xy4195511973514594	Cole Lawrence densely vegetated and possibly slowing flows on the upstream end, but did not indicate that there are any issues with
D	35	5D	Perrys Corners Road	xy4189638073550359	The last section toward the outlet is pulling apart and causing the road to cave in; they have never seen it flood the road; note that this structure is a conservation priority (significant barrier)

Photo	Structure #	Map Key	Road	Crossing Code	Notes
E	36	5D	Perrys Corners Road	xy4189754173547786	The only issue is when the inlet gets blocked with the debris, then the water has gone over the road ~once every 5 years; Would make sense to do this structure when they do the one above, ideally within the next 5 years
F	31	5C	Morse Hill Road	xy4190063373576388	Headwall is failing; they don't have issues with flooding or debris
G	13	3E	N Center Street	xy4196367273519163	Concrete is failing; they don't have issues with flooding or debris
H	7	3D	Old post Road 2	xy4197602673525807	Poor condition, nothing left for the guiderail to attach to
I	28	5B	Sheafer Road	xy4190072073616305	There have been on-going discussions of closing the road, it is currently a town road, but there are landowners who are avid fishermen and they want to replace/remove the culvert; o Probably not worth focusing on this one because of those on-
