Culvert Prioritization Results

Top 7 Crossings for Flood Risk

Town Prioritization Workshop Results

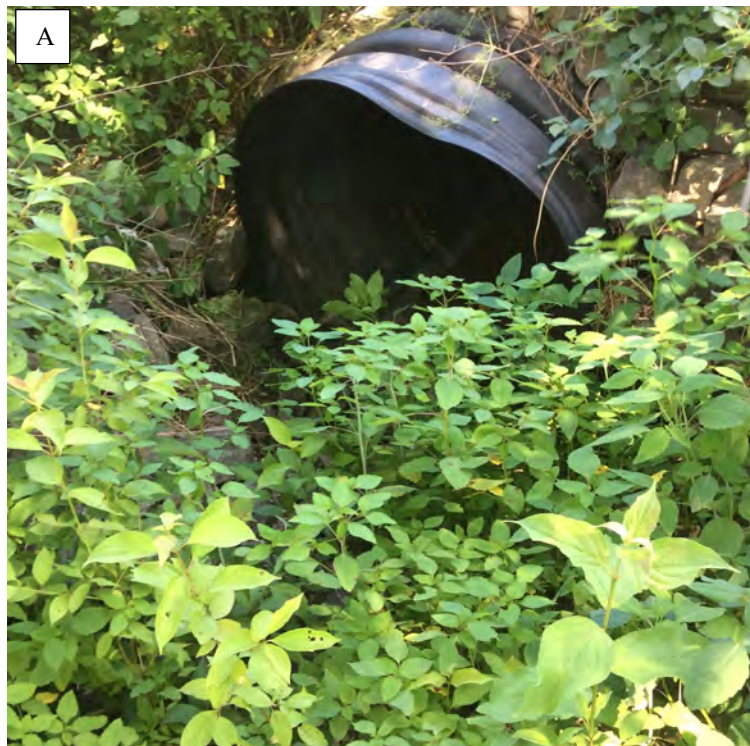
This chart is a summary of town and county-managed road-stream crossings with the shortest flood intervals (i.e. most likely to flood the road) based on modeling performed by the University of Connecticut. Not that only closed-bottomed structures (e.g., culverts) were modeled for risk of failure.

Photo	Flood Interval	Structure #	Road	Map Key	Crossing Code
A	2	27	Mill Road	4E	xy4193453873513191
B	2	106	Kaye Road Detour	2E	xy4200003373496673
C	2	16	Rudd Drive	3E	xy4197944973504130
D	5	24	Mill Road	4E	xy4191837473518146
E	10	52	Boston Corners Road	2E	xy4199734673507936
F	2	25	Mill Road	4E	xy4192036973518111
G	50	53	Boston Corners Road	2E	xy4200652573508196
