Town of North East

Road-Stream Crossing Management Plan

Delivered by
The Housatonic Valley Association
October 14, 2020
Updated
November 8, 2021

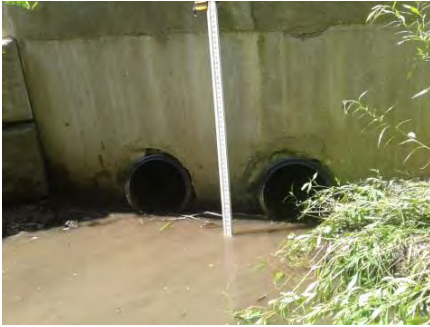
Undersized Crossings

A crossing that is too small relative to its bankfull width can lead to faster flows, which in turn can cause erosion at the inlet and outlet (see Outlet Drops and Scour & Erosion below). Undersized crossings are often accompanied by outlet drops and/or scour pools that result from excess flows.

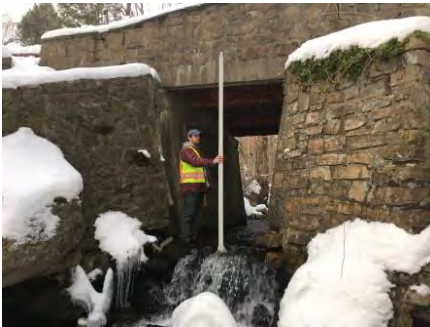
Outlet Drops/Perched Culverts

Crossings that are undersized may have large drops at the outlet, which are called outlet drops or perched culverts. Such drops can be caused by erosion/scouring of the downstream stream bed

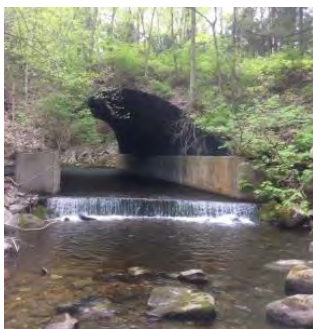
Shallow Crossings

Crossings that are undersized or improperly aligned can lead to high flows and erosion that can lead to the water inside the structure being too shallow. Inadequate depths can pose a barrier to fish passage. They also usually lack a substrate that matches stream bed. These crossings can be impassable or even dry for long periods of time.

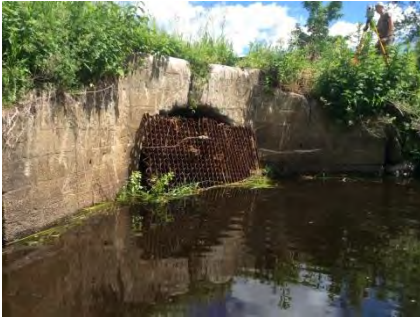
Ponding is the backup of water upstream of an undersized crossing. Typically, the ponded water upstream becomes stagnant, leading to increased temperatures, lower oxygen levels, and poor fish habitat. Ponding can lead to stream bank and road erosion, damage of surrounding property, and creation of wetland ecosystems. It may occur seasonally due to high waters/flooding, or year-round due to induced effects such as clogging.

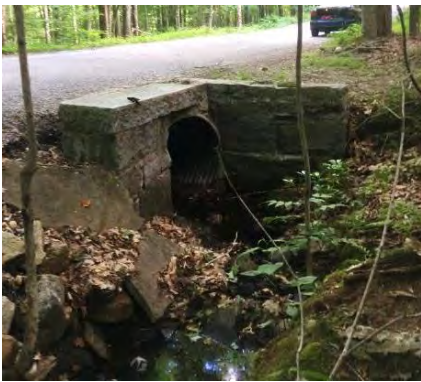
Misaligned Crossings

A crossing whose inlet is skewed in relation to the stream is considered misaligned. Misaligned crossings can result from improper installation (e.g. installing a pipe perpendicular to the road, even though the stream approaches at an angle). Misaligned crossings have a higher probability of clogging, scouring or eroding, and producing ponding.

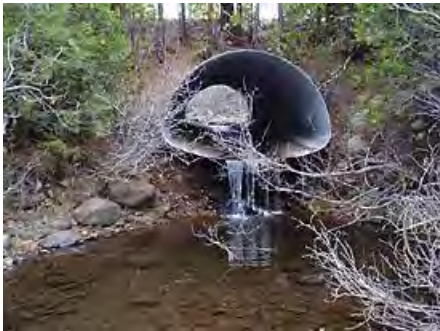
Scour and Erosion

Scour and erosion goes hand-and-hand with high flow and ponding, and is a consequence of all crossing insufficiencies besides shallow crossings. Scour pools often form at the downstream end of perched crossings, leading to the undercutting of the crossings, or in a worse case, the road. Eroded stream banks occur both upstream and downstream of the crossing. Lastly, scouring of natural substrate within the crossing degrades passage and natural habitat for aquatic and terrestrial life.

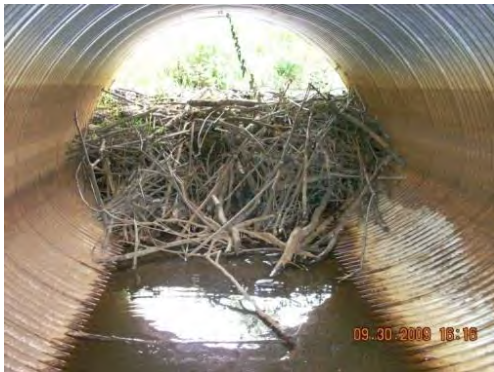
Undersized culverts, which constrict flow, are almost irresistible to beavers. Source: www.martinezbeavers.org/wordpress

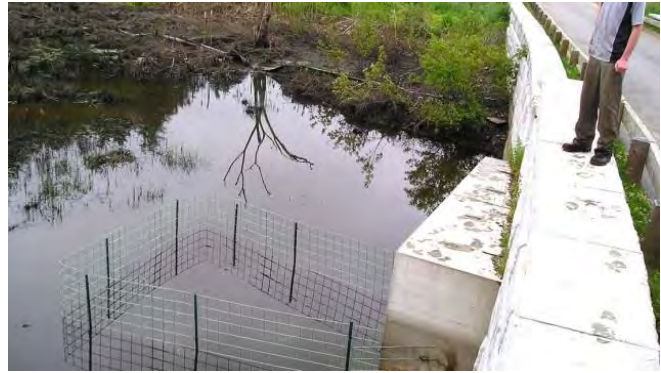
Culvert fences are the most commonly used beaver device by the Forest Service, however they may block fish passage. USFS concludes that the best solution is culvert replacement. Source: www.beaversolutions.com

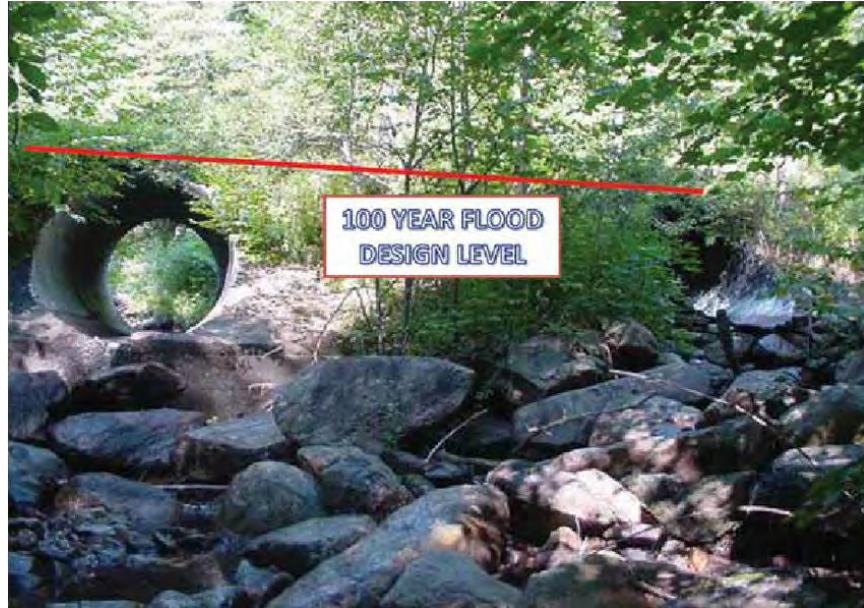
Double-barrel hydraulically designed culvert on Jenny Coolidge Brook, Green Mountain National Forest, VT

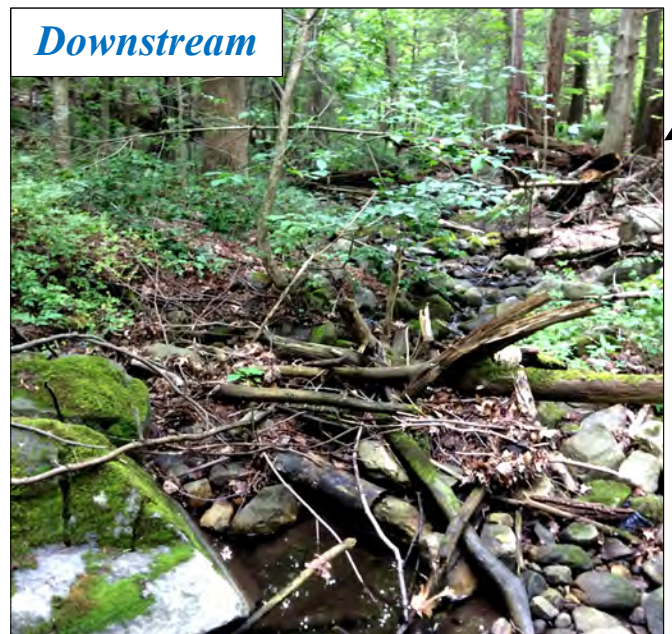
Downstream

Scour Pool: Large
Bankfull Width (feet): 12
Water Depth/Velocity Matches Stream: Yes/Yes
Structure Substrate Type: Cobble
Structure Substrate Matches Stream? Comparable

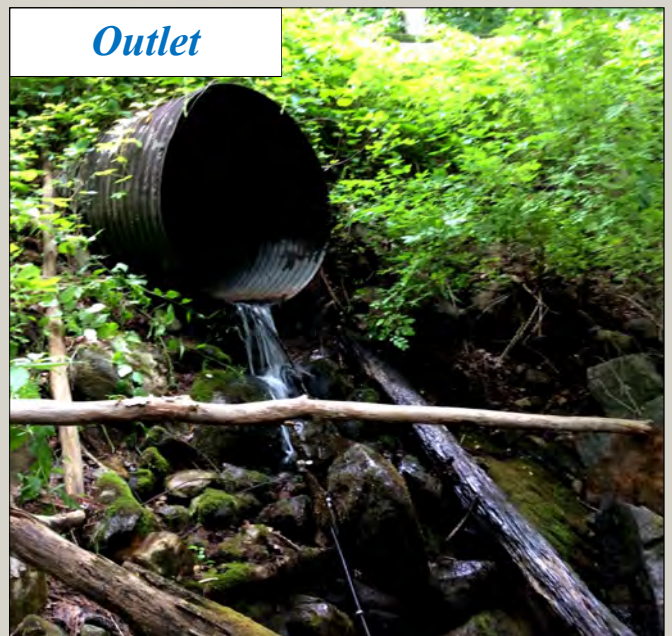
Outlet Shape: Round Culvert
 Outlet Drop/Grade: Free Fall Onto Cascade
 Drop to Stream Surface/Bottom: 5.5/5.8

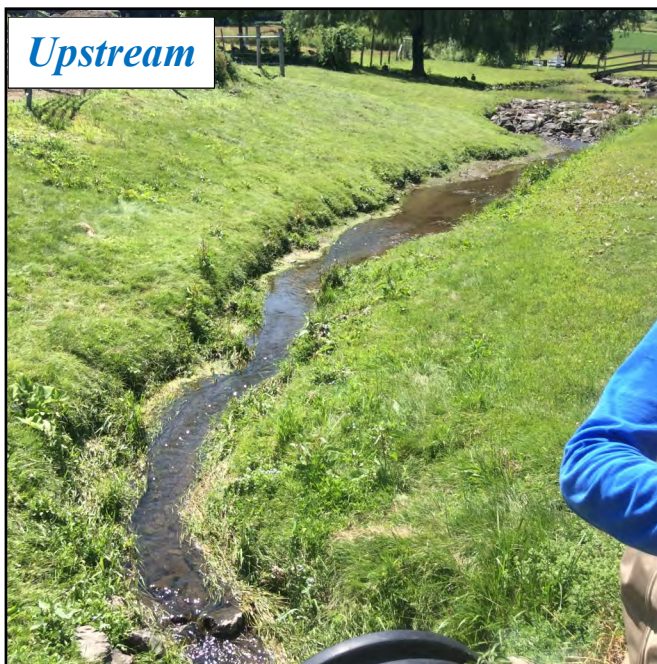
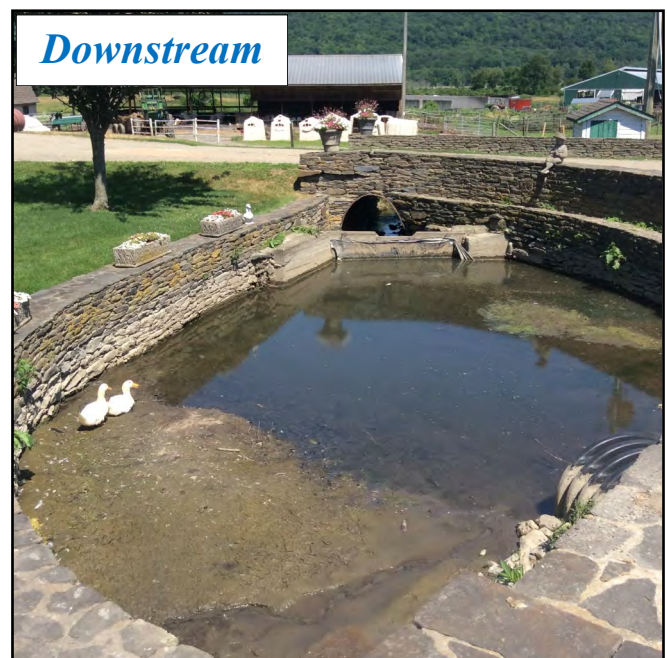
Crossing Comments: Dam at culvert 50 feet downstream unknown if scour pool would be present without dam.

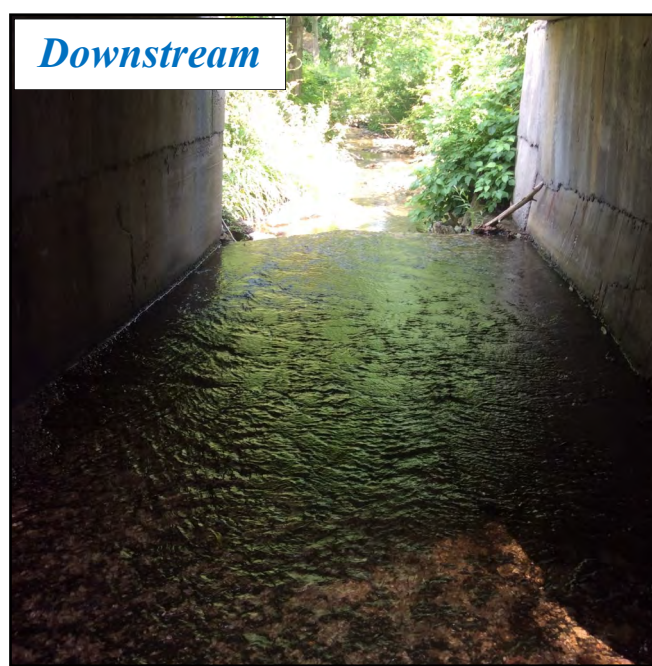
Crossing Comments: This structure is basically a part of xy4199350273507056, it is the concrete structure just upstream of the other structure's inlet

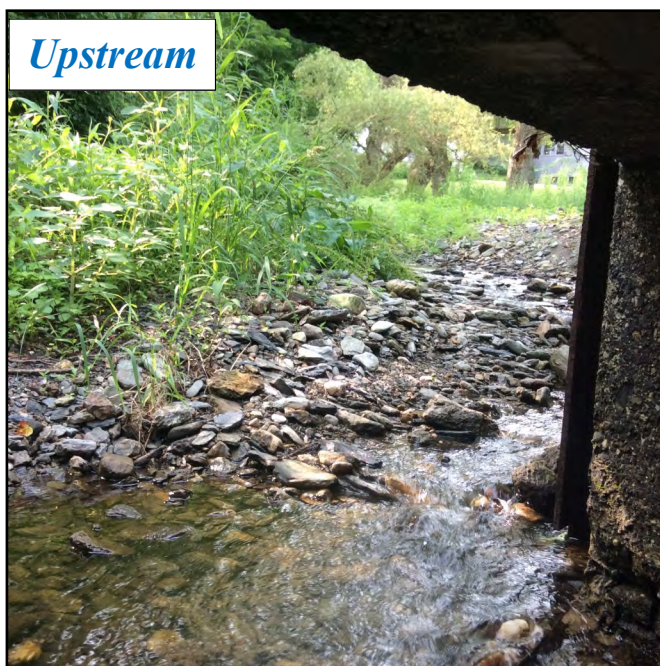
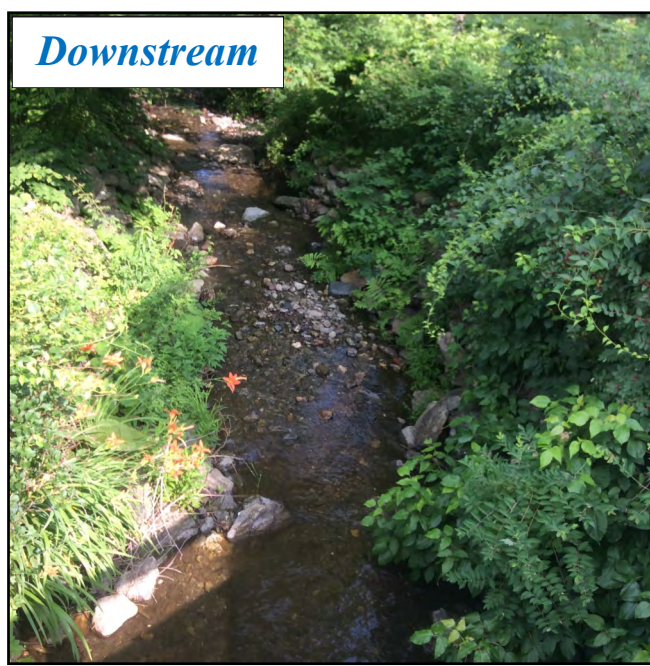
Crossing Comments: Presence of other culvert prevented good inlet photo so I took two and put the other one as an Other photo see xy4199349273507109 for the record of the other structure just in front of the inlet

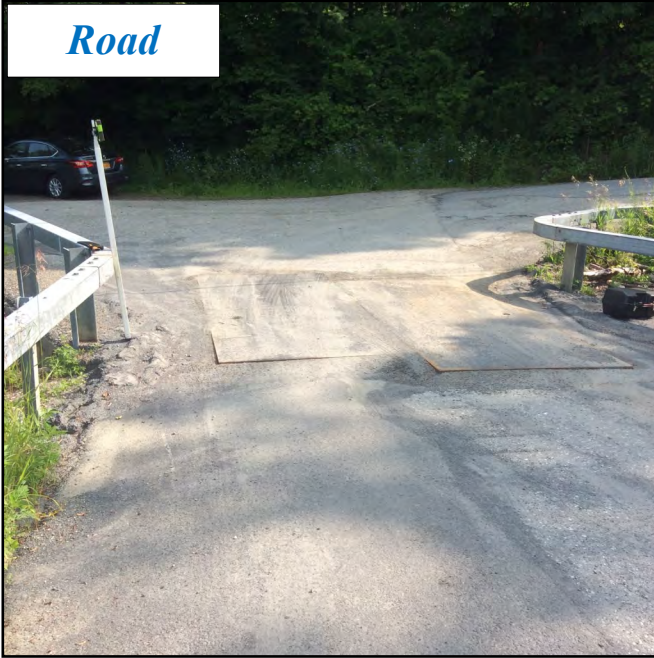
Road

Structure Comments: Another culvert is the barrier, makes the flow narrower and is directly in

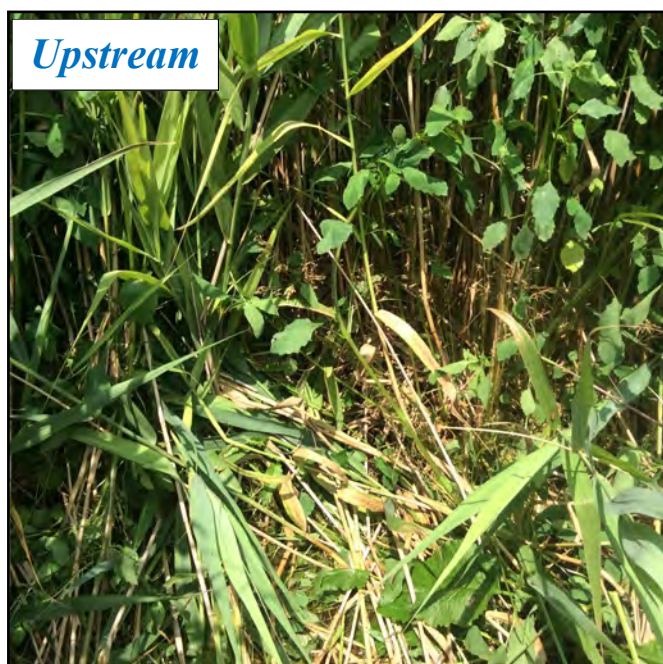
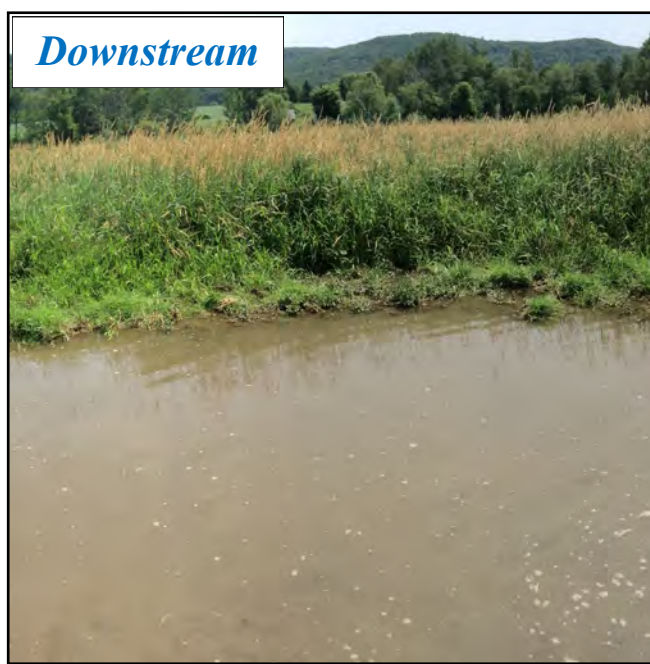
Crossing Comments: Upstream and downstream are wetlands areas so bankfull estimated

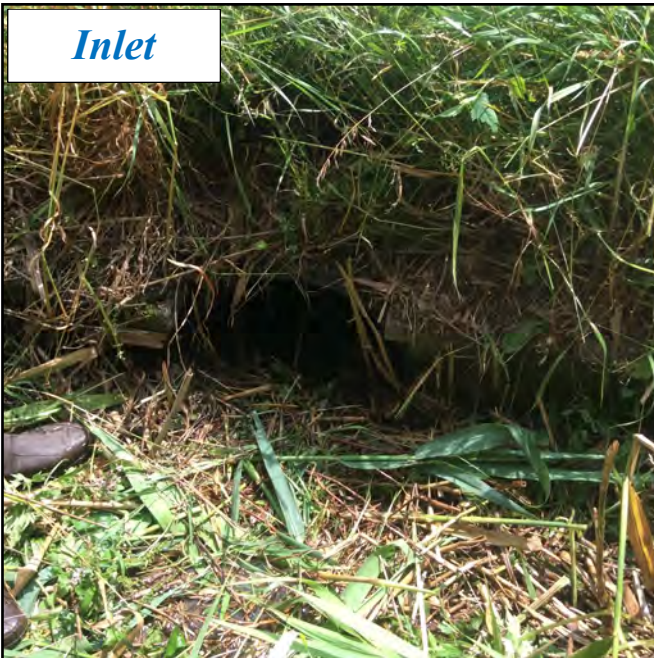
Physical Barrier(s) (Severity): None
 Slope (%): 0.05
 Structure Comments: Inlet drop of 0.4 feet

Inlet Shape/Type: Round Culvert/Wingwalls
 Inlet Drop/Grade: Inlet Drop

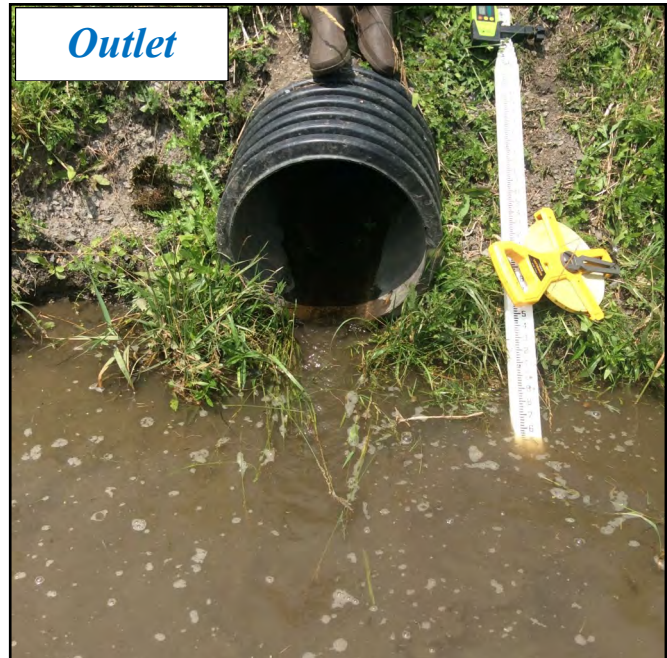
Outlet Shape: Round Culvert
 Outlet Drop/Grade: Free Fall
 Drop to Stream Surface/Bottom: 0.1/0.3

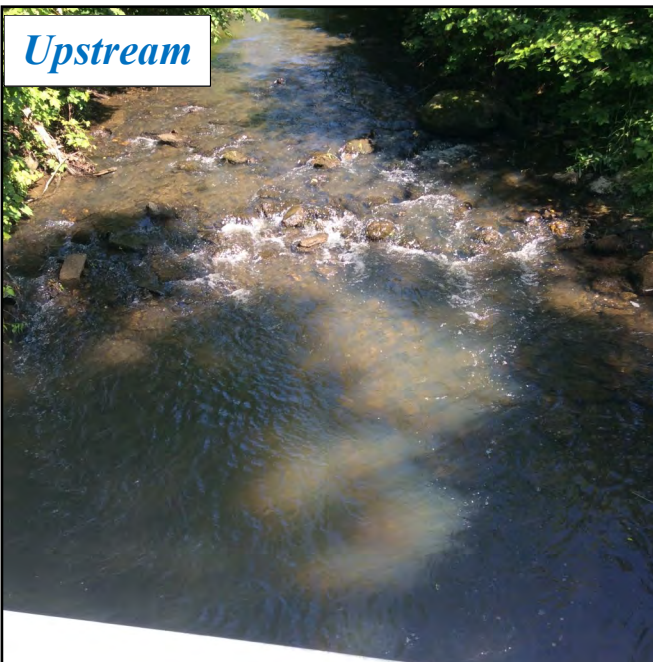
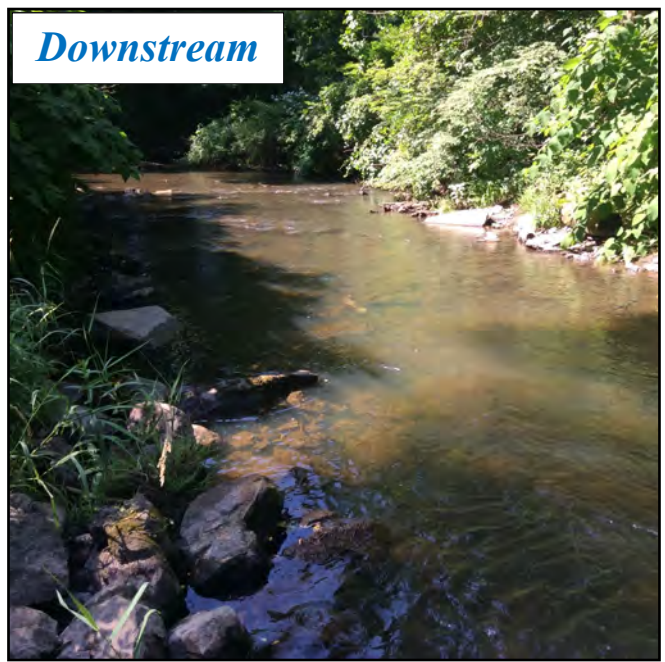
Crossing Comments: Large pool just before inlet, possible due to confluence with Kelsey Brook, inlet is 0.8 feet from stream bottom, but is still under water

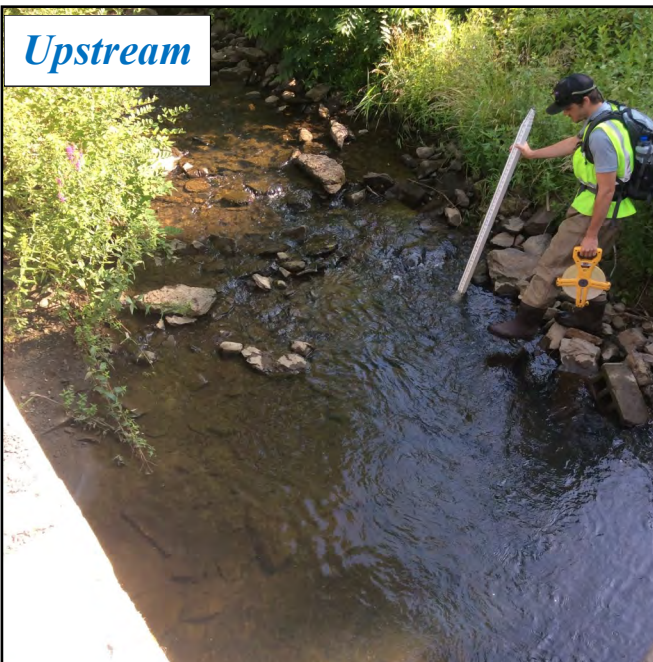
Upstream

Crossing Comments: Horizontal cracks spanning inlet and outlet headwalls

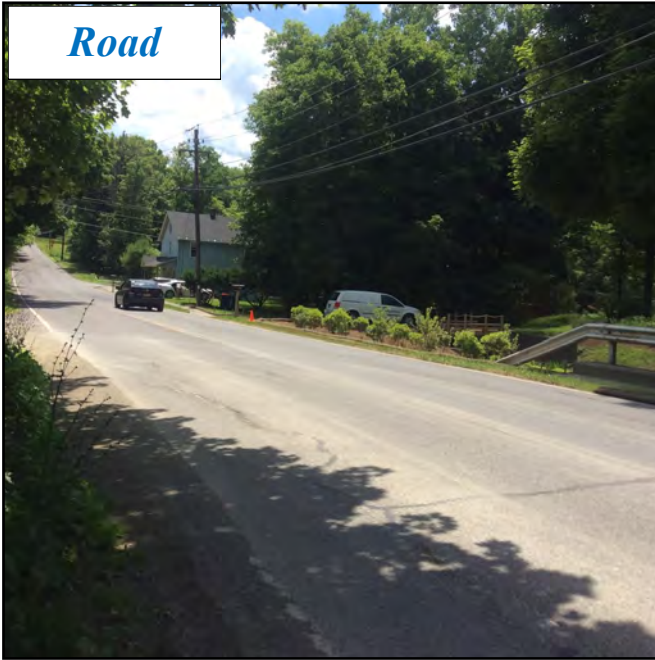
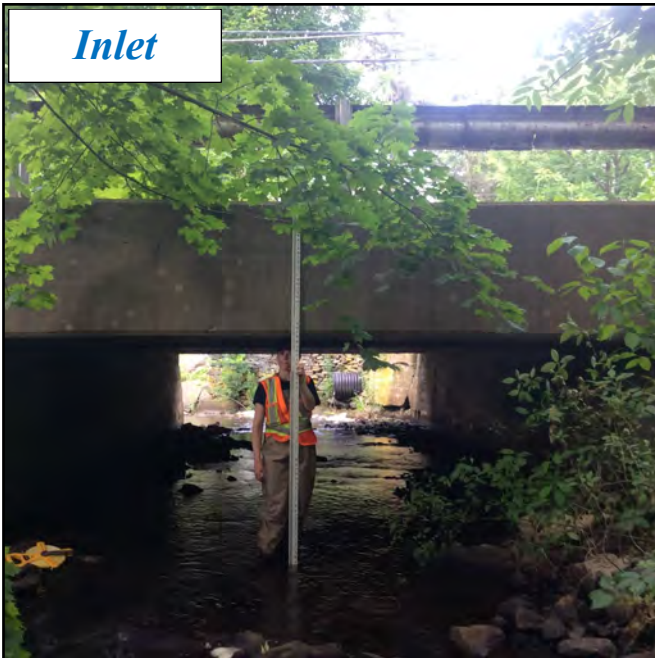
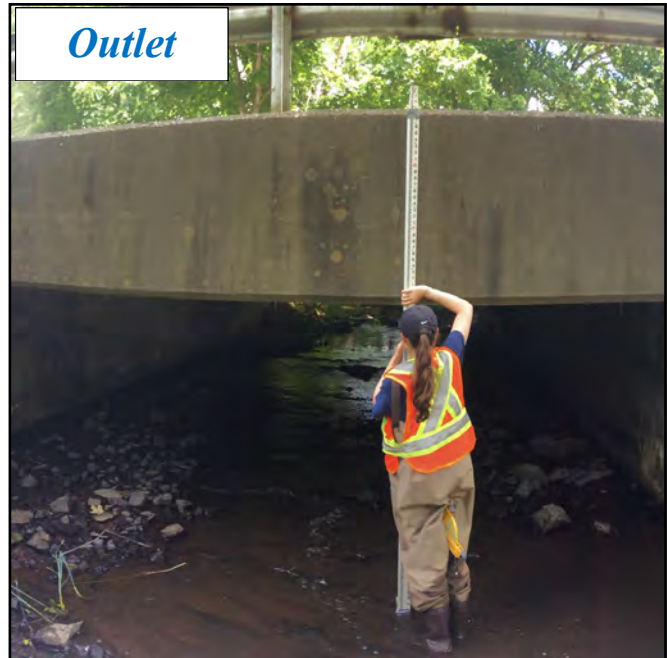
Crossing Comments: Channel heavily modified downstream

Cole Lawrence has observed increased frequency of flooding, about six times per summer. NAACC barrier evaluation = moderate barrier to aquatic organism passage

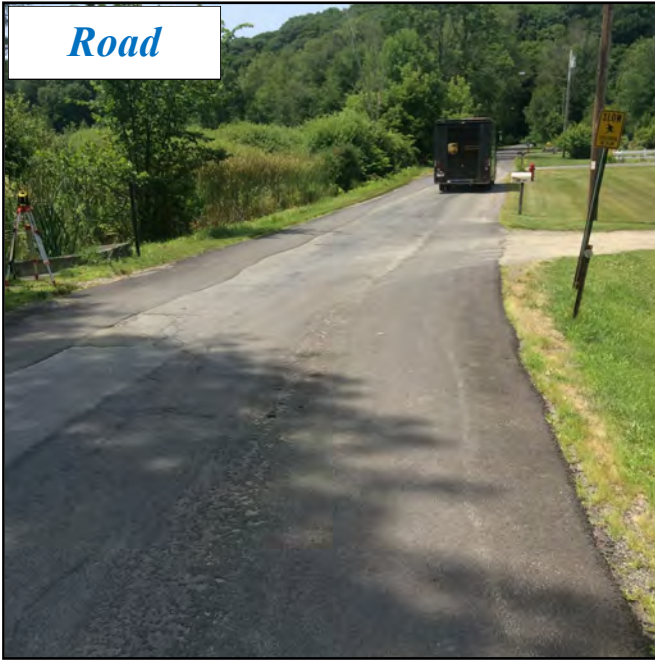
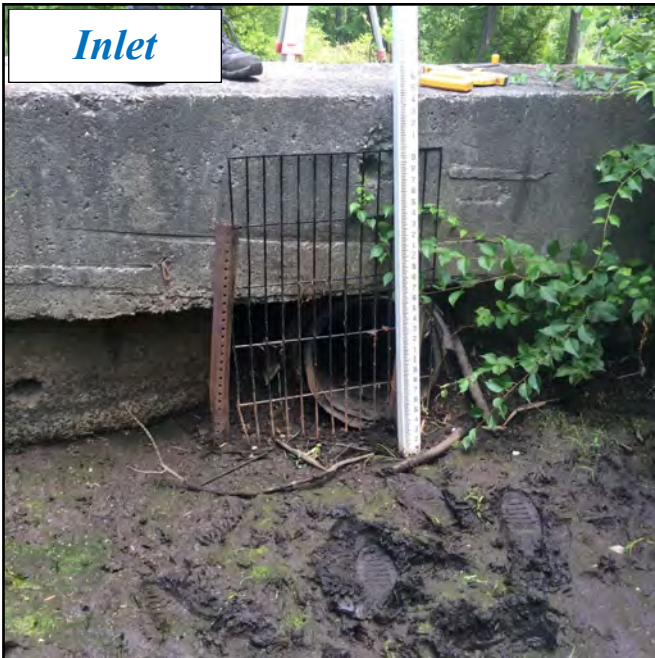
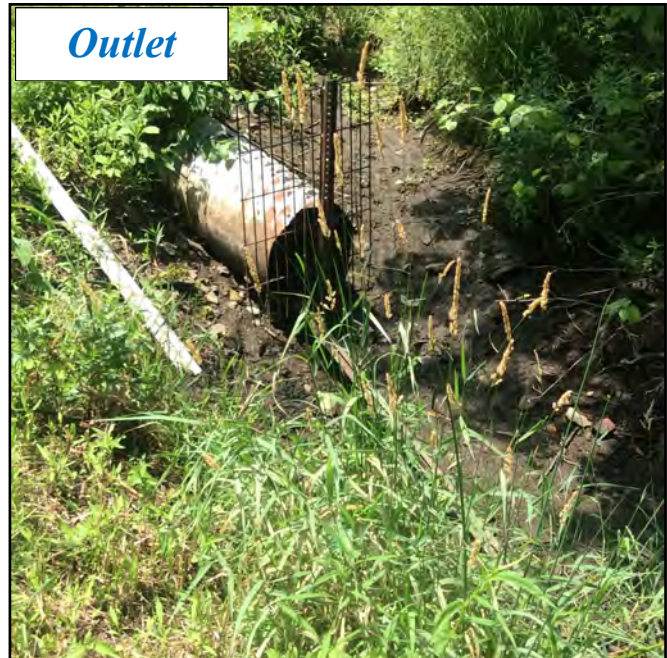
Structure Comments: Fencing in front of it would prevent any animal besides a mouse from getting

Concrete is failing; they don't have issues with flooding or debris

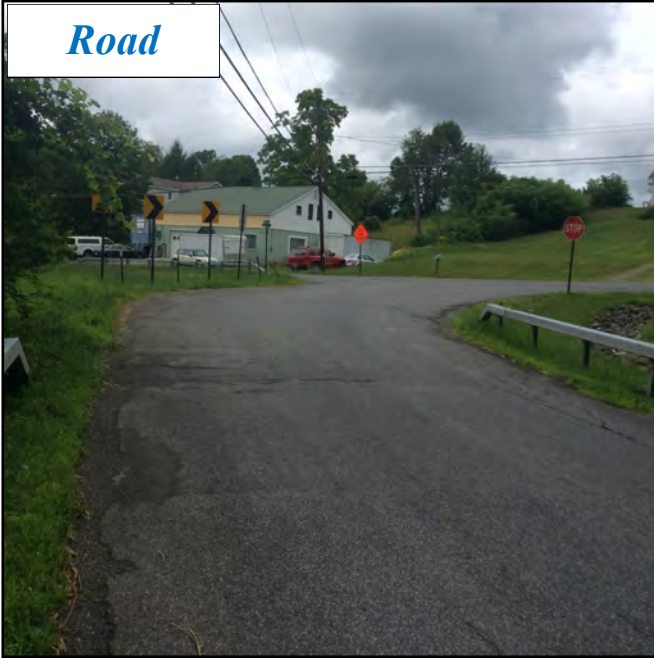
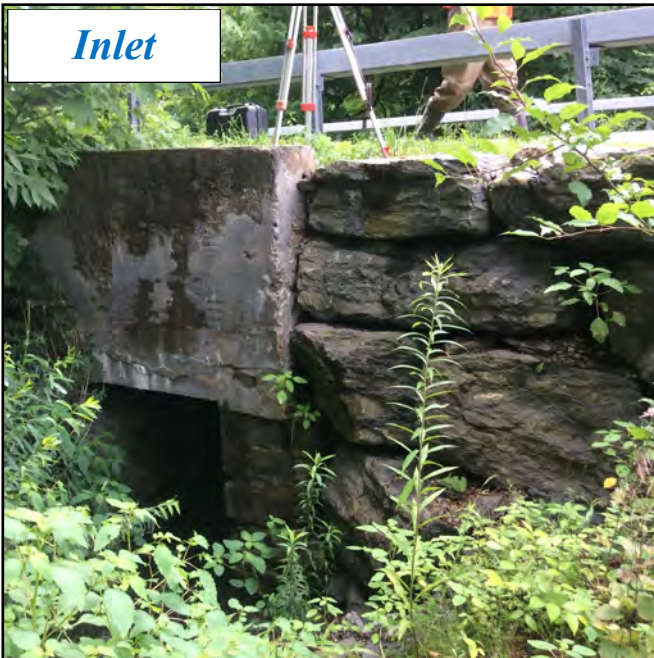
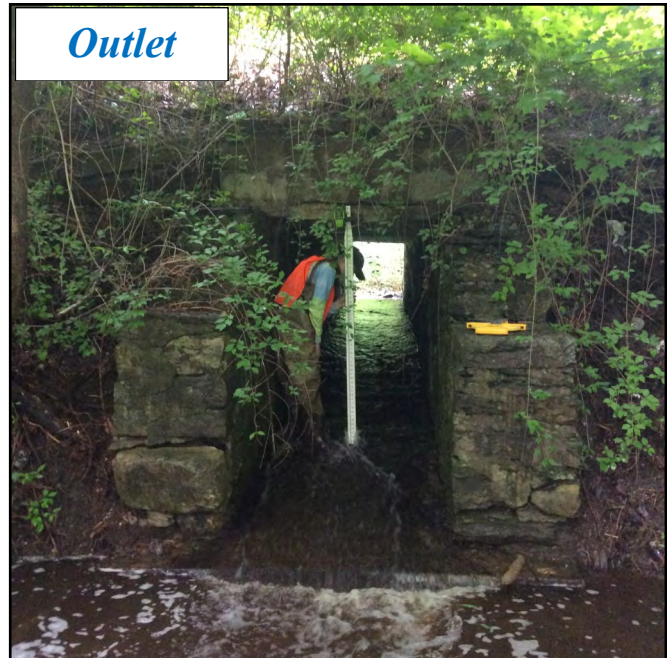
Crossing Comments: Wingwall starting to crumble at inlet side and headwall cracking at outlet side.

Structure Comments: There is a gradual drop 7 feet downstream of outlet opening when the con-

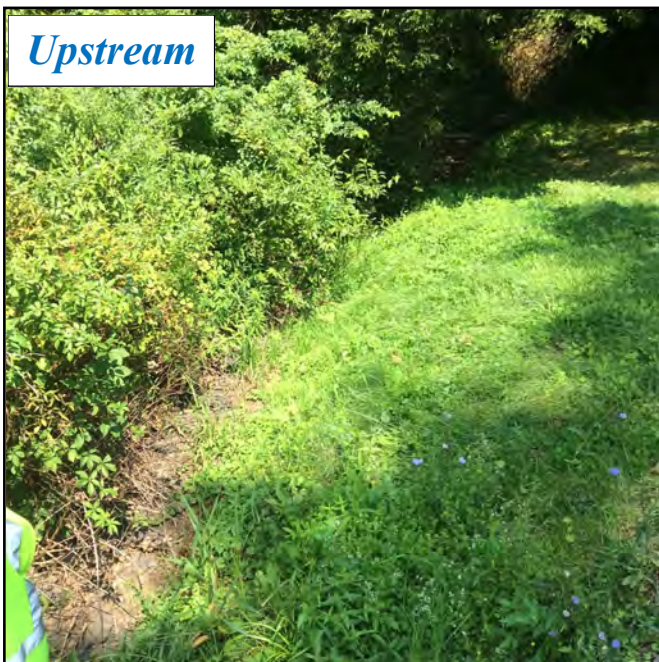
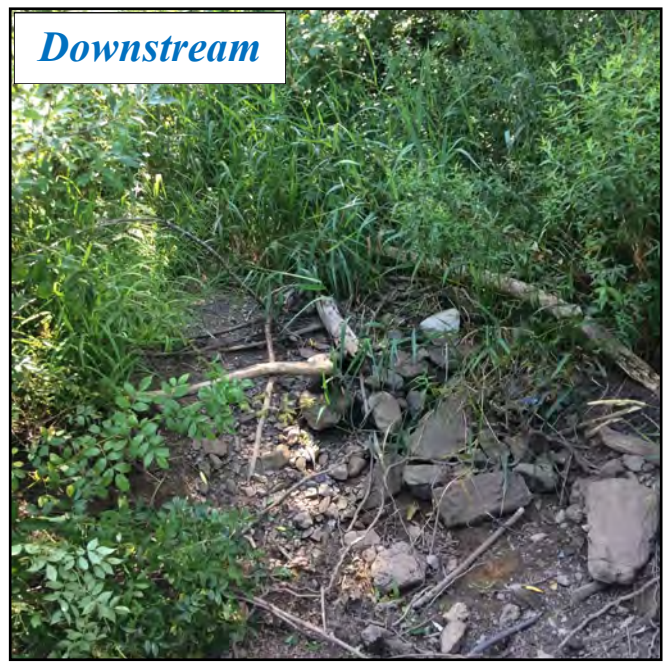
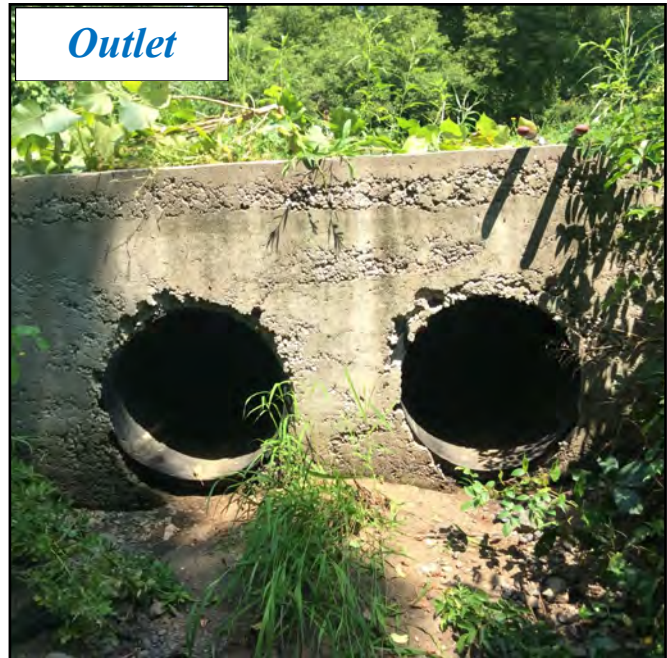
Crossing Comments: Even though dry, significant depression at outlet resembling where a scour pool would be.

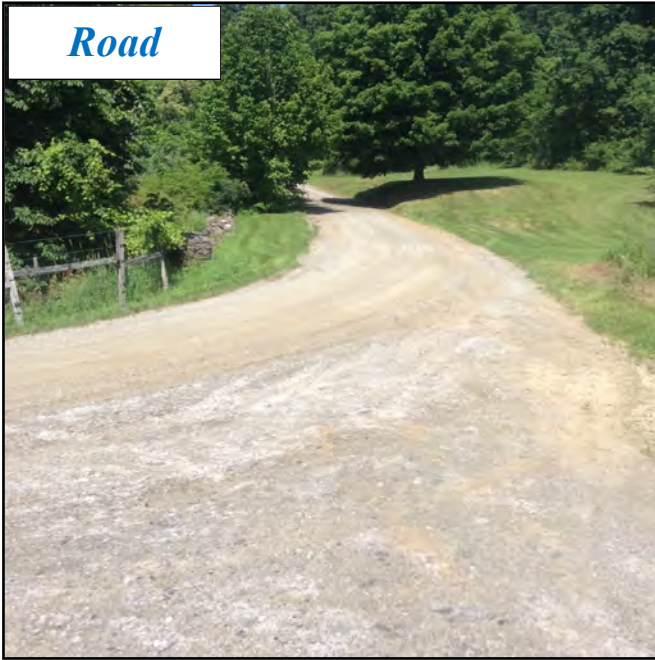
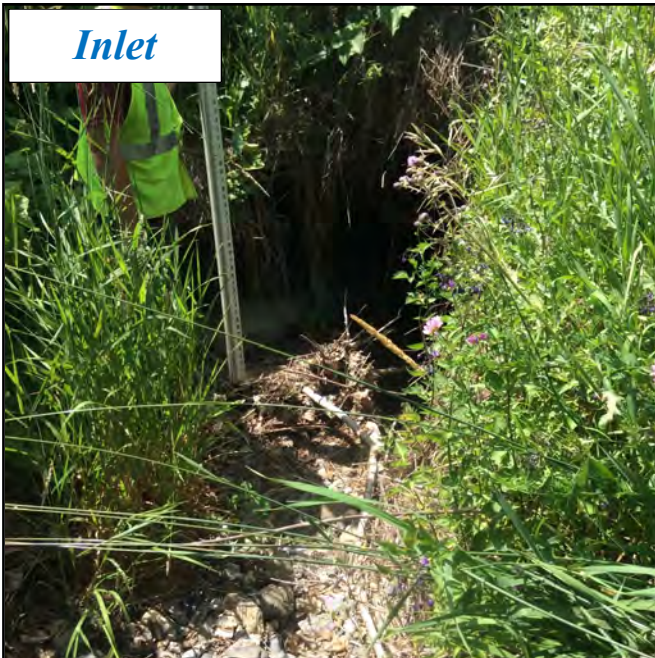
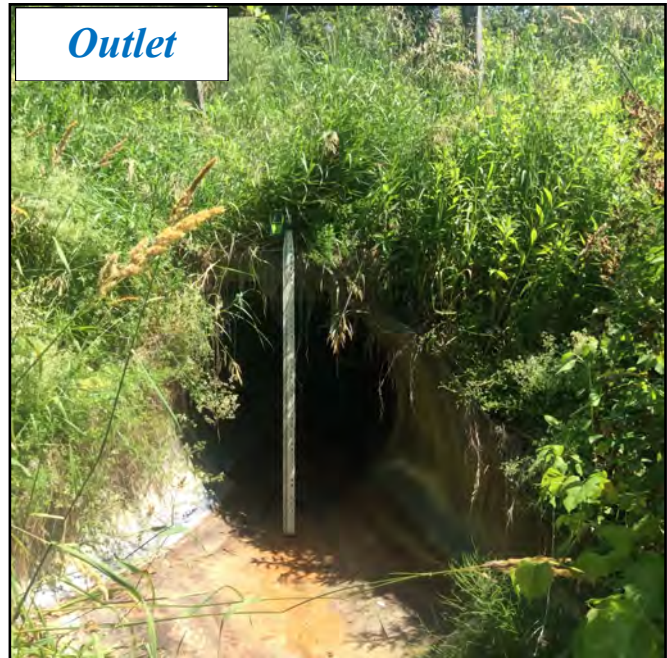
Structure Comments: Bottom corroding away, not extensive yet. Outlet fair distance from the

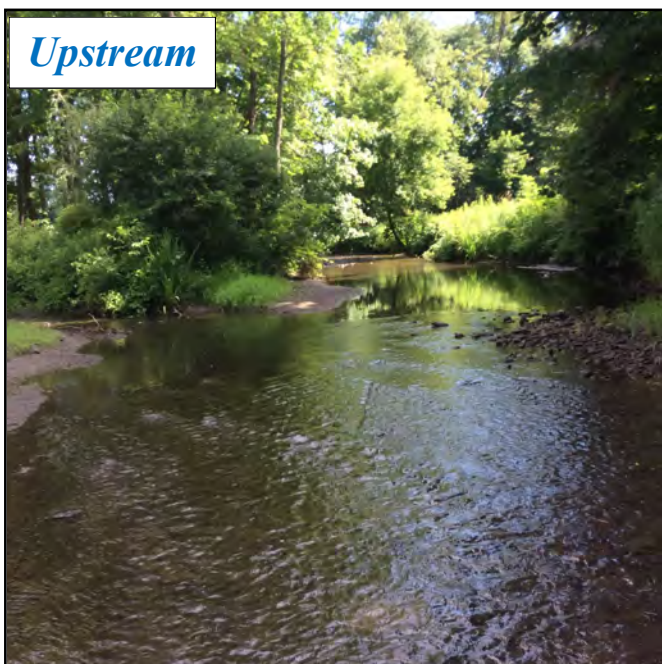
Upstream

Crossing Comments: Bankfull confidence low because a tributary enters a few feet upstream

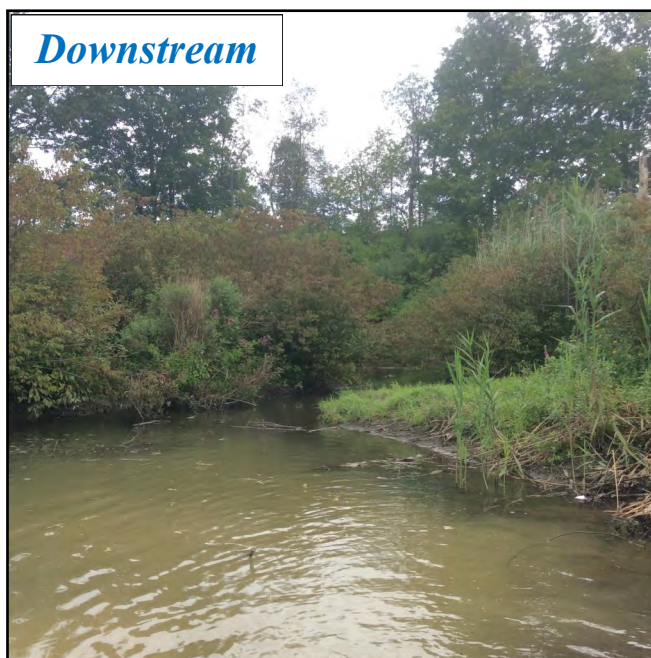
Downstream

Crossing Comments: 100 feet downstream, the stream flows alongside Mill Road under the Harlem Valley Rail Trail where it constricts significantly (about 3 feet wide). There are cement blocks channeling the stream which is undercutting the bank in places which may

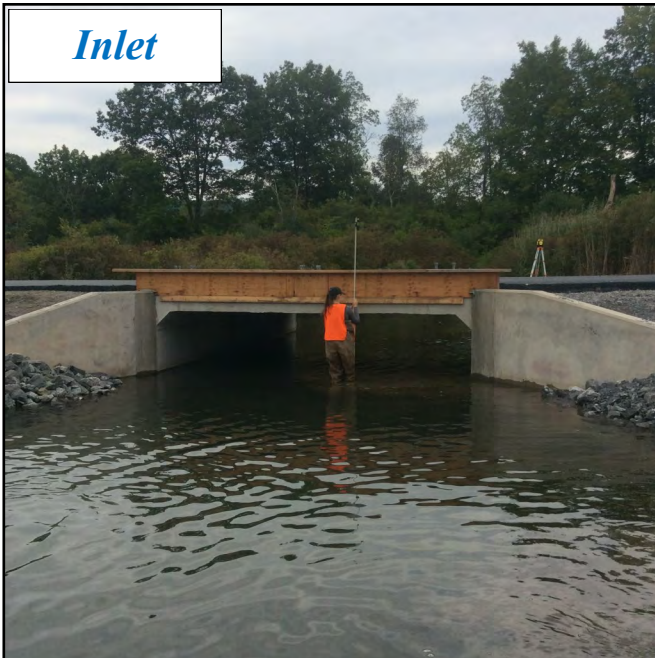
Inlet

Structure Comments: Structure is brand new, 16 feet, built in wetlands

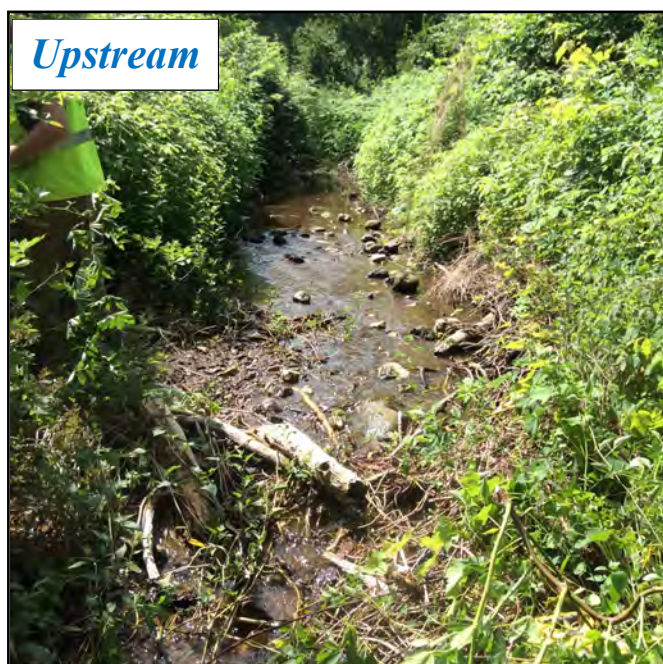
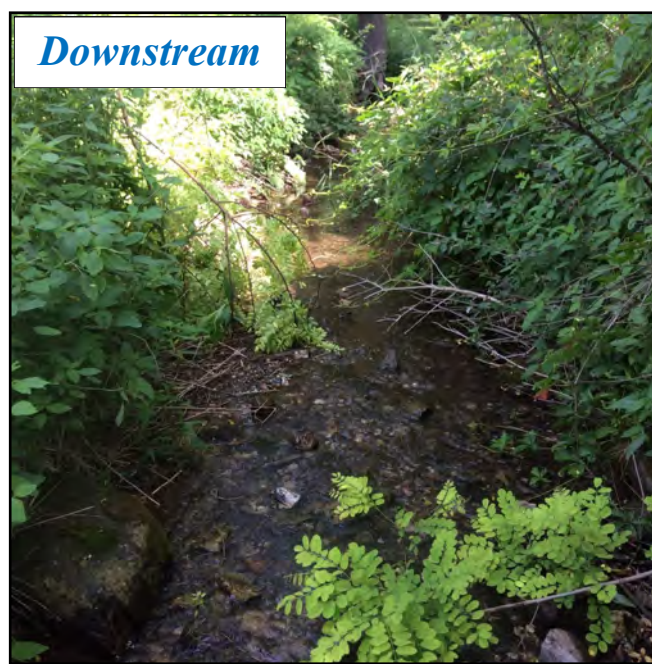
Crossing Comments: Property owner is very willing to replace

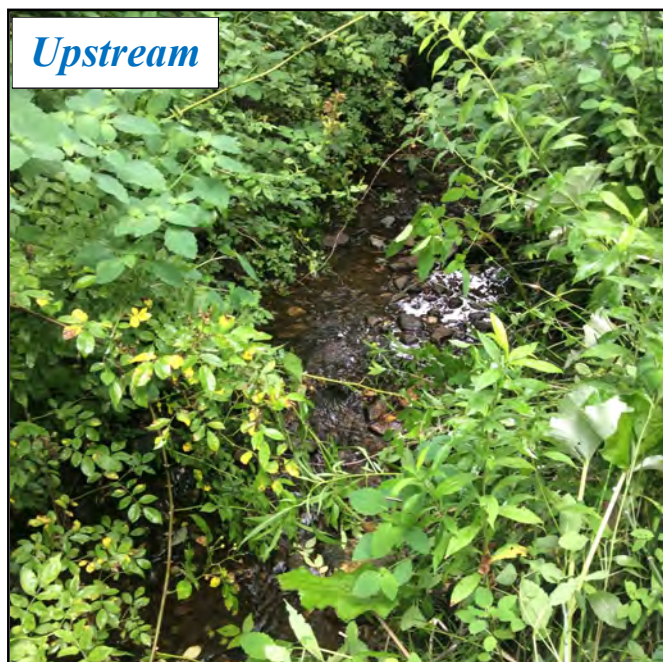
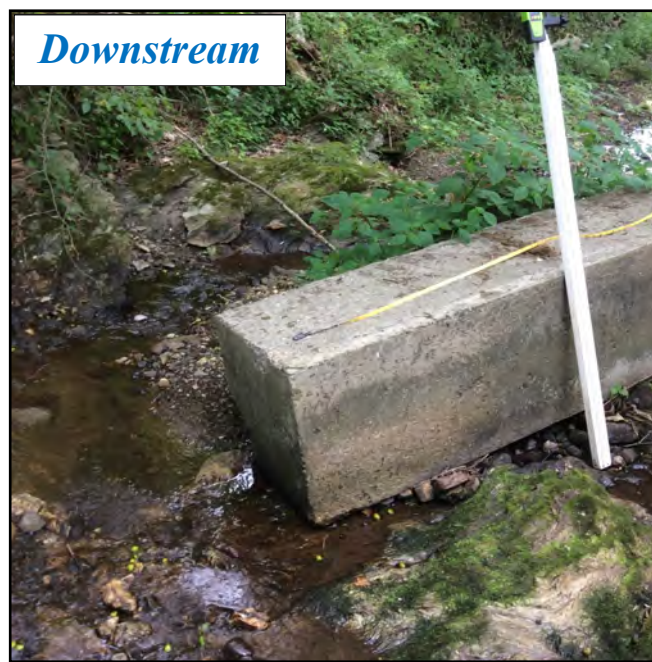
Headwall is failing; they don't have issues with flooding or debris

Crossing Comments: There is a large concrete slab near the outlet that is not blocking flow but is redirecting it and causing small amount of debris buildup. The reason that the height is so different than width for structure 1 is that there is debris build-up in front of it

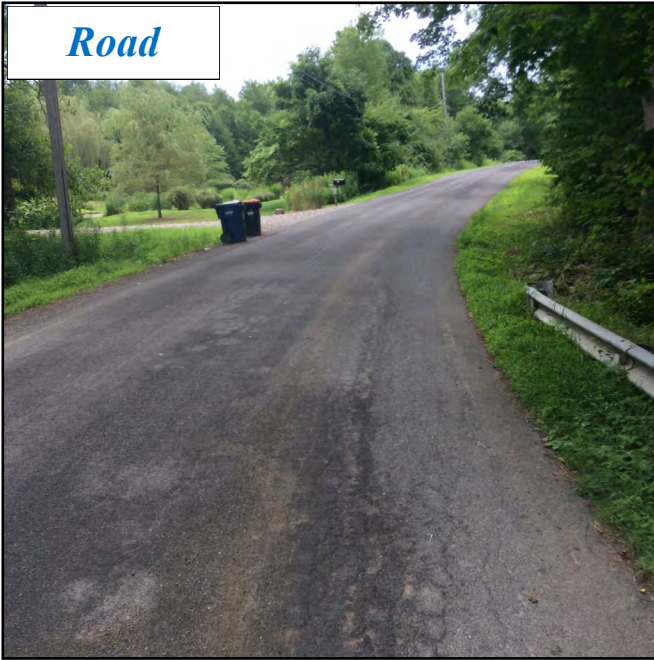
Road

Structure Comments: Height is actually 2 feet,

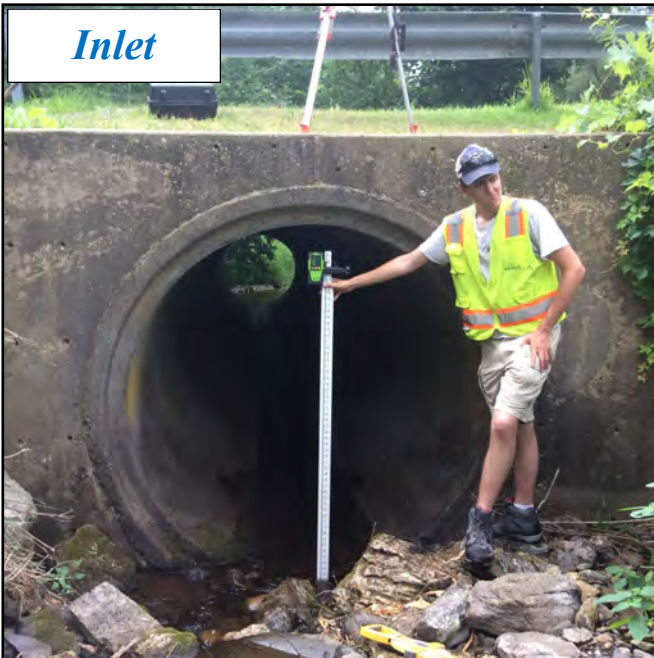
Inlet

Structure Comments: Multiple small drops of less than 0.3 feet in structure

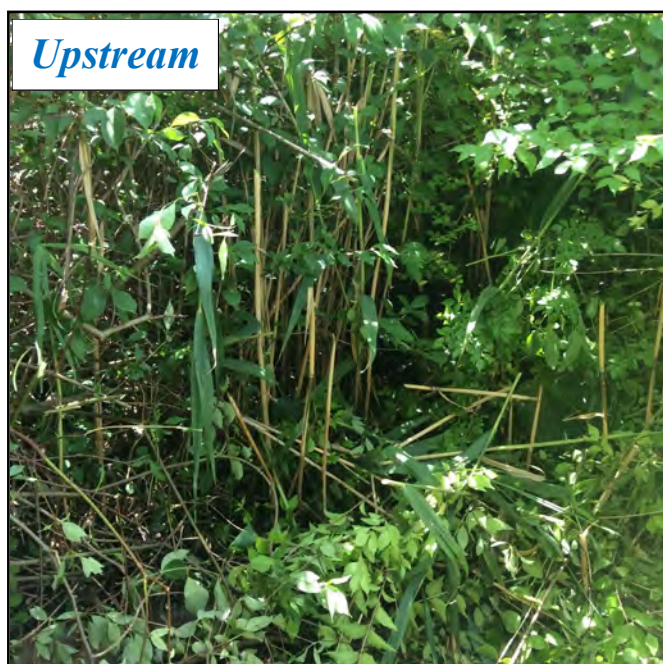
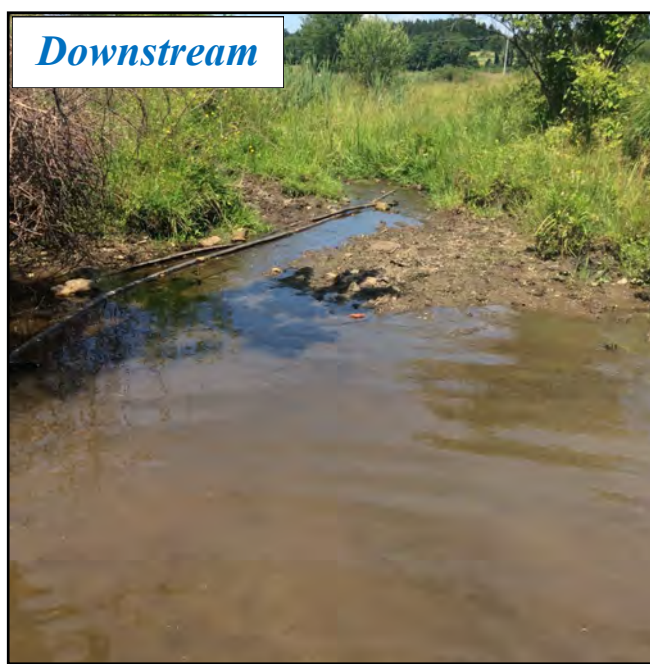
Crossing Comments: Bankfull was estimated due to marshes both upstream And downstream. Cows using downstream area to cross through.

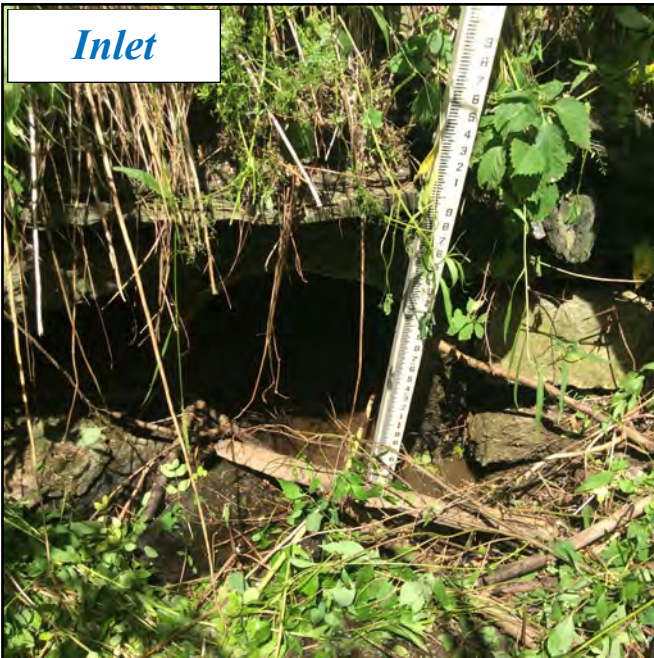
Inlet

Structure Comments: The inlet is concrete and outlet plastic

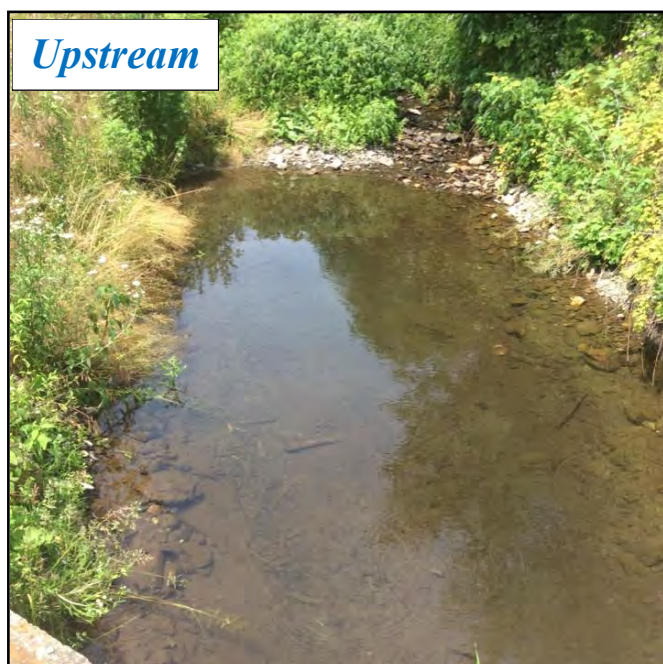
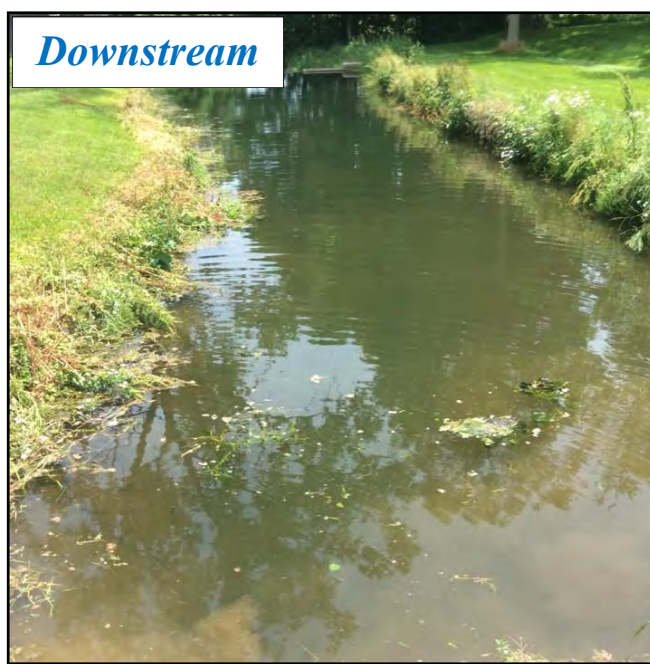
Crossing Comments: Rock walls along upstream channel

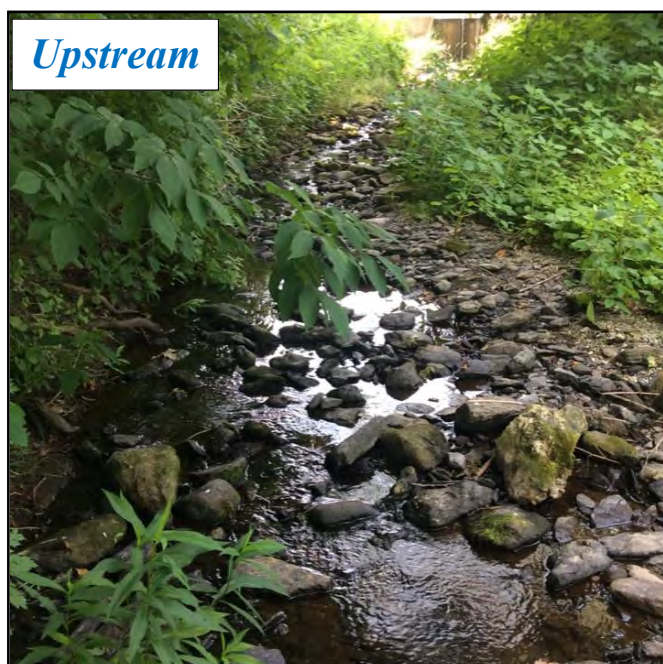
Crossing Comments: Low estimation for bankfull because of dam upstream of culvert.
