Town of North East

Road-Stream Crossing Management Plan

Delivered by
The Housatonic Valley Association
October 14, 2020
Updated
November 8, 2021

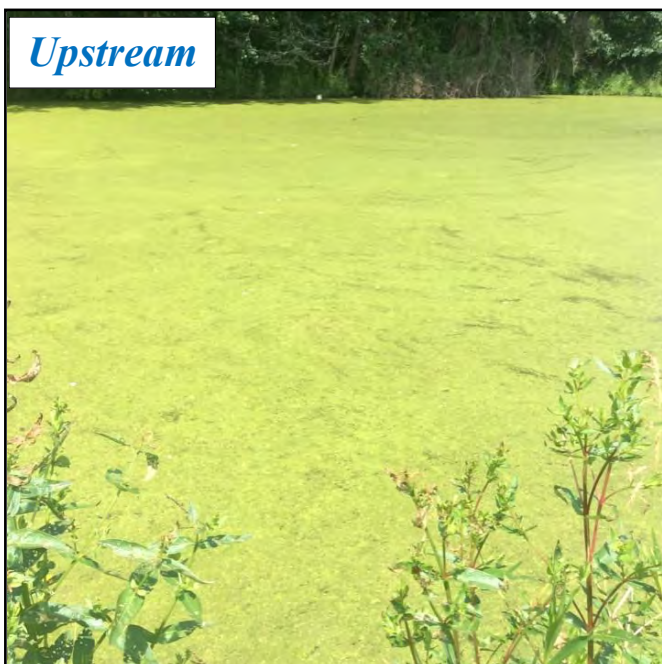
Upstream

Crossing Comments: The upstream is all wetlands and difficult to estimate. There is pond of standing water. Structure is collapsing and in very poor condition. Outlet side has eroded sediment hanging in front of it.

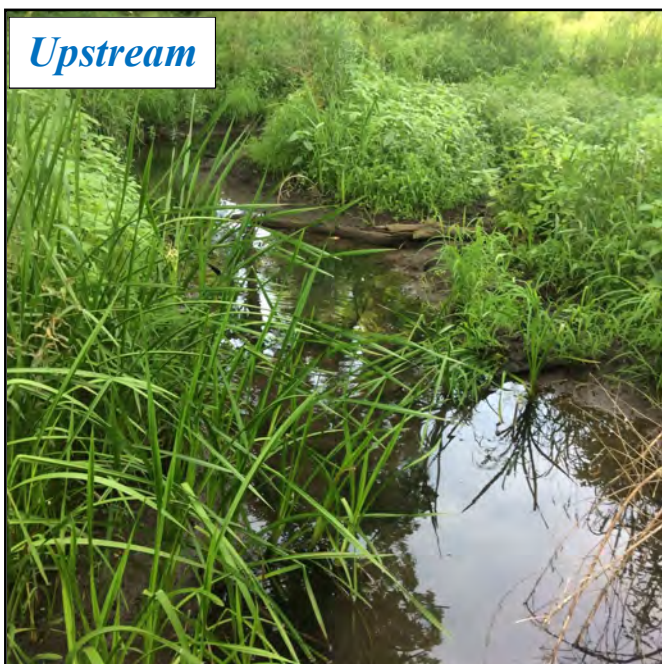
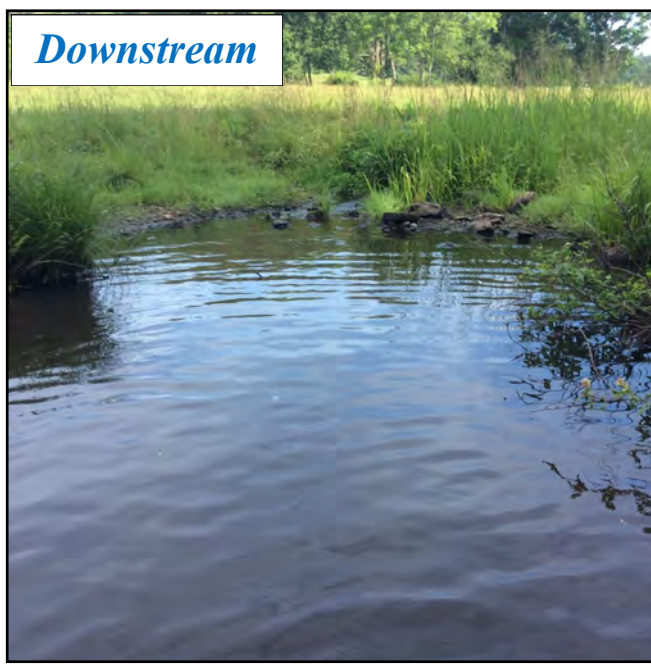
Crossing Comments: structure 1 is partially inaccessible since there is no outlet visible. Other photo shows where the outlet would be.

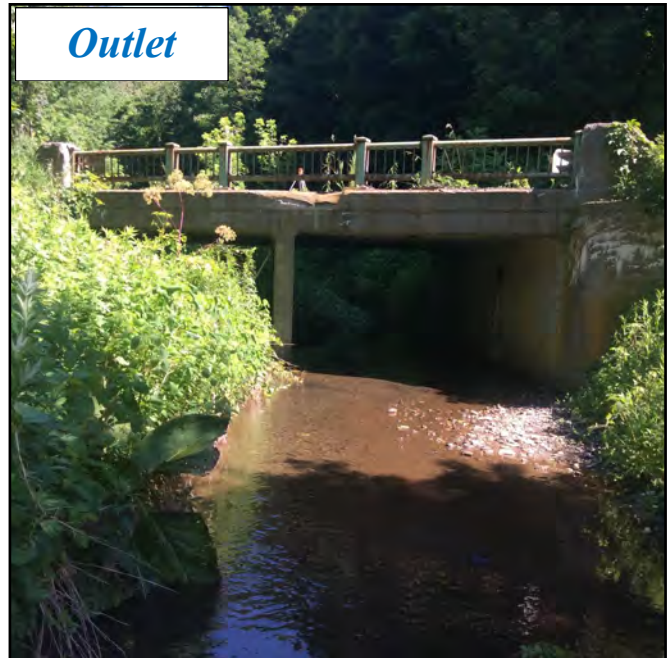
Structure Comments: Observed minnows, crayfish, and small trout on the inlet side, saw only minnows and crayfish crossing. Trout attempted to cross when it saw us coming but turned around because it could not swim through. The bottom of the culvert was about 0.2 feet off of the streambed

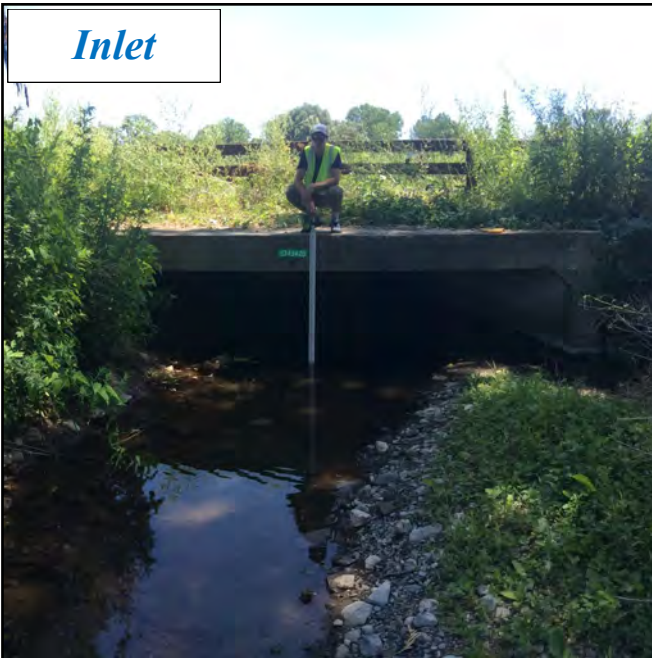
Inlet

Structure Comments: There was water in the structure at the inlet and up to about 2 feet before

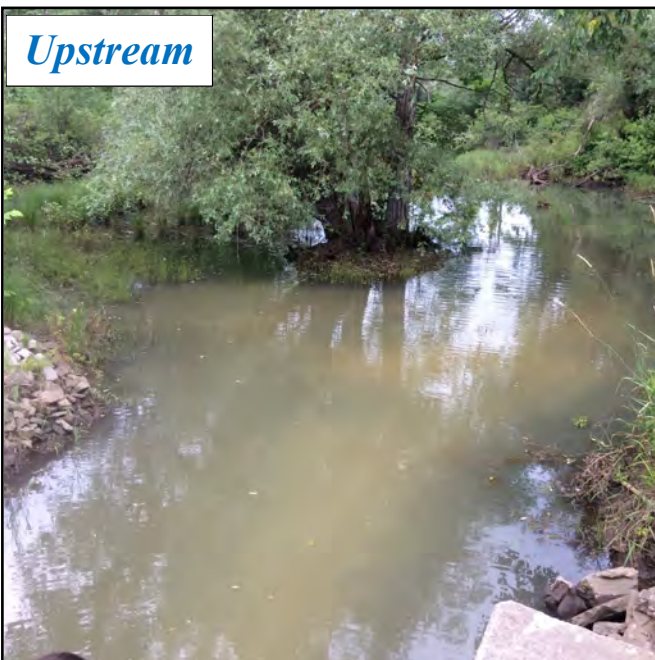
Upstream

**Crossing Comments:** There is a channel flowing around culvert. Very poor shape. Metal corroding and land over culvert eroding. Bankfull is estimated due to upstream being a pond.

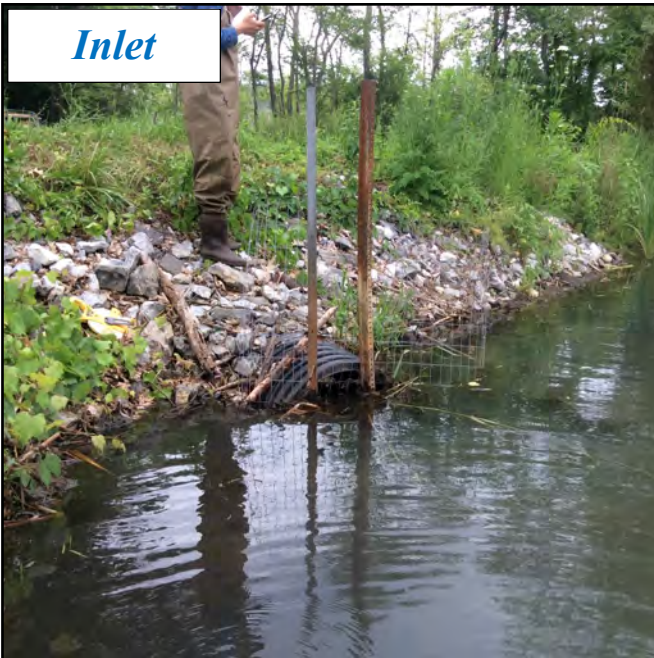
Inlet

Structure Comments: On the inlet side the fencing was very clogged with sediment and debris, it

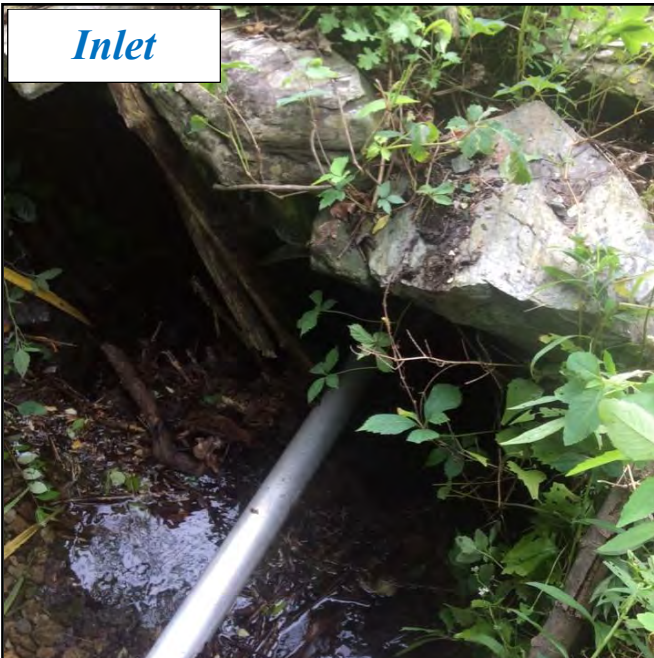
Inlet

Structure Comments: Drop of 0.8 feet

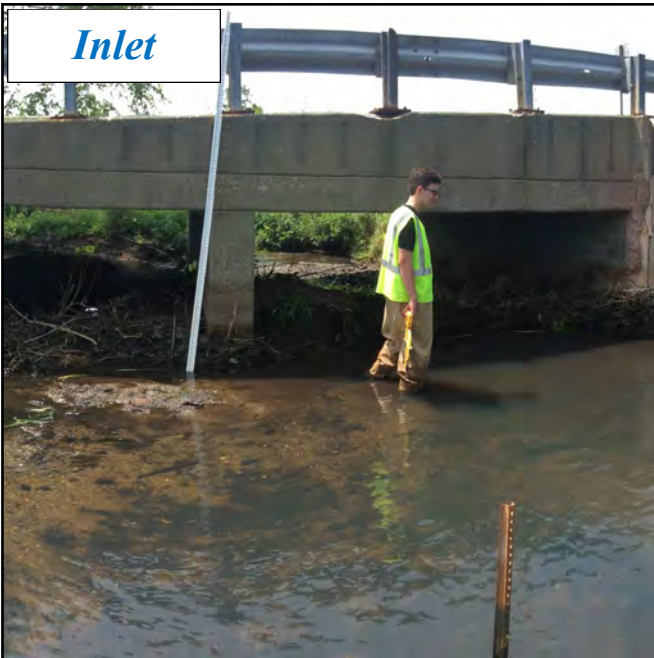
Inlet

Structure Comments: Beaver dam blocking flow

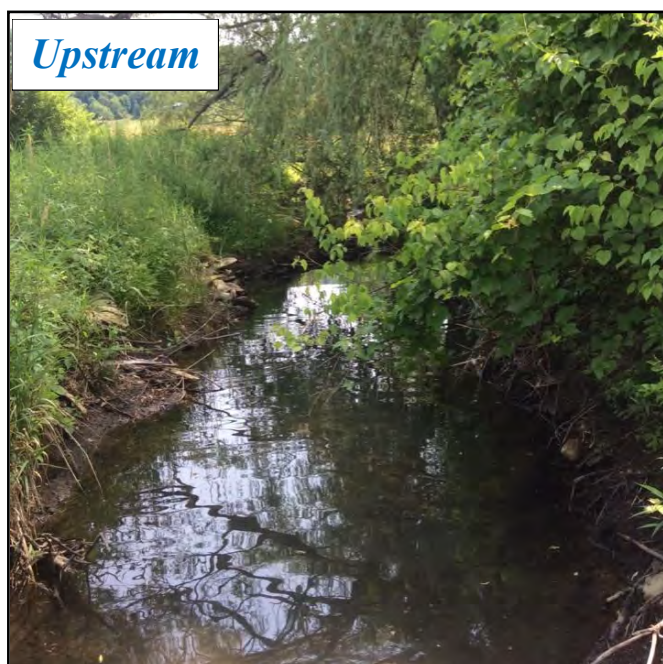
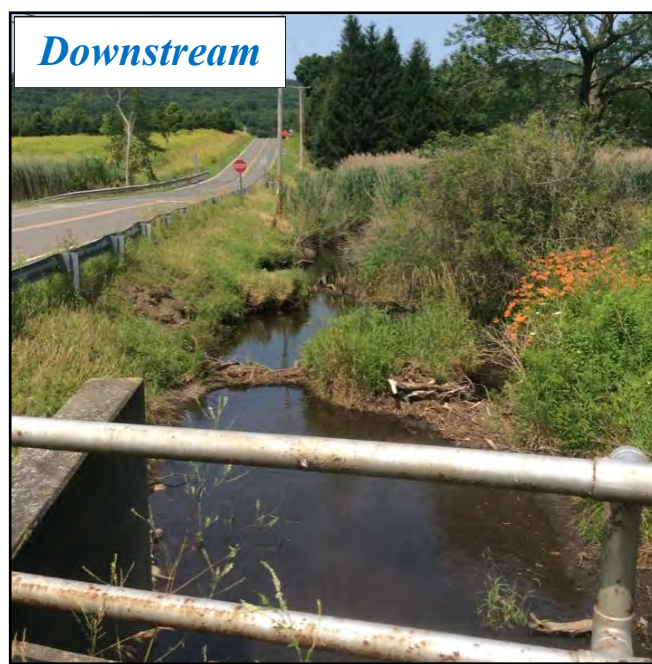
Crossing Comments: Dam just upstream, beaver dam just downstream

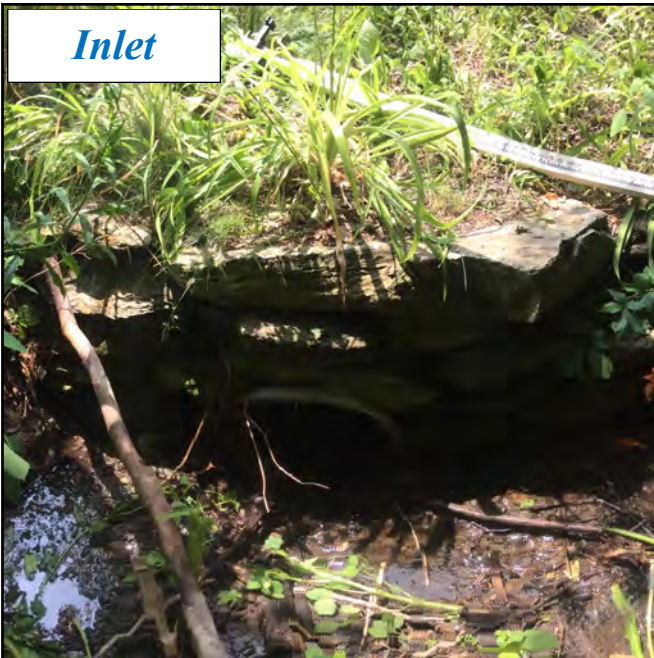
Physical Barrier(s) (Severity): None
 Slope (%): 0.03
 Structure Comments: Inlet drop 0.3 feet

Inlet Shape/Type: Round Culvert/Headwall
 Inlet Drop/Grade: Inlet Drop
 Dimensions:
 Width: 1.5, Height: 1.4
 Substrate/Water Width: 0.9
 Water Depth: 0.10

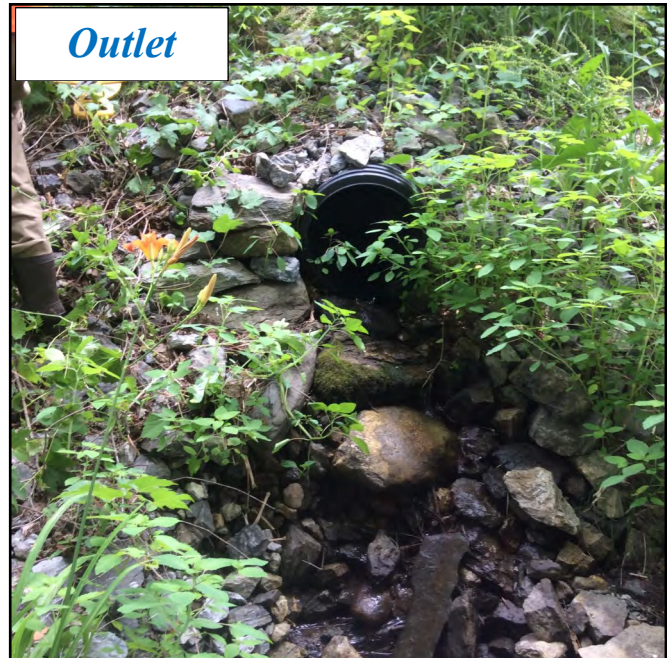
Outlet Shape: Round Culvert
 Outlet Drop/Grade: Cascade
 Drop to Stream Surface/Bottom: 2.9/3.0
 Dimensions:
 Width: 1.6, Height: 1.5
 Substrate/Water Width: 0.50
 Water Depth: 0.10

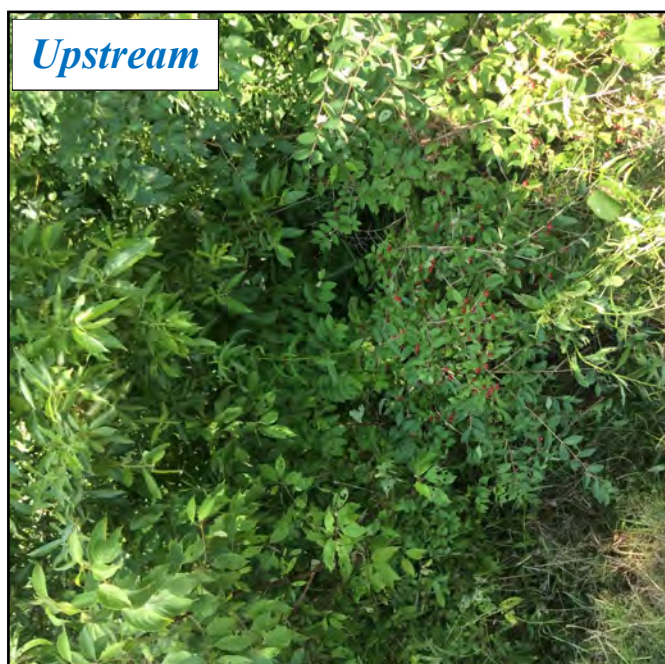
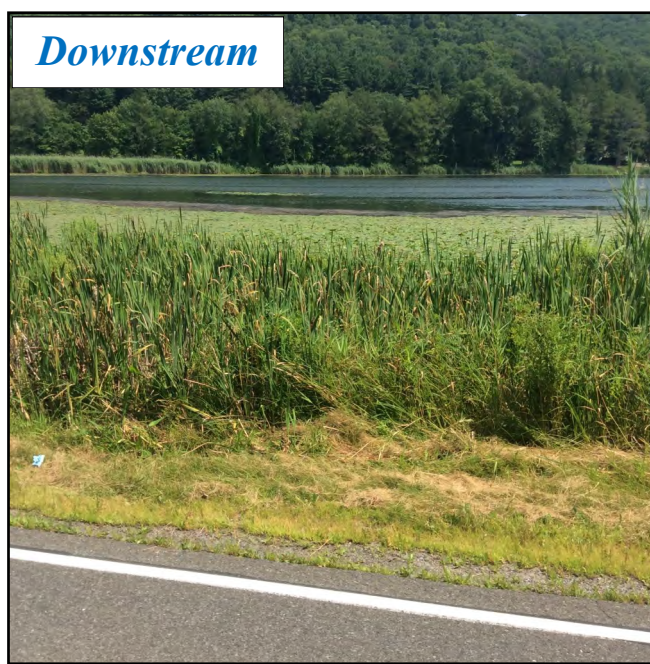
Crossing Comments: Structure was buried and inaccessible on the outlet side. Outlet side is Rudd Pond. Inlet is extremely overgrown and sediment has clogged the inlet pipe.

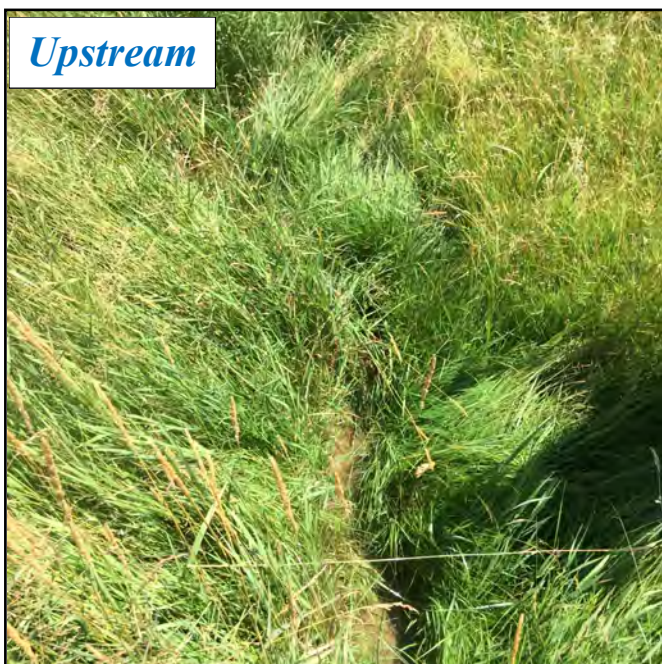
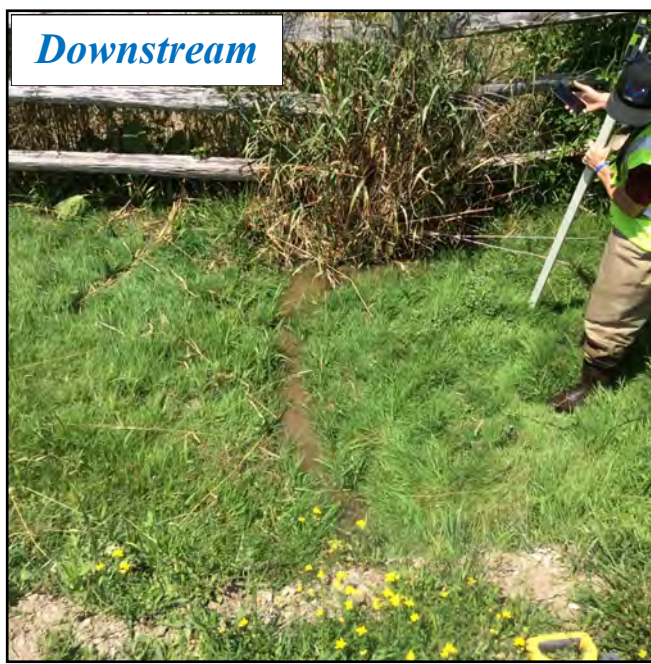
Crossing Comments: Fences on either side with mowed grass, neither side is very natural and we estimated the bankfull measurements across 25 feet

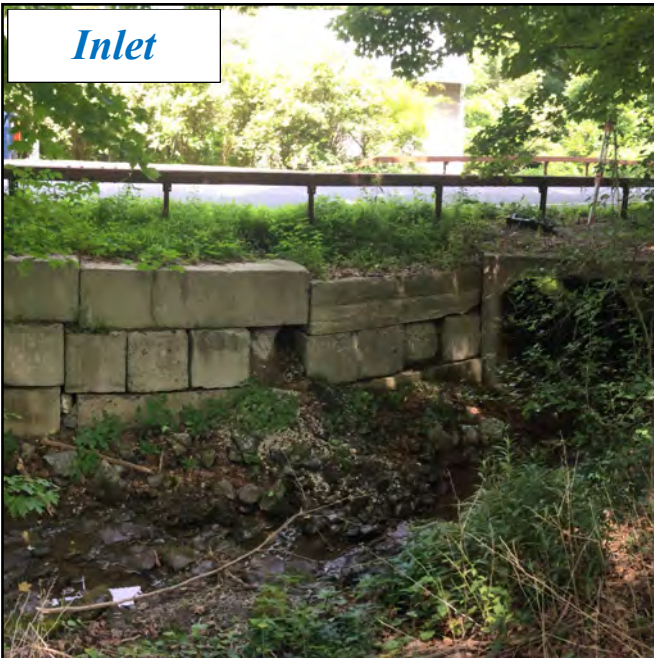
Structure Comments: Inlet perch height is 0.1 feet, substrate partially in culvert, not 25%

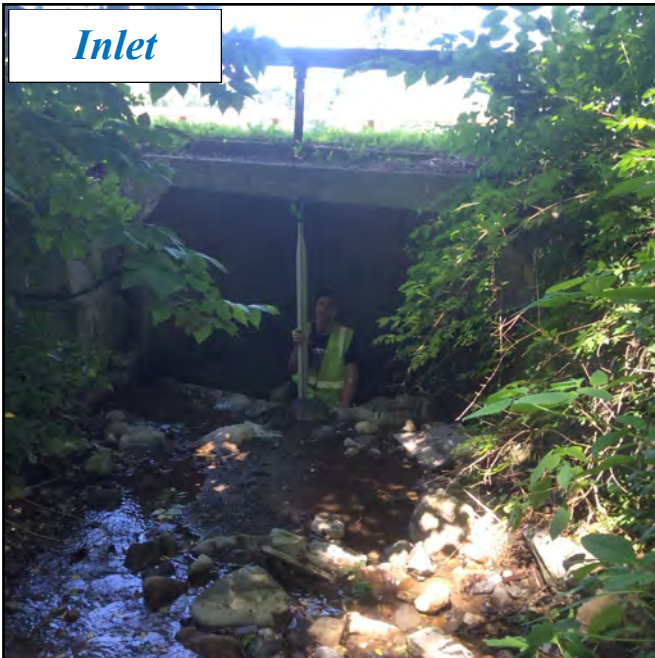
Structure Comments: Inlet drop 1.5 feet

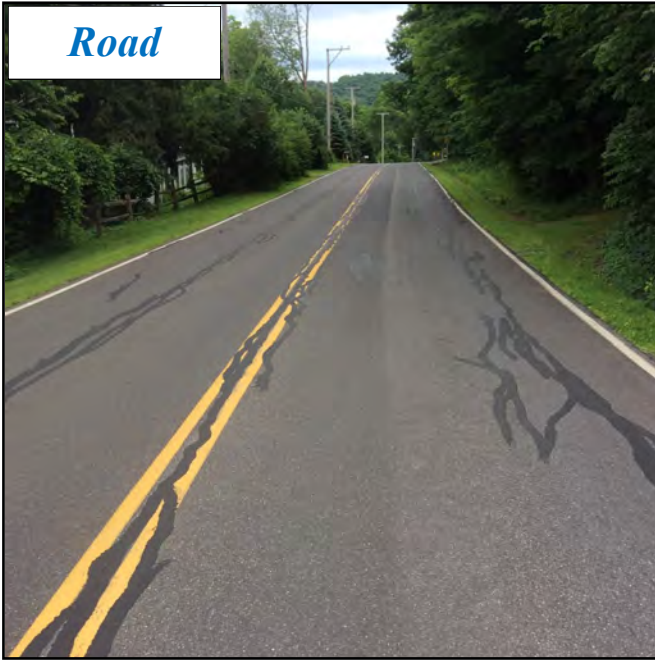
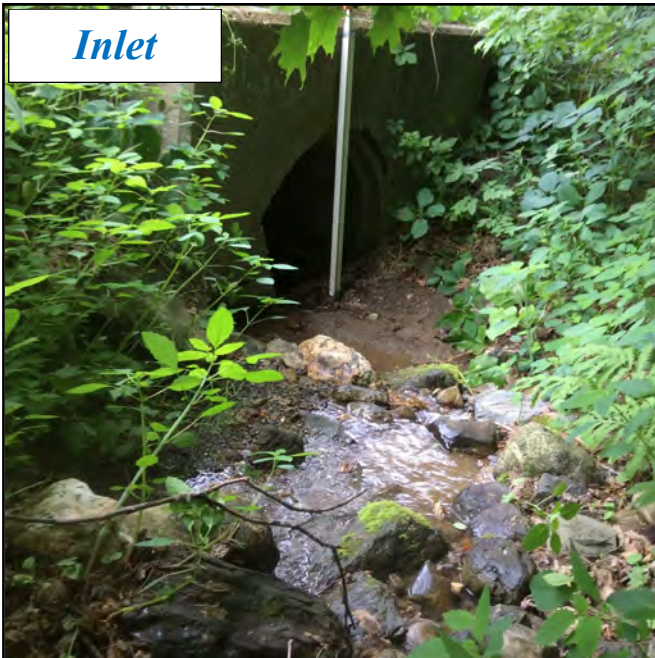
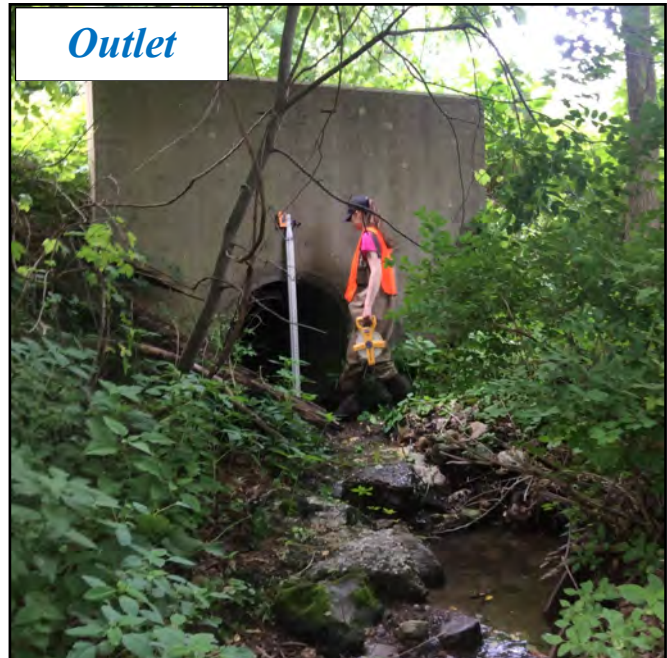
Structure Comments: Outlet drop was very small

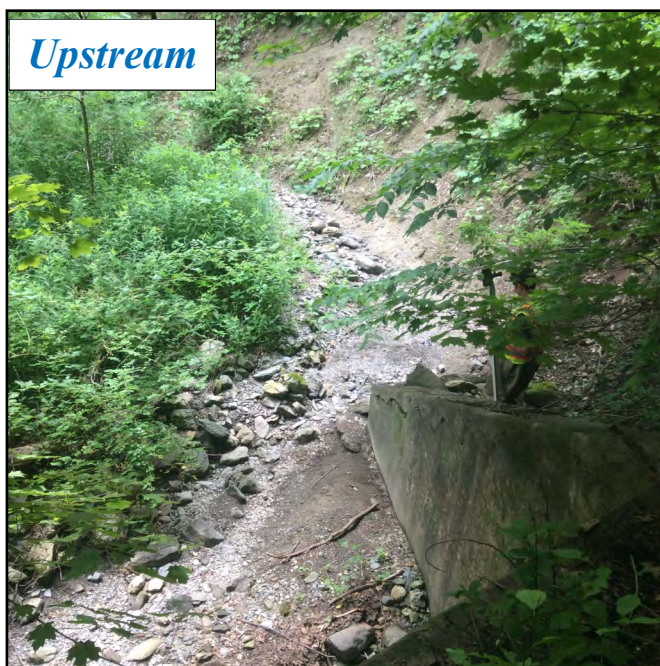
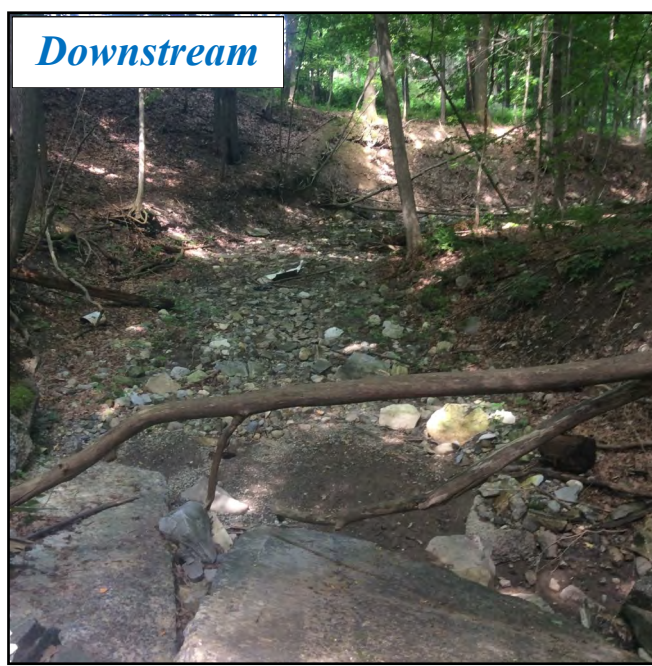
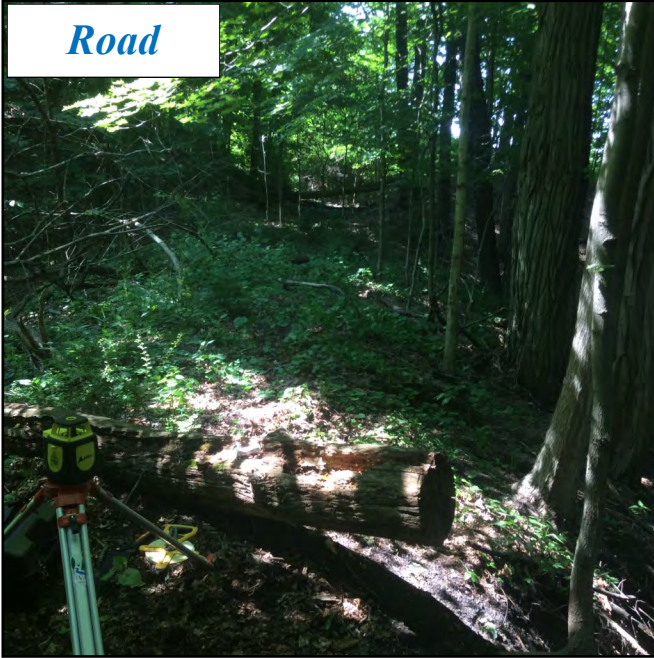
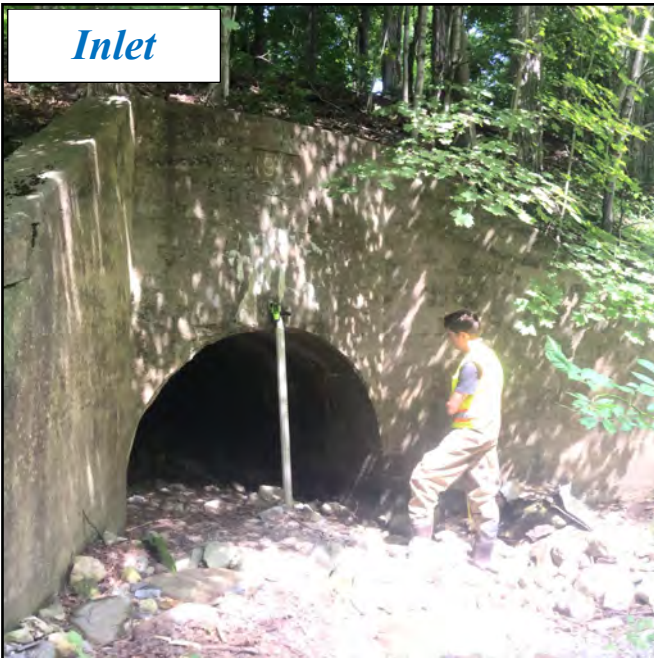
Condition: Poor

Crossing Comments: Landowner right next to bridge says that the town is already planning on replacing this structure.

Barrier Evaluation: Severe barrier

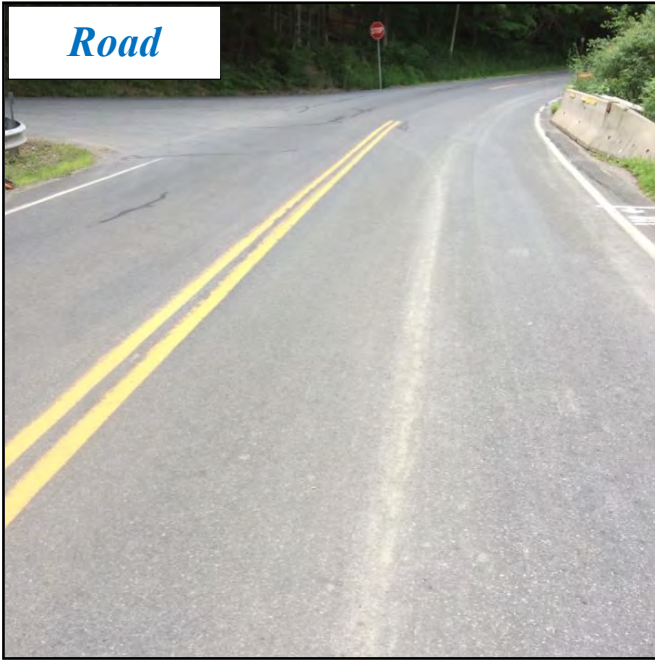
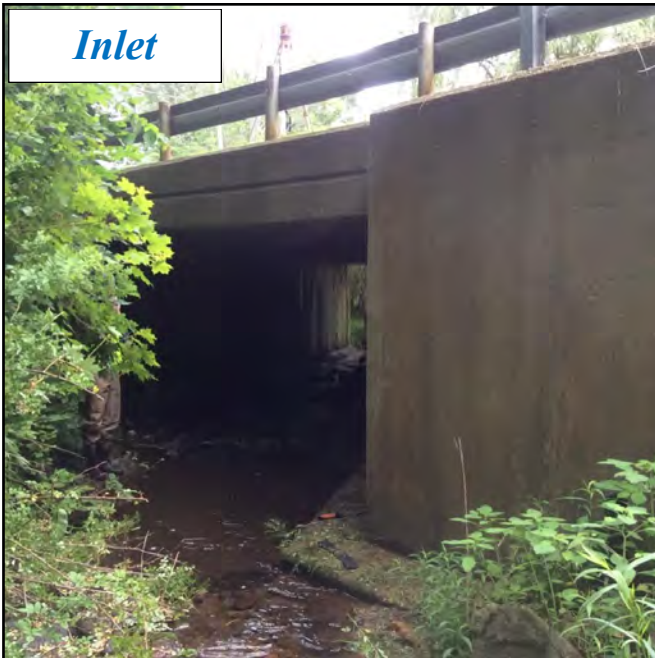
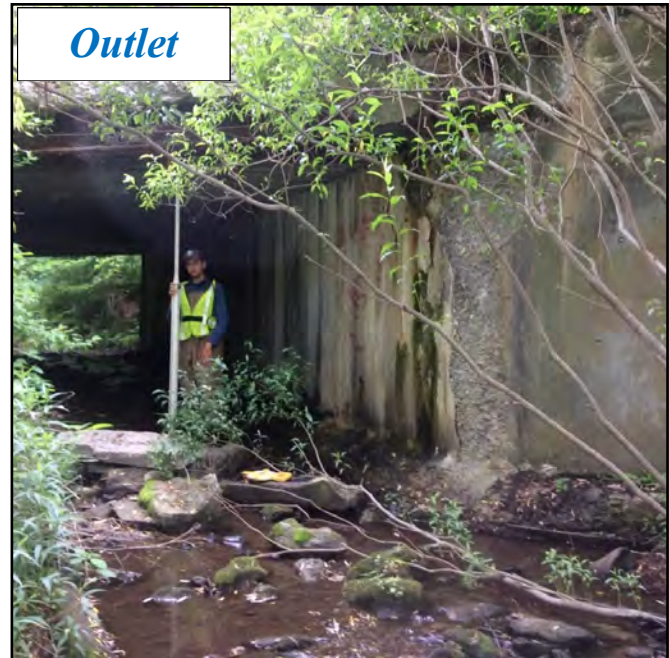
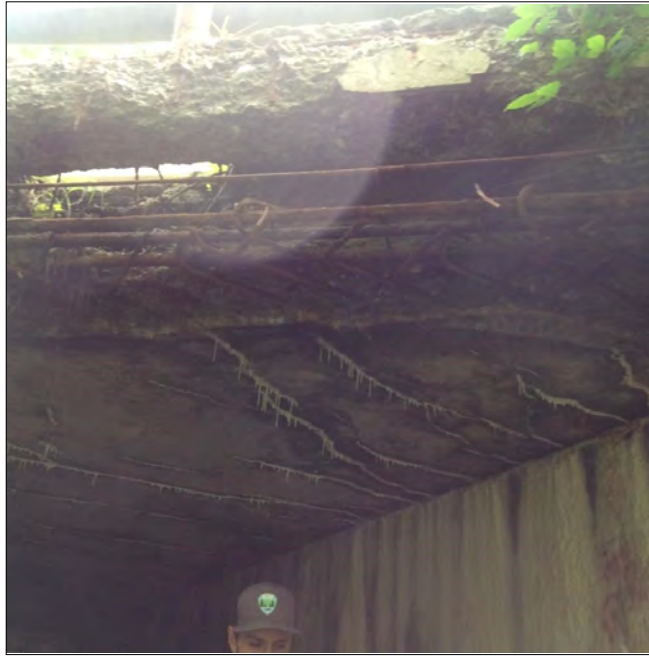
Structure Comments: The outlet side is starting to

Barrier Evaluation: Severe barrier

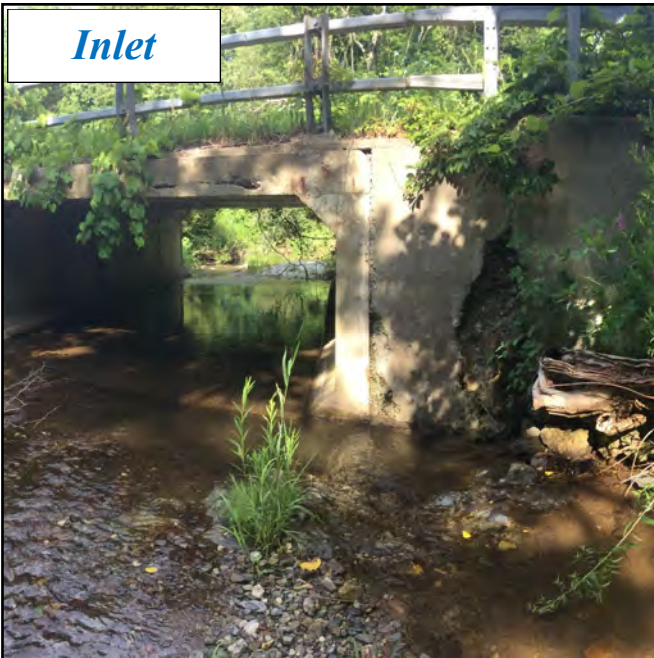
Inlet

Structure Comments: Perched by 0.3 feet

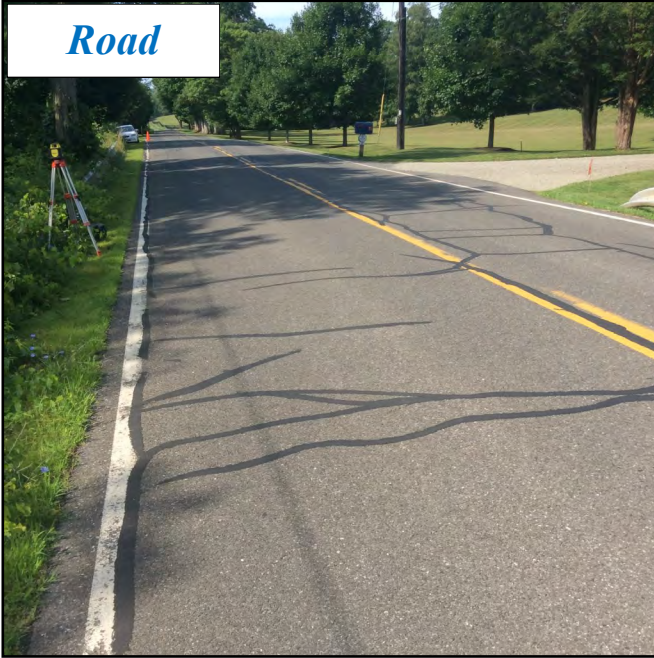
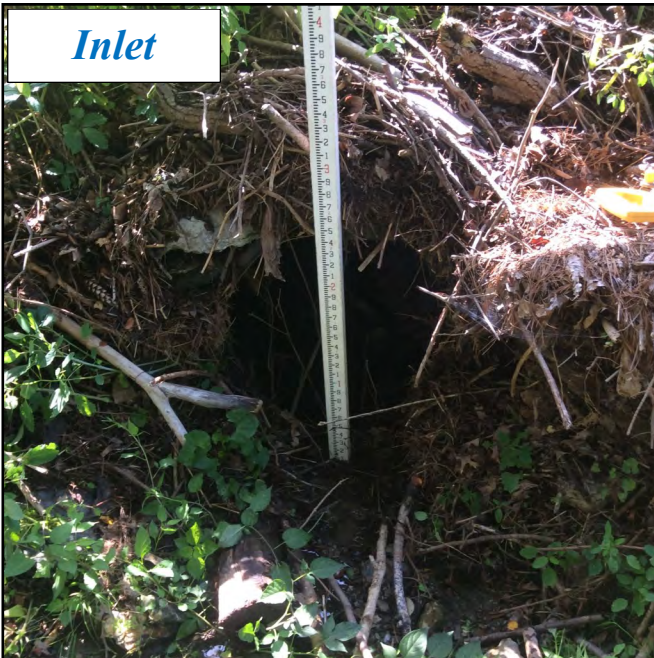
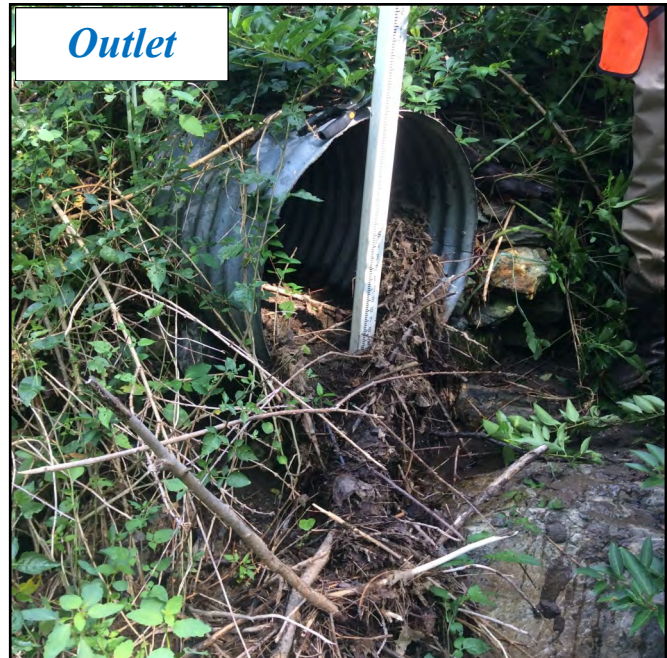
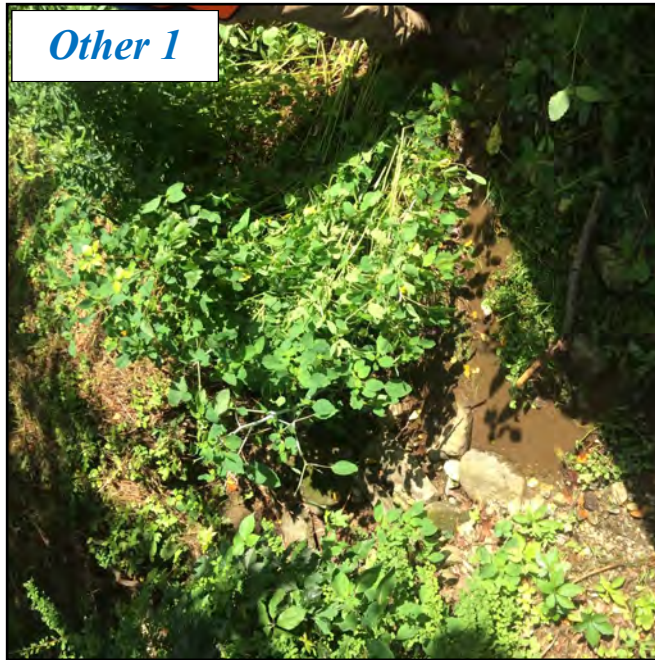
Crossing Comments: Forks off upstream into two channels, one leads to pond 15 feet up the other is presumably for runoff and is dry. Only one bankfull measurement due to brevity of upstream channel before it opens up to the pond. Condition poor due to corrosion at bottom.

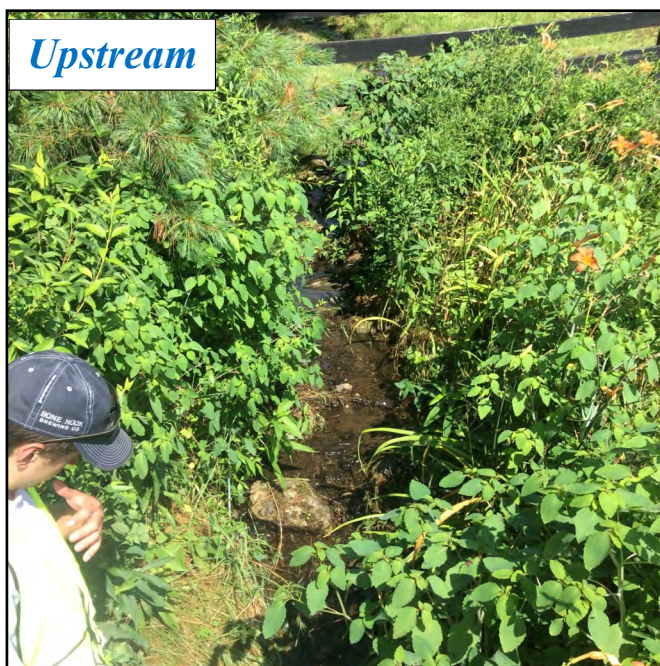
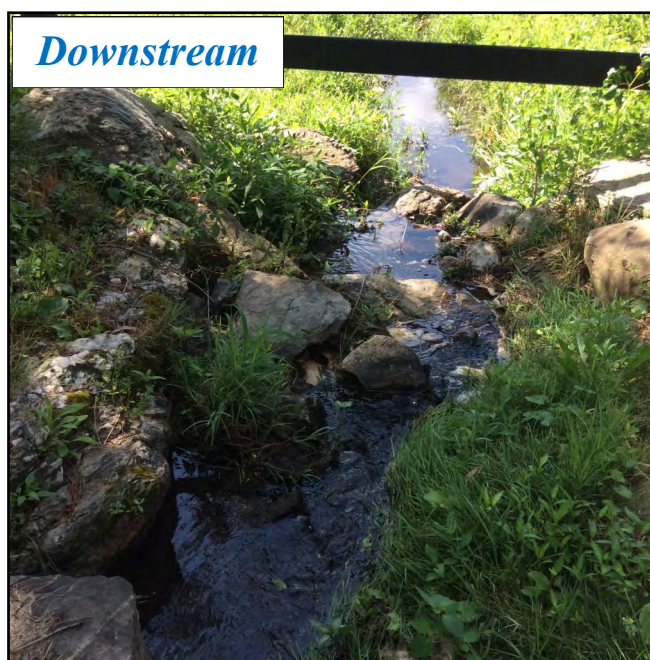
Crossing Comments: Next to Farm with horses and livestock grazing close by. Utility pipe entering near inlet.

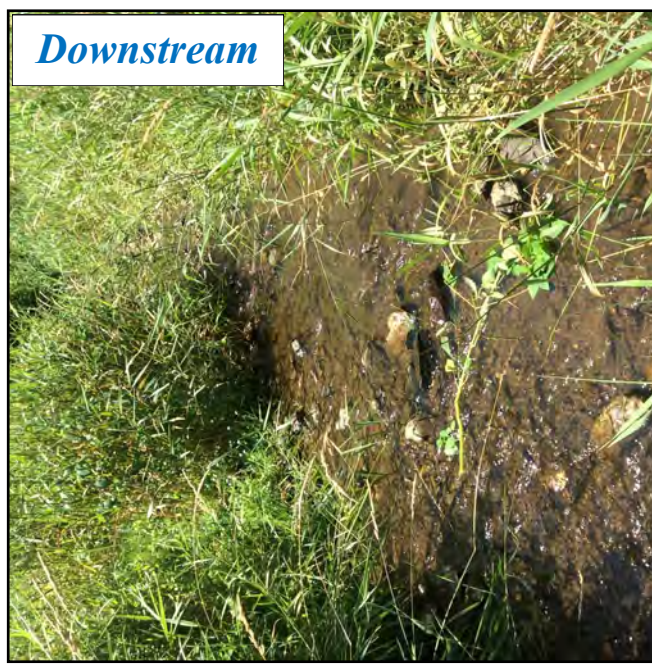
Crossing Comments: Bankfull taken downstream due to multiple channels upstream.

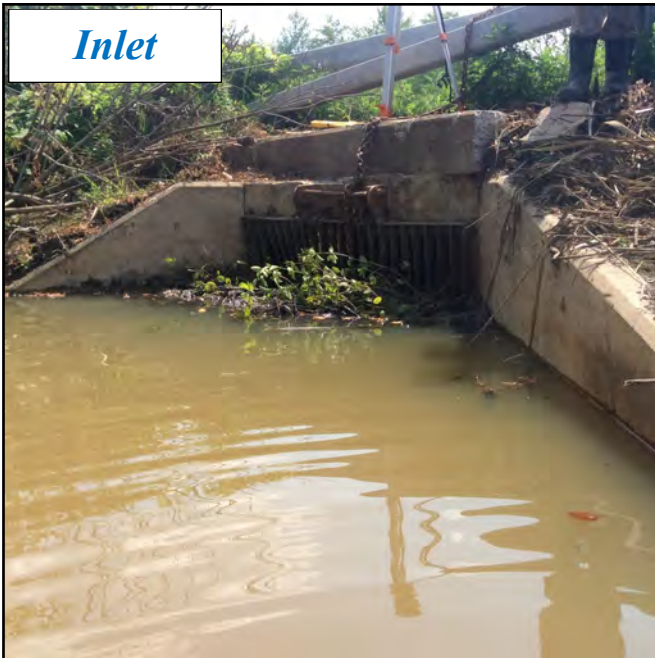
Inlet

Structure Comments: So clogged with debris we

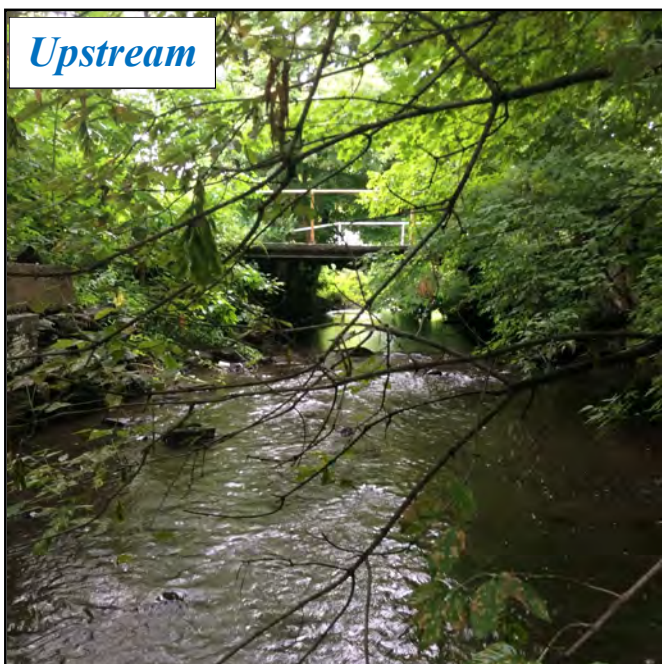
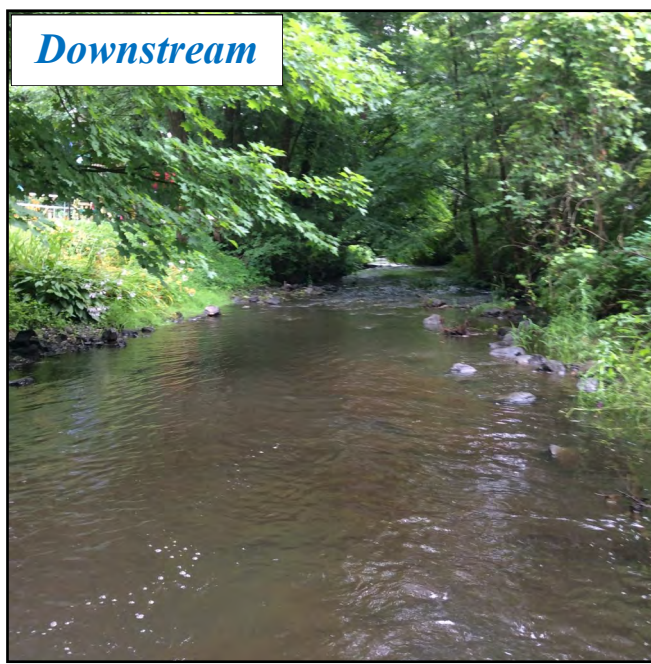
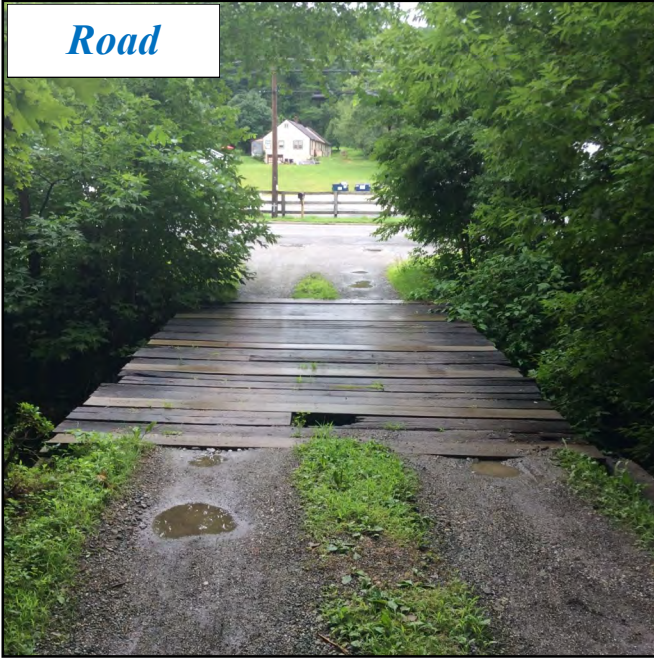
Condition: Poor

Crossing Comments: Hole in deck of bridge

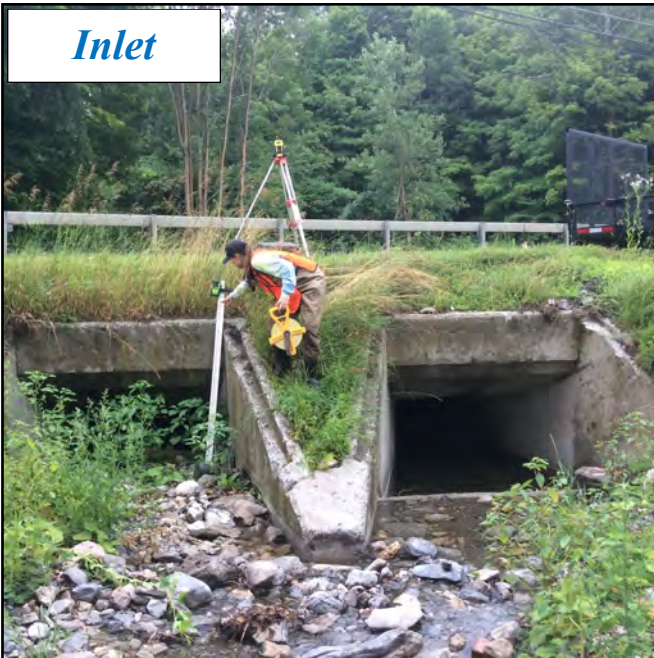
Structure Comments: Inside structure water depth is 0.5 feet. Inlet drop of 0.8 feet; water is deeper

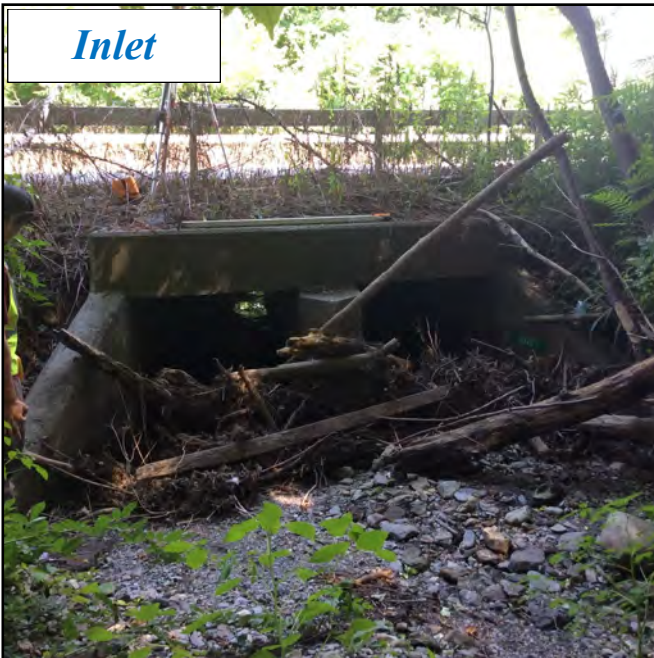
Inlet

Structure Comments: inlet drop of 4 feet because of debris build-up

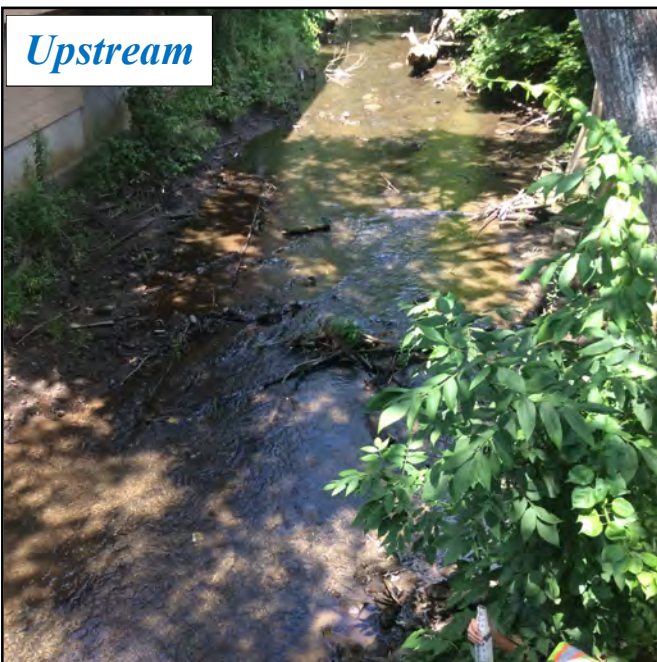
Upstream

Crossing Comments: Channel modification occurring further upstream. See other photo

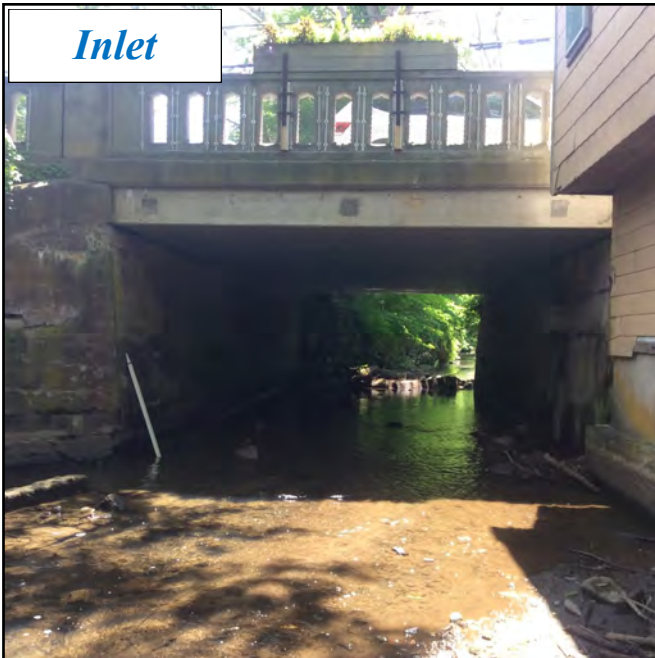
Inlet

Structure Comments: Large logs and concrete

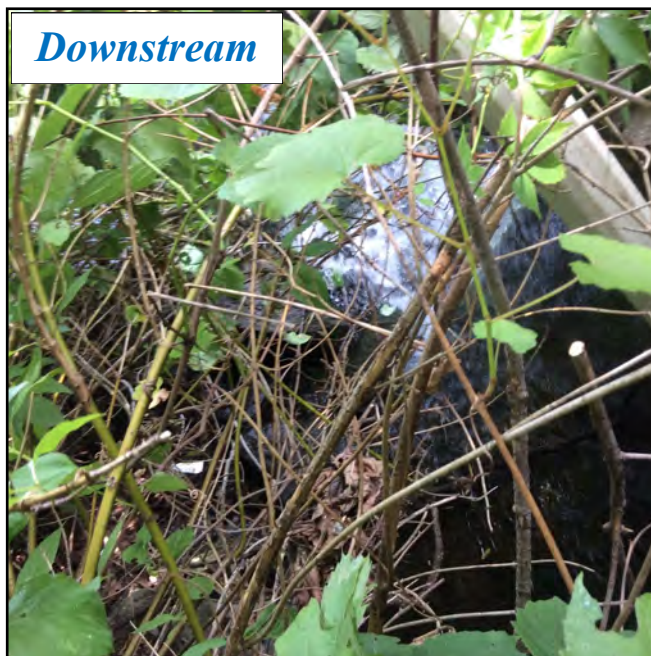
Downstream

Crossing Comments: We are unsure if this is a buried stream or just runoff from four brothers pizza, it seems like a lot of water for runoff though.

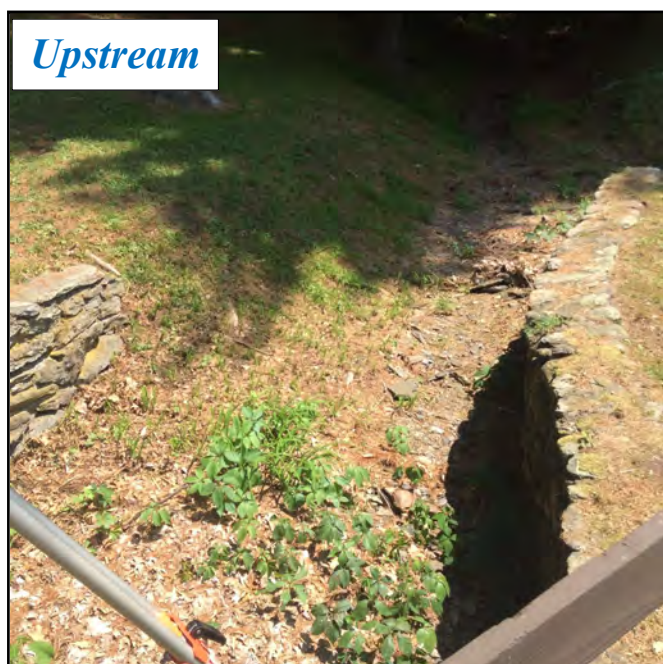
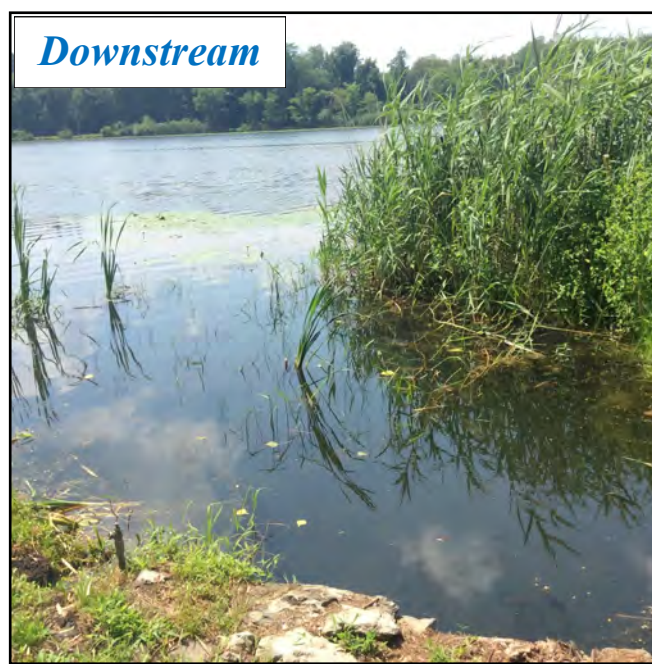
Crossing Comments: Starts as concrete pipe ends as metal

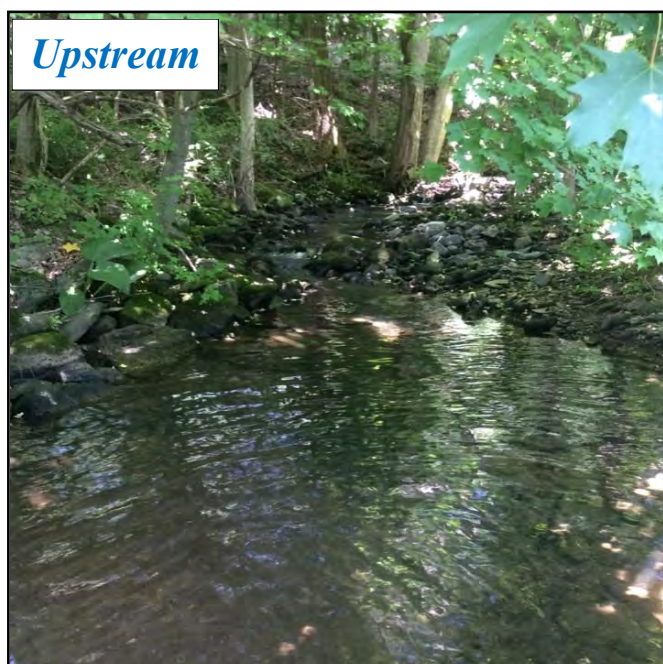
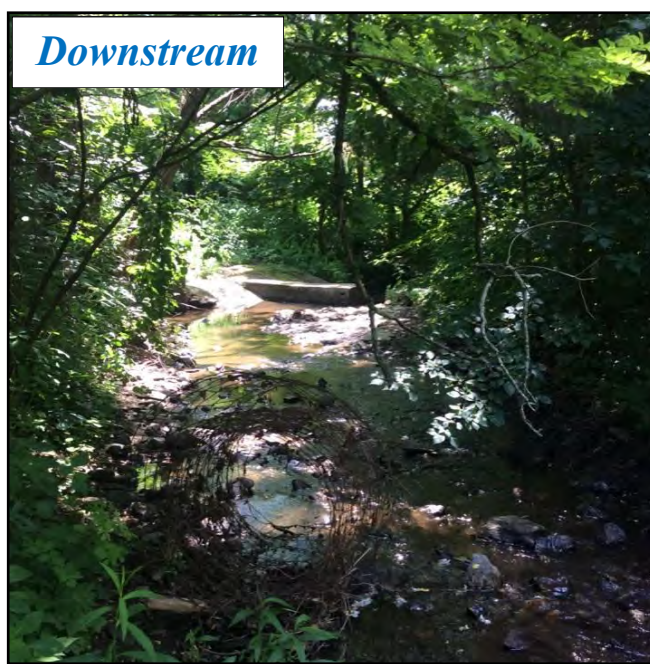
Crossing Comments: Dam 75 feet downstream of crossing.
