Town of North East

Road-Stream Crossing Management Plan

Delivered by
The Housatonic Valley Association
October 14, 2020
Updated
November 8, 2021

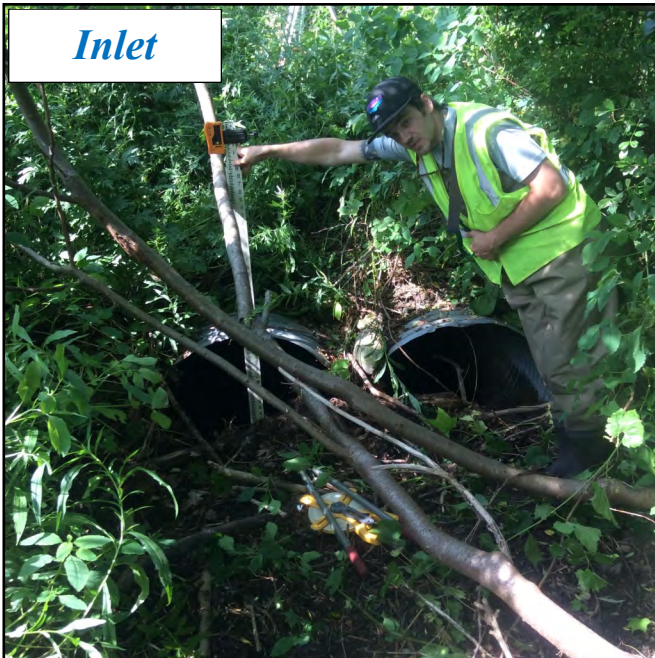
Inlet

Structure Comments: 1.4 feet inlet drop due to debris build up

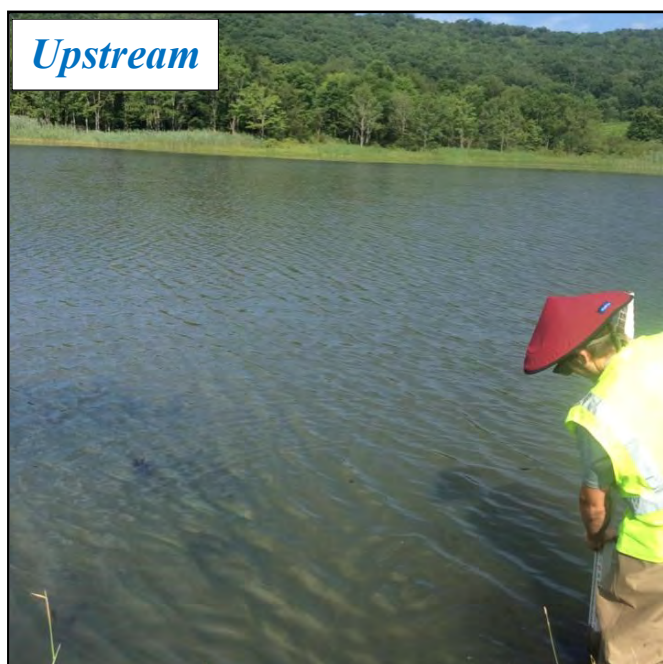
Crossing Comments: The structure is buried more than 3 feet underwater on the unfinished section of the Harlem Valley Rail Trail

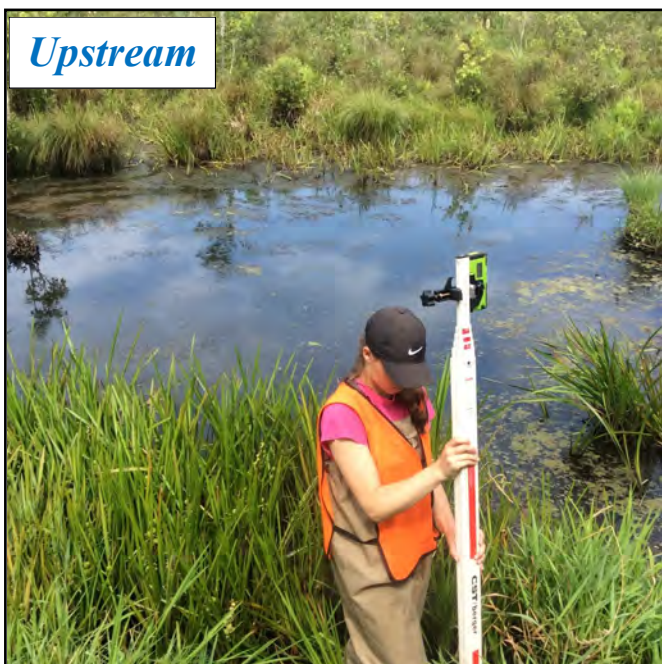
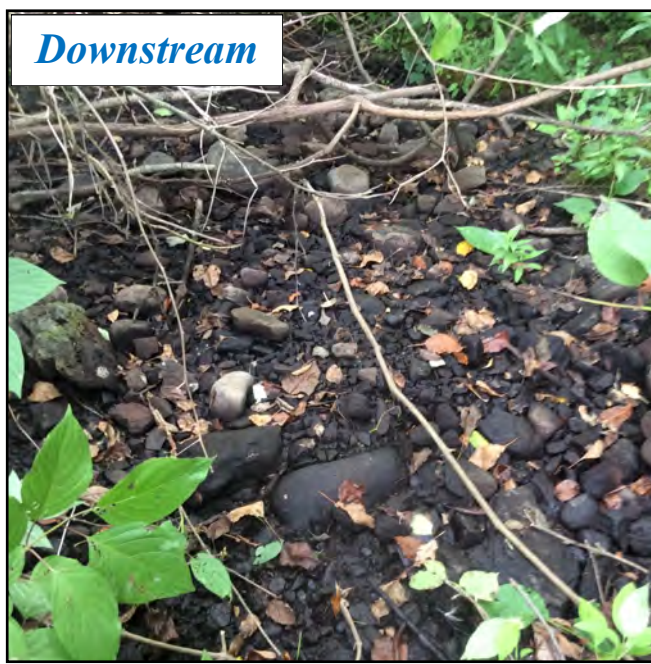
Crossing Comments: Farmer mentioned that he installed the pipe himself

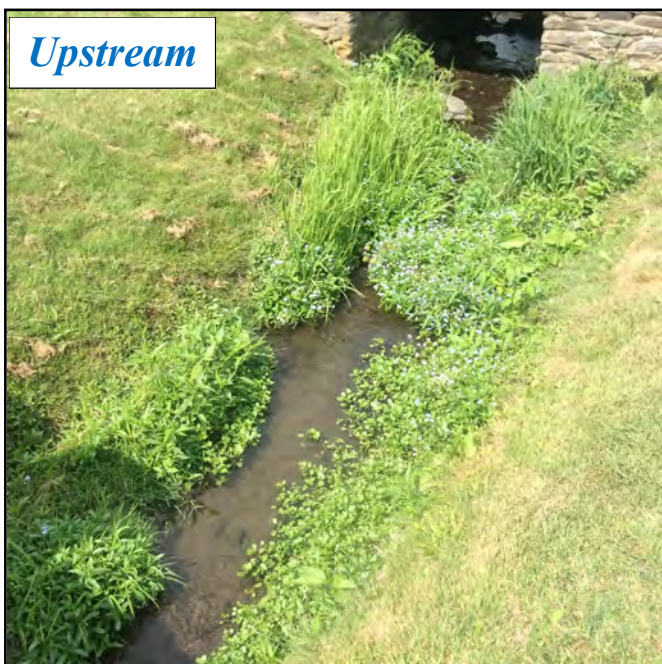
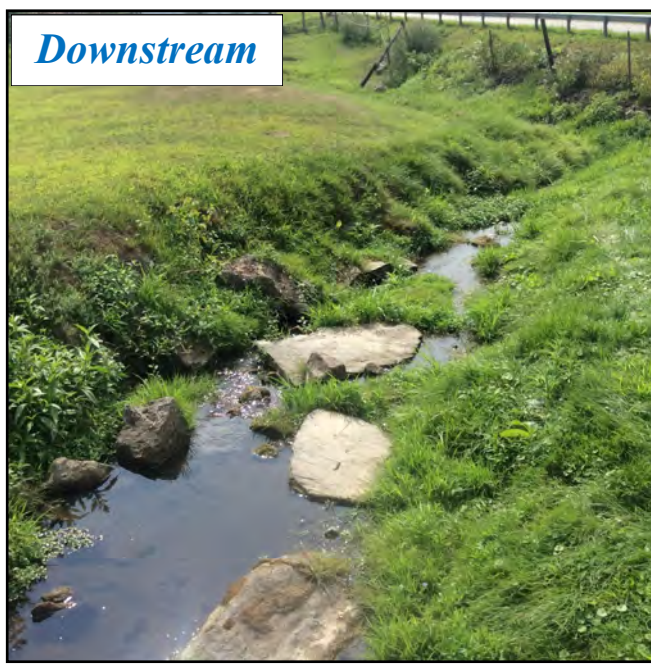
**Crossing Comments:** Dam and another culvert upstream of culvert

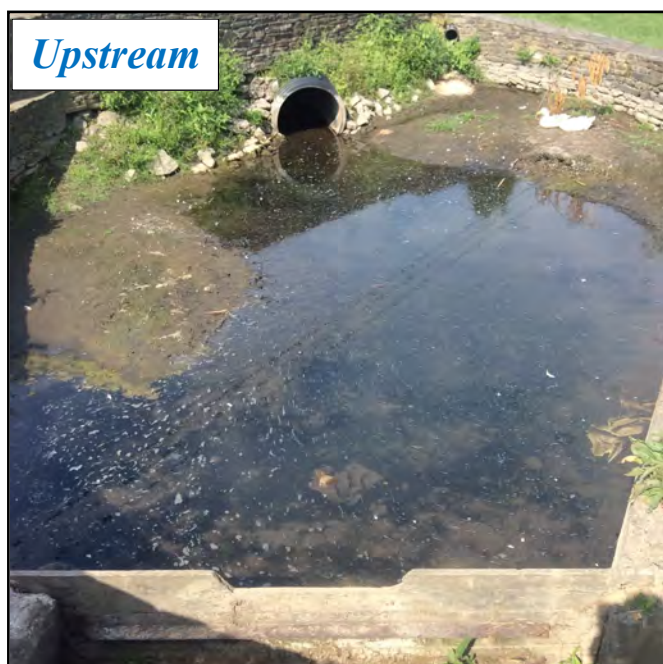
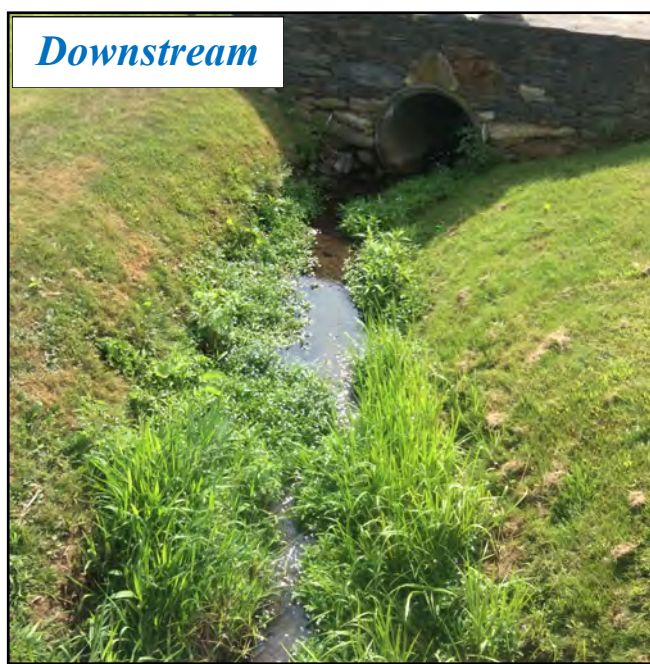
Crossing Comments: Dam 6 feet upstream from inlet

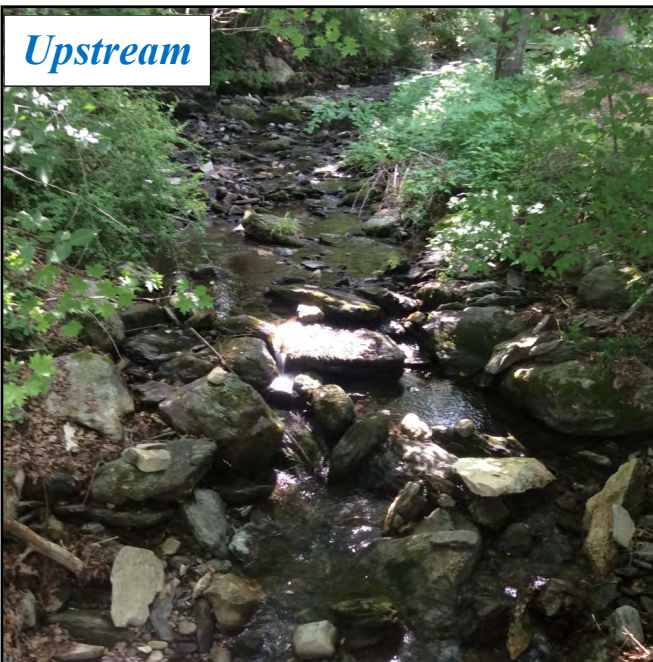
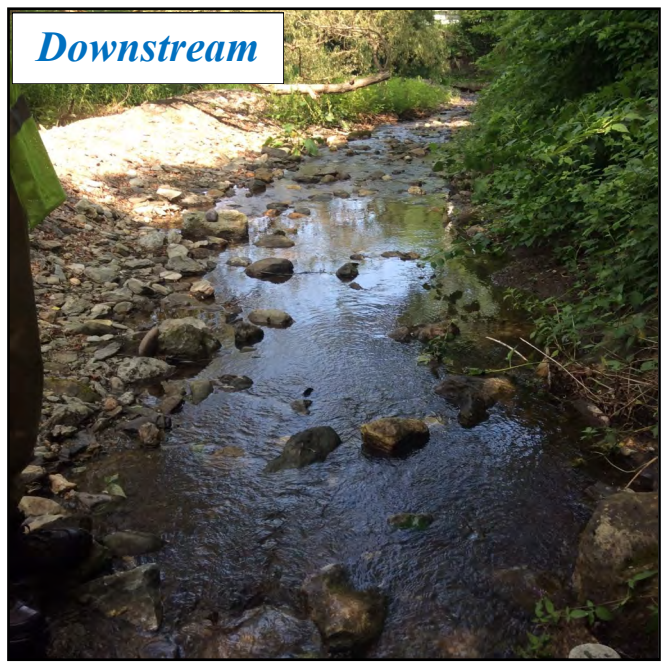
Crossing Comments: Steep free fall about 4 feet high is 30 feet downstream of this bridge.

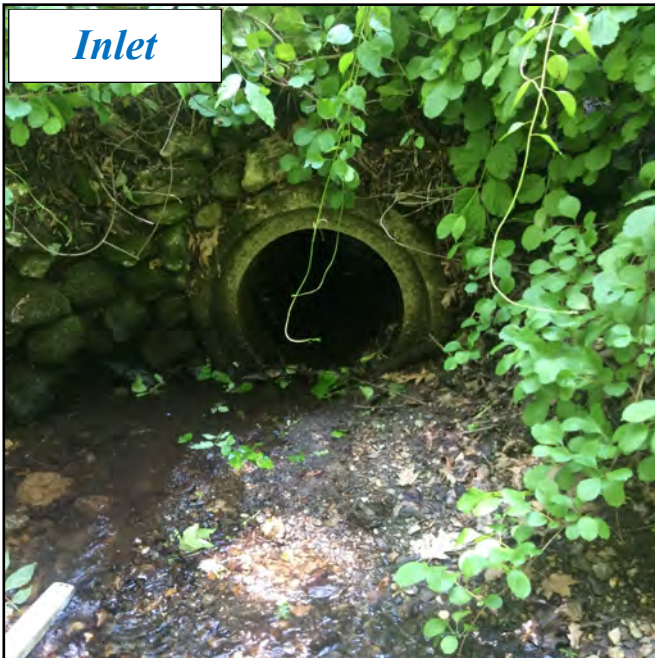
Inlet

Structure Comments: Free fall at outlet would be a barrier

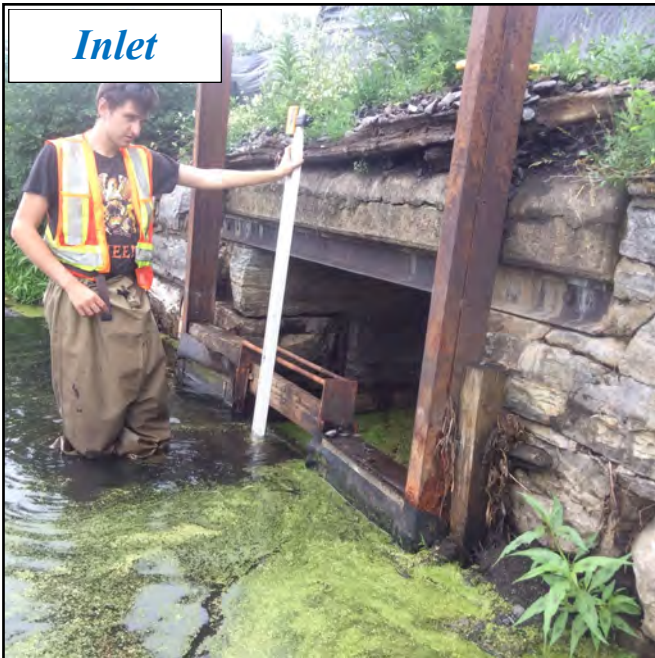
Structure Comments: Inlet drop is 0.6 feet

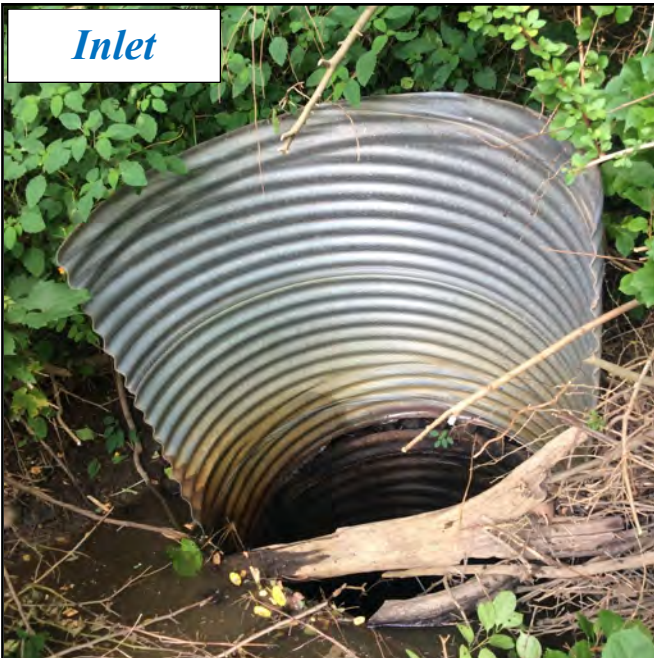
Physical Barrier(s) (Severity): None
 Slope (%): 0.06
 Structure Comments: Inlet drop of 6.2 feet.
 Length was estimated.

Inlet Shape/Type: Round Culvert/Projecting
 Inlet Drop/Grade: Inlet Drop

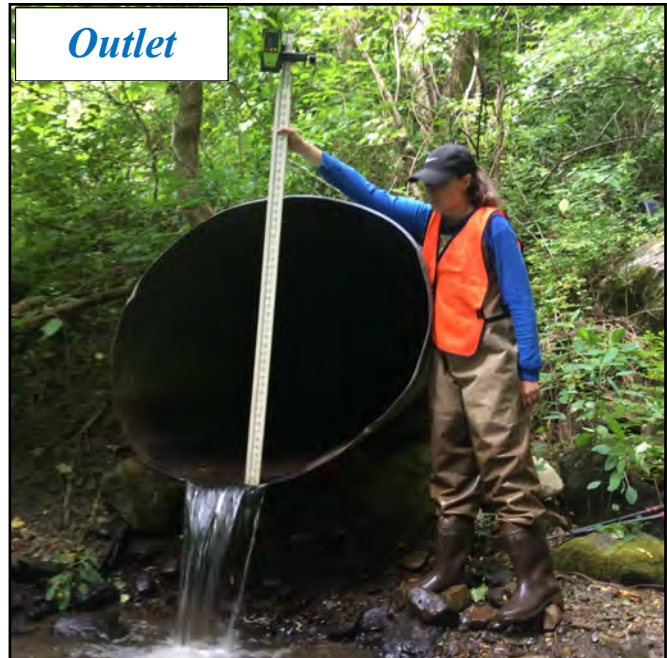
Outlet Shape: Round Culvert
 Outlet Drop/Grade: Free Fall
 Drop to Stream Surface/Bottom: 1.9/2.4

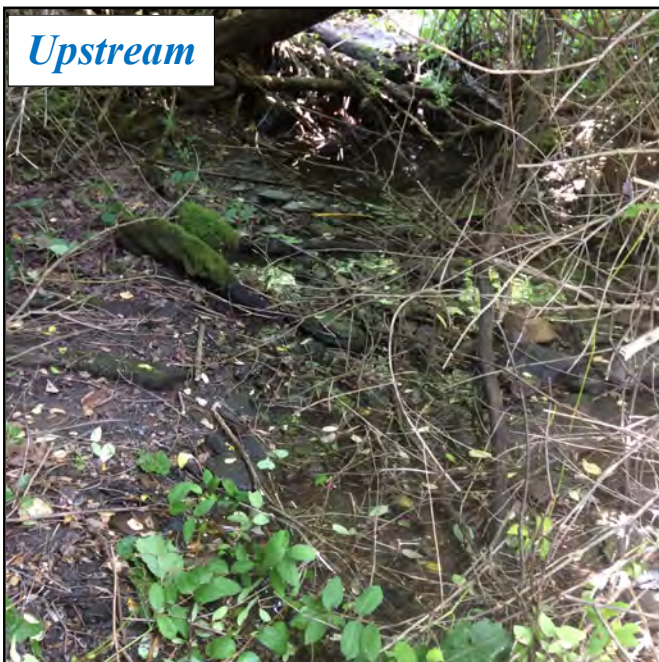
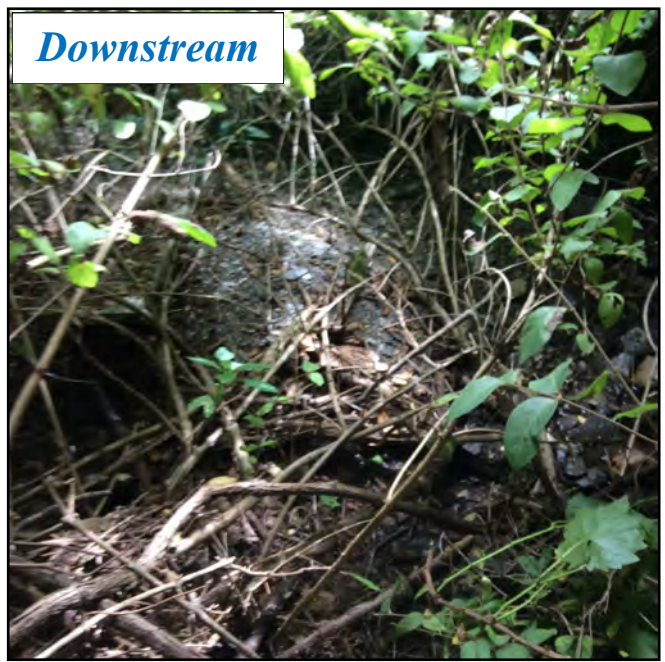
Crossing Comments: Bridge is very overgrown and starting to crumble at sides. Woman mentioned that a major flood happened recently where the water was 2 feet high and coming down to her house from this wooded area.

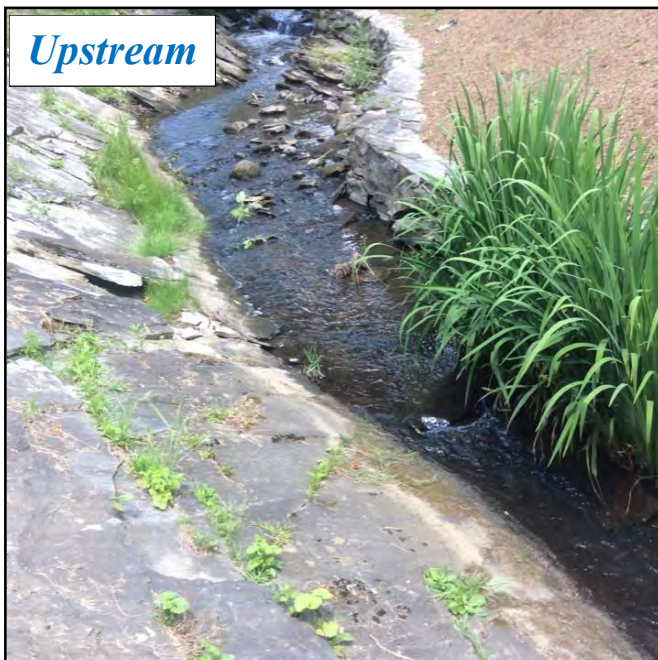
Crossing Comments: Channel upstream heavily modified. Taking more natural bankfull that we used for crossing upstream of this bridge.

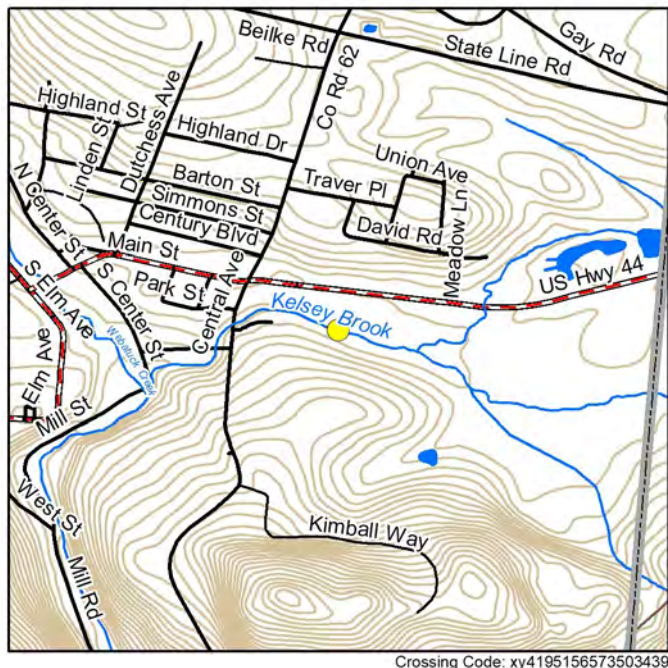
Crossing Comments: There is a large pool at inlet side due to debris damming up both inlet structures. Structure in poor condition. Tops are flattening out.

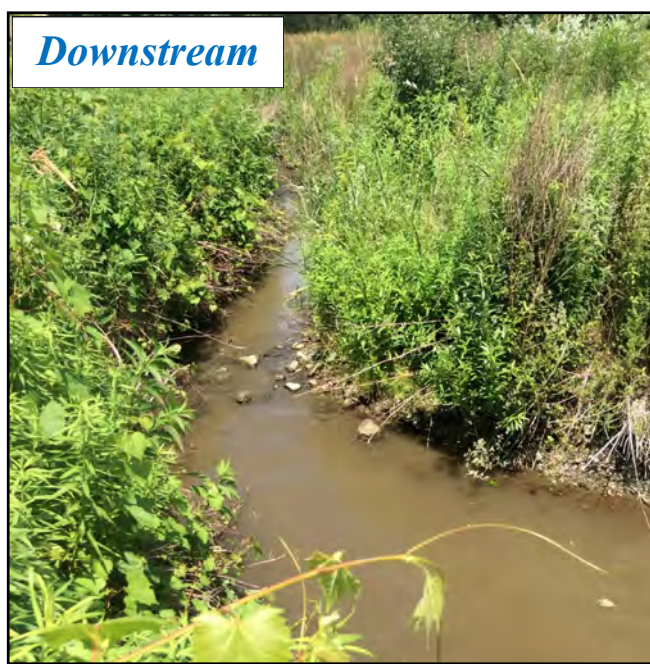
Downstream

Crossing Comments: There is a dam 5-10 feet from inlet, it's creating a waterfall.

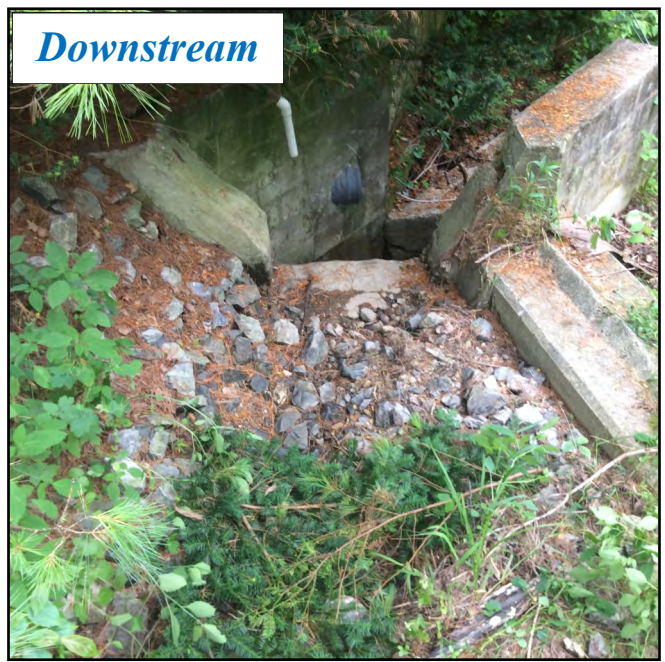
Downstream

Crossing Comments: The streambed under this bridge is dry because a grate just upstream carries the stream through 2 metal pipes and out into a concrete channel

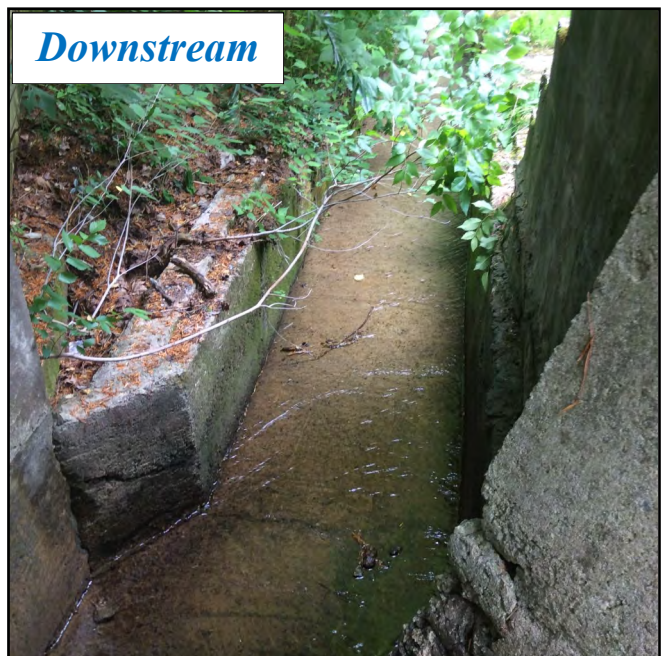
Downstream

Crossing Comments: This structure runs underneath the bridge at xy4192755273598694, Outlets emptied into channel

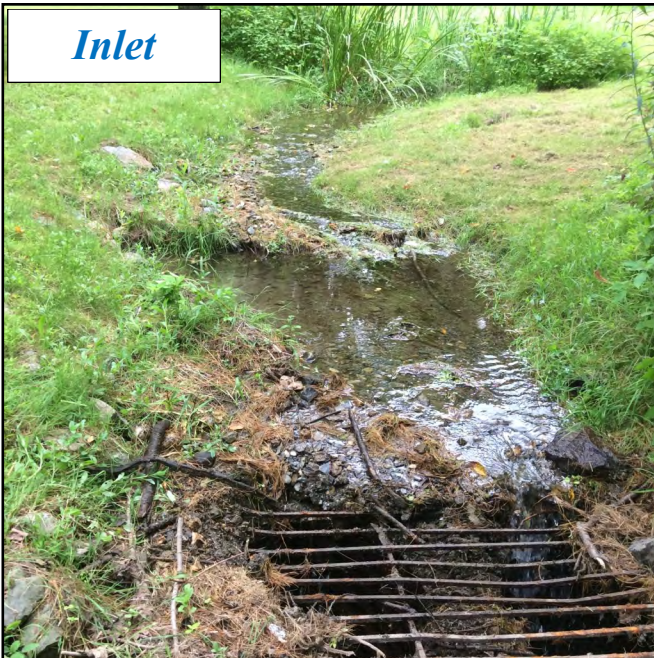
Structure Comments: Inlet drop height is the height we measured for the structure. Outlet drop

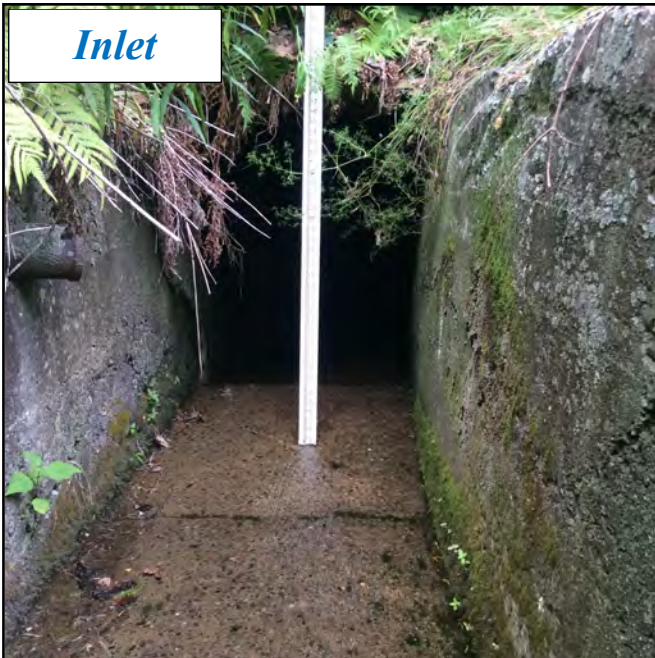
Inlet

Structure Comments: Five drops on the inside of the structure. Three are about 0.4 feet in height,

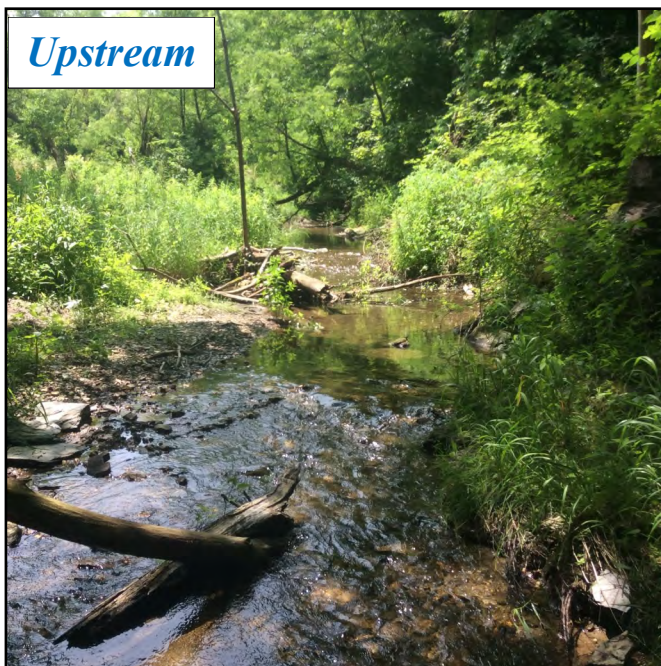
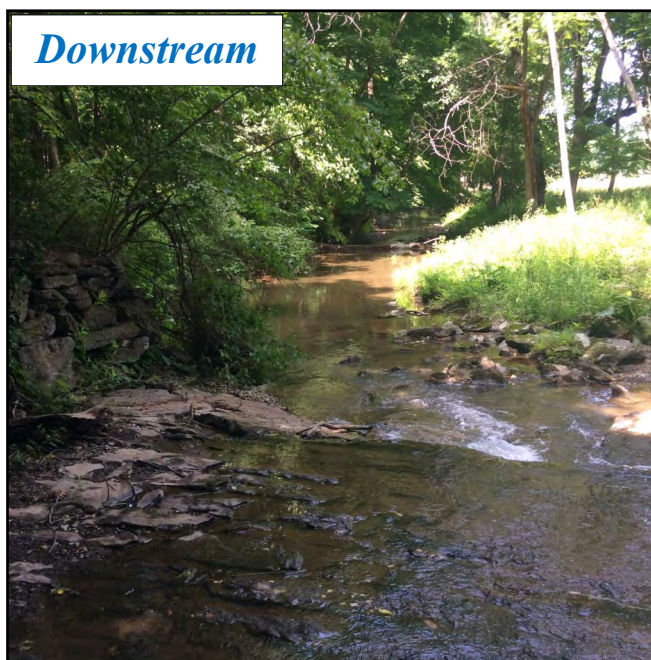
Crossing Comments: Elevation needed but too steep for stadia rod, need to do benchmarking

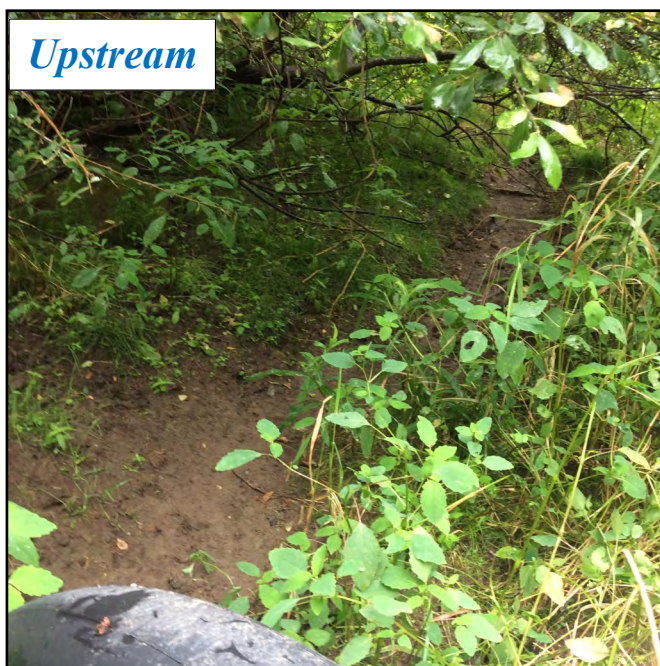
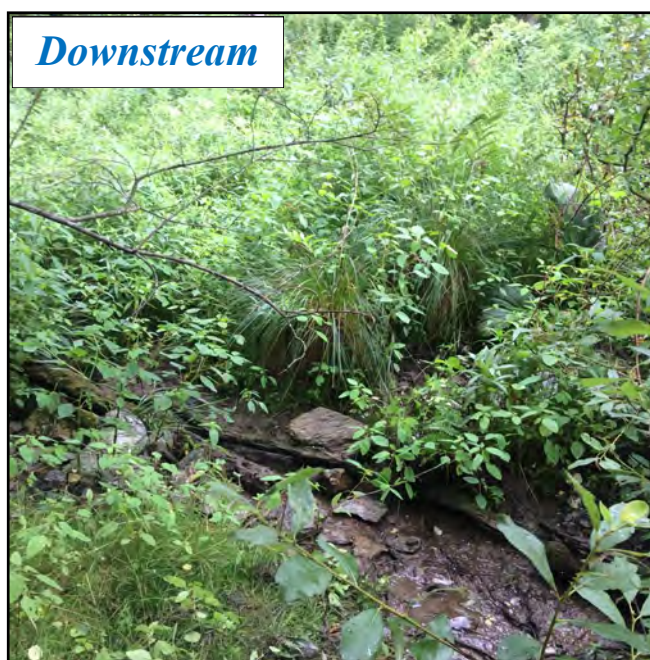
Crossing Comments: Bankfull estimated due to no easy to determine upstream channel and mostly wetland.

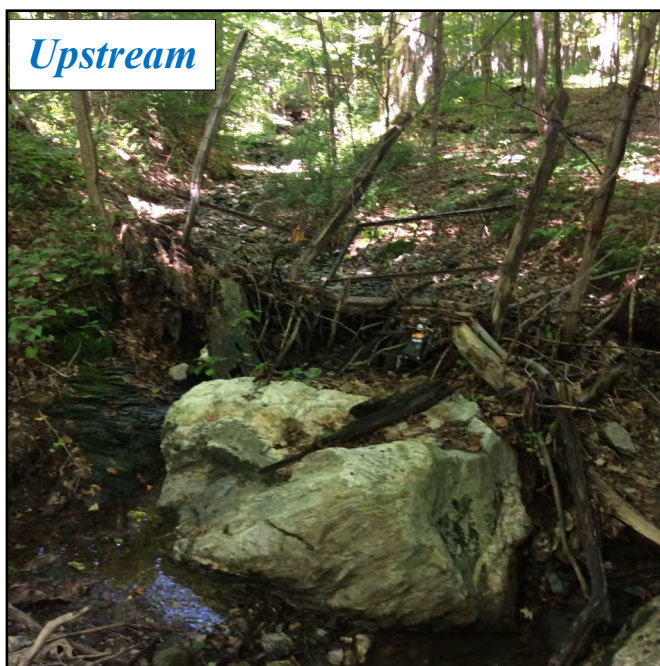
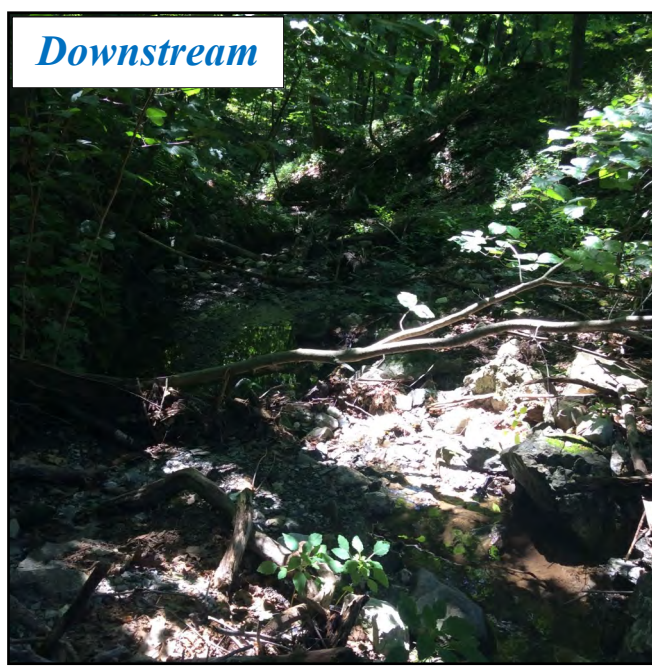
Crossing Comments: There is a large fence 15 feet upstream from the inlet with some debris blocking some flow of the stream.

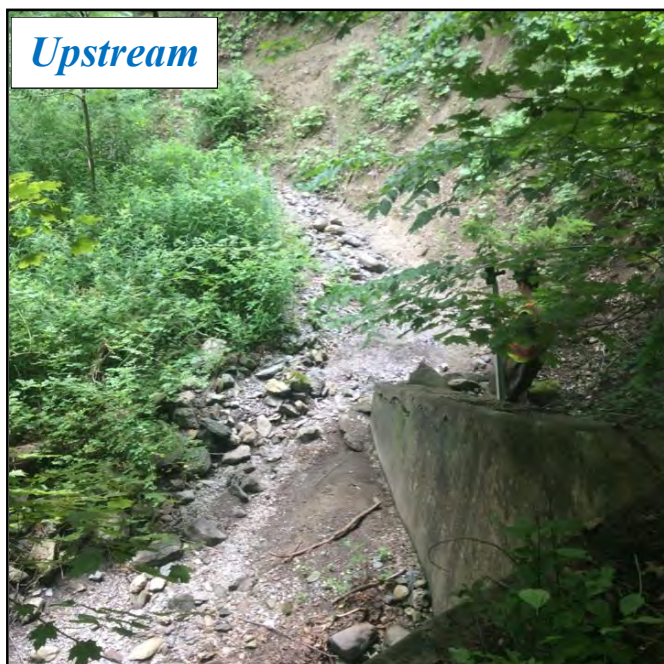
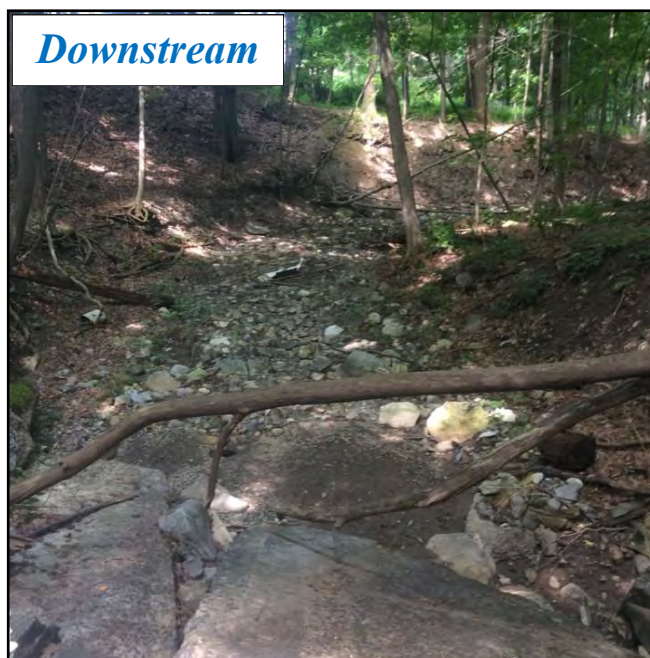
Crossing Type: Bridge
 Number of structures/cells: 1
 Condition: Poor
 Constriction: Spans Only Bankfull/Active Channel
 Alignment: Skewed (>45°)
 Internal Features/Structures: None

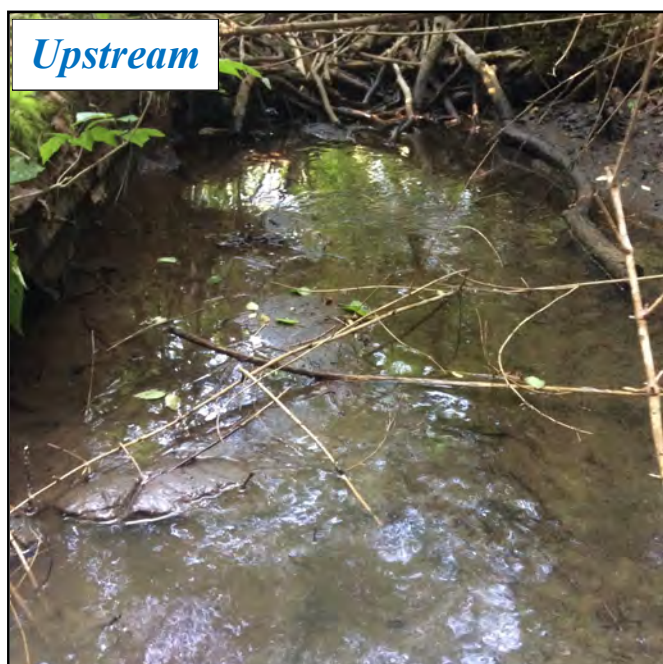
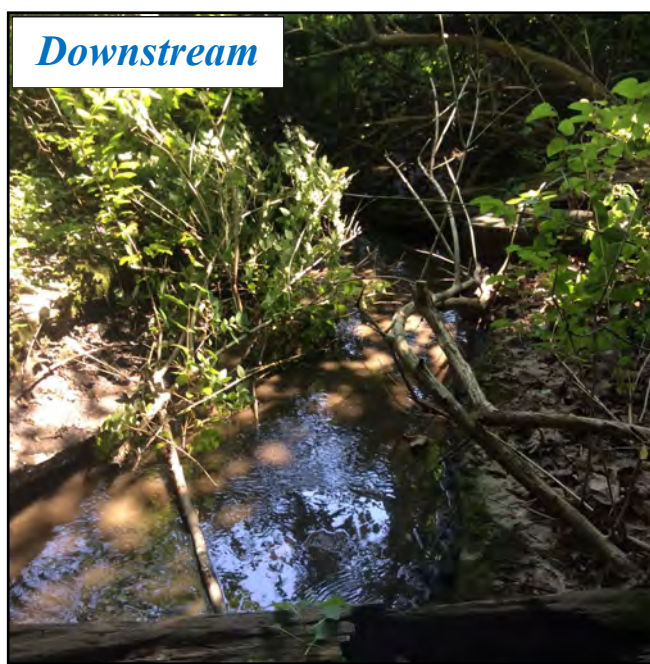
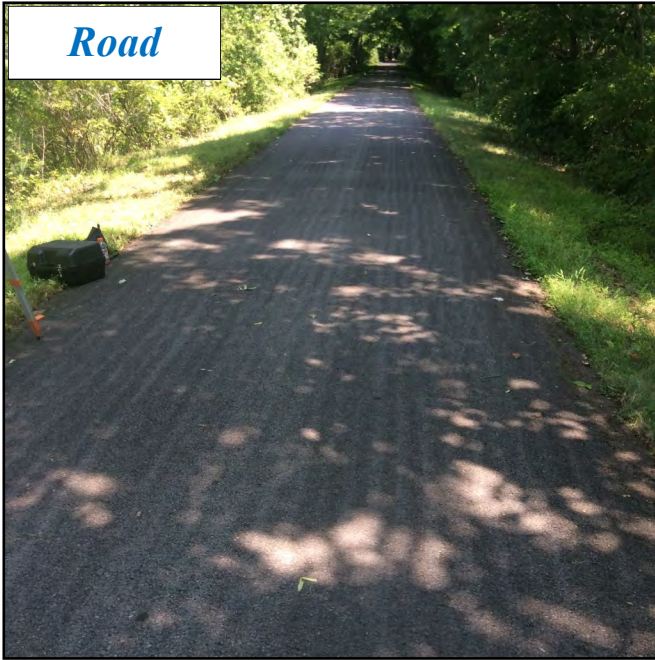
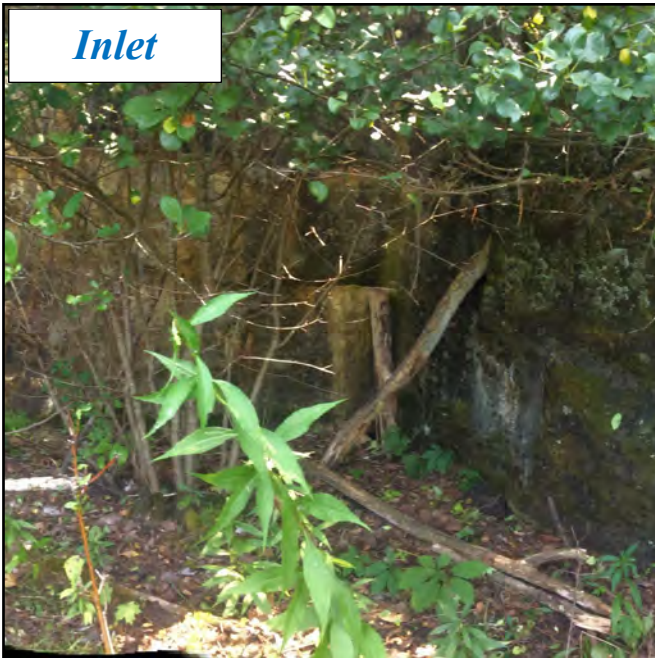
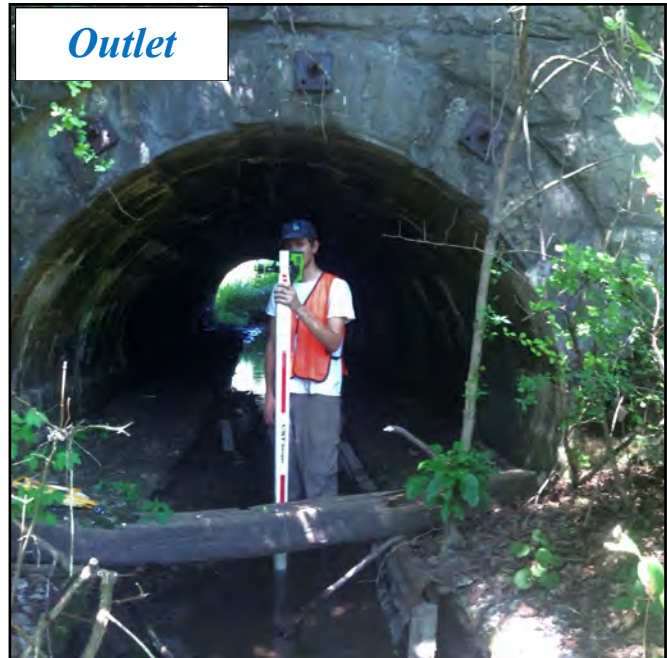
Crossing Comments: Metal siding to stream in culvert falling off. Bankfull estimated due to dense wetlands on both sides.

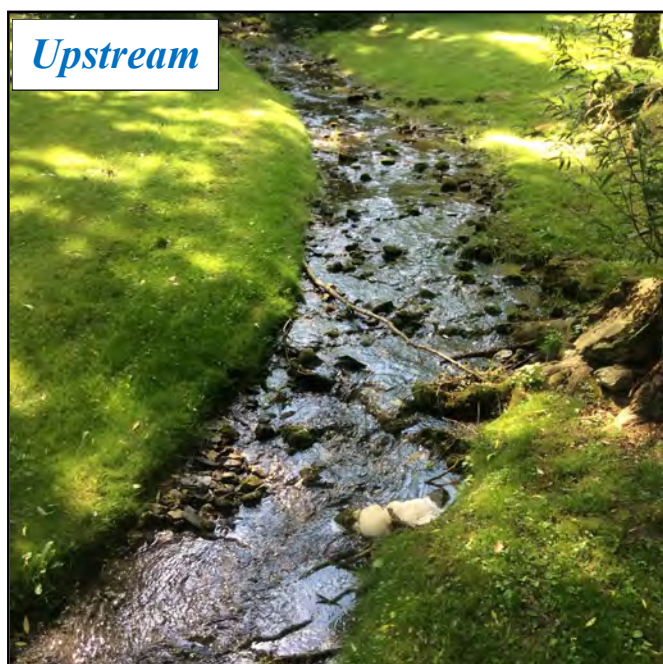
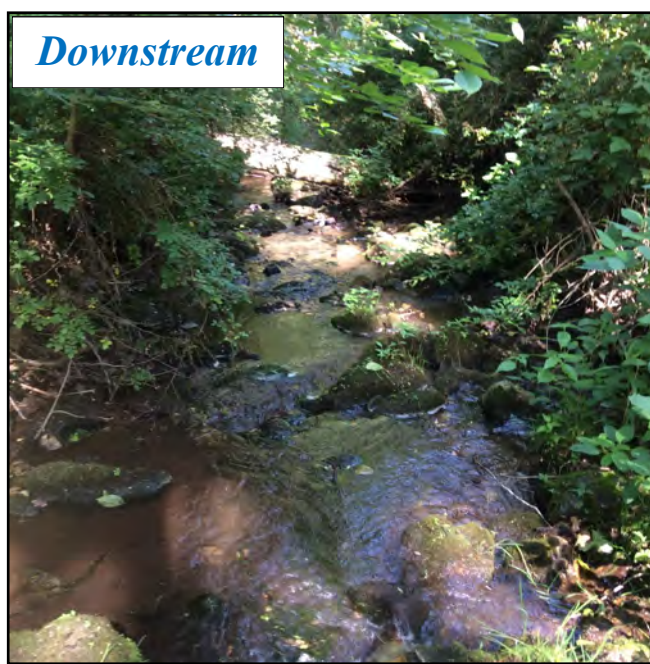
Crossing Comments: Does not appear to be any rocks or fill ,arterial between pipes. Put sticks to prevent water flow underneath and in between the pipes.

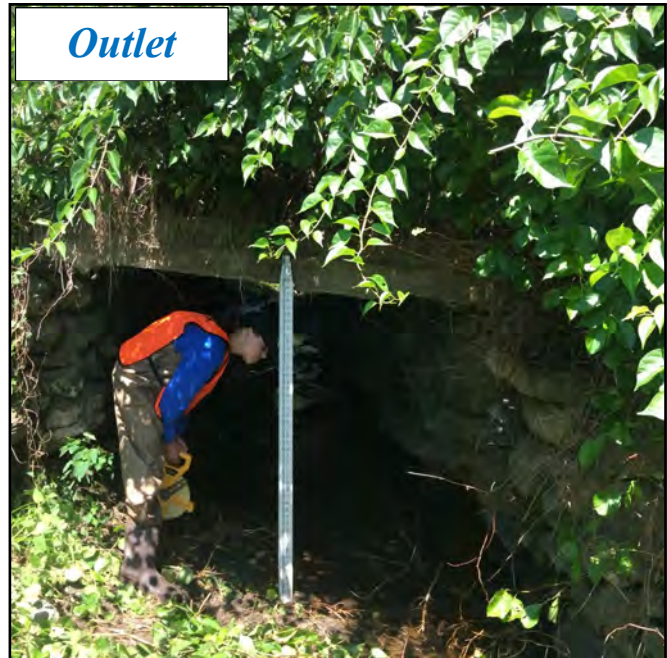
Outlet Shape: Box/Bridge with Abutments

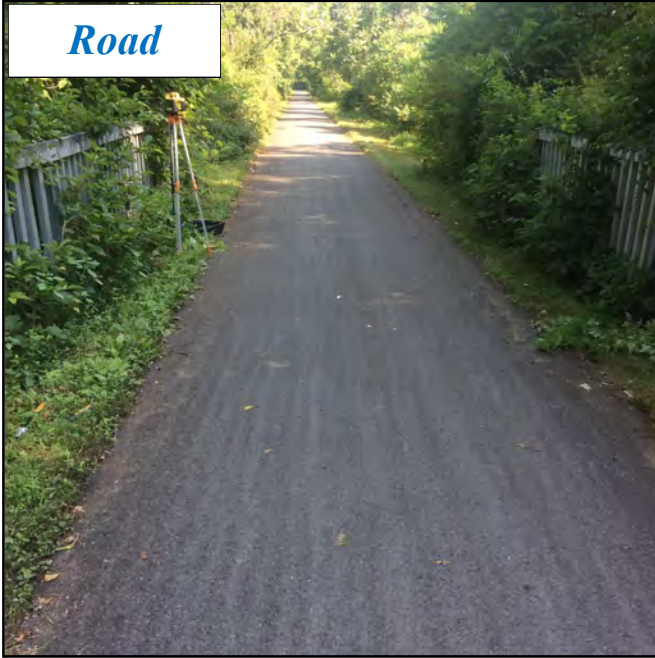
Road Type: Trail

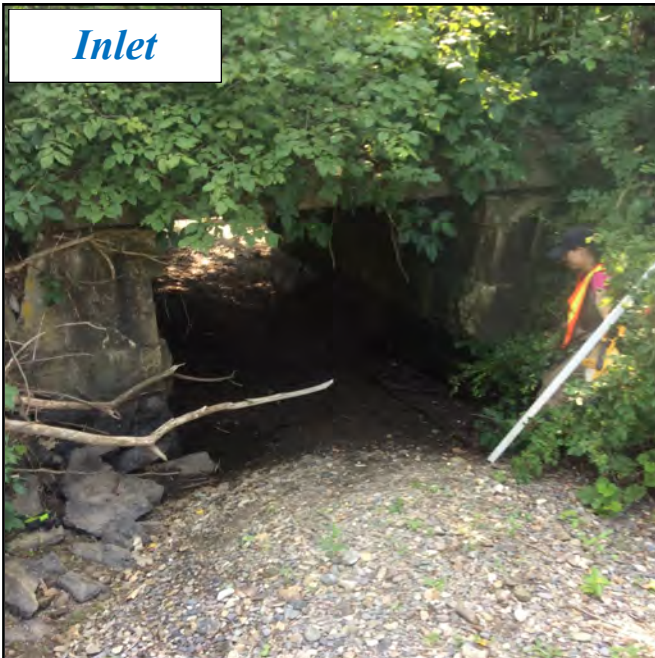
**Inlet**Inlet Shape/Type: Box/Bridge with Abutments/
Headwall and Wingwalls

Inlet Drop/Grade: At Stream Grade

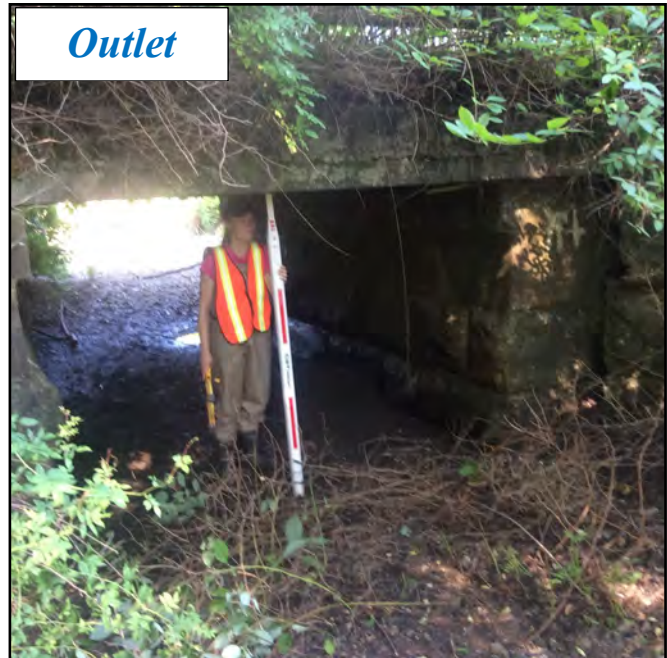
Outlet Shape: Box/Bridge with Abutments
